# Youghal Courthouse.

Youghal, Co. Cork.

**Conservation Report & Heritage Impact Assessment:**

*4th April 2024*

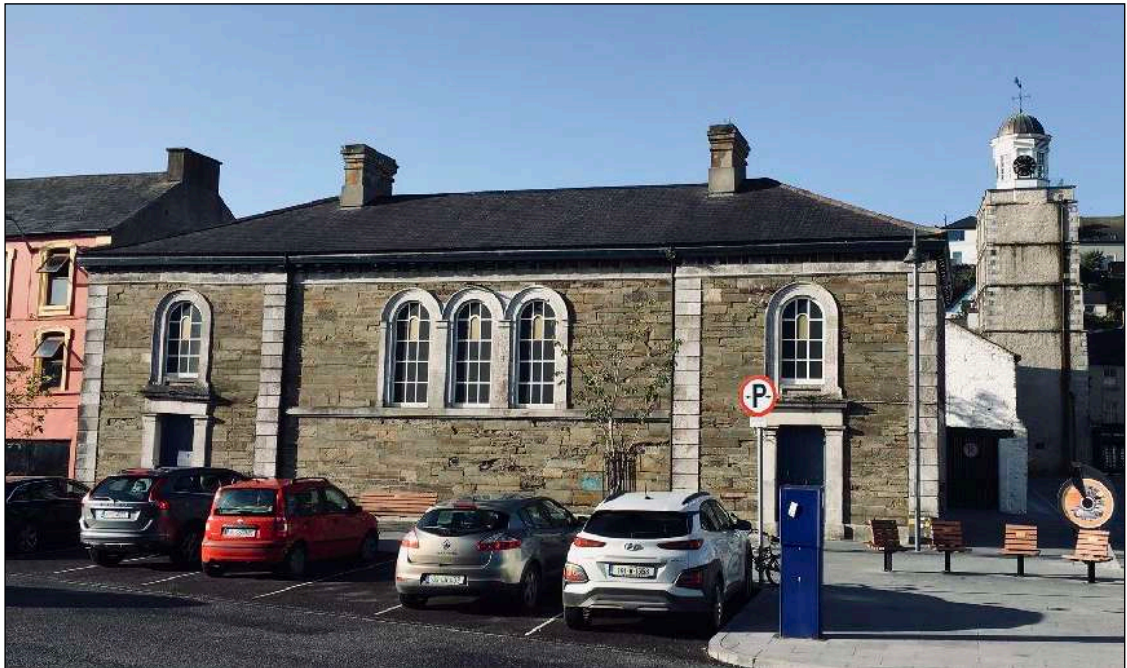
It would appear the OPW had the building re-roofed in 2014, after the building was starting to deteriorate as a result of water ingress.

The new roof appears to be Bangor Welsh slate, appropriate to the building.

• Fig 17. Courthouse Re-roofed in 2014 by OPW.

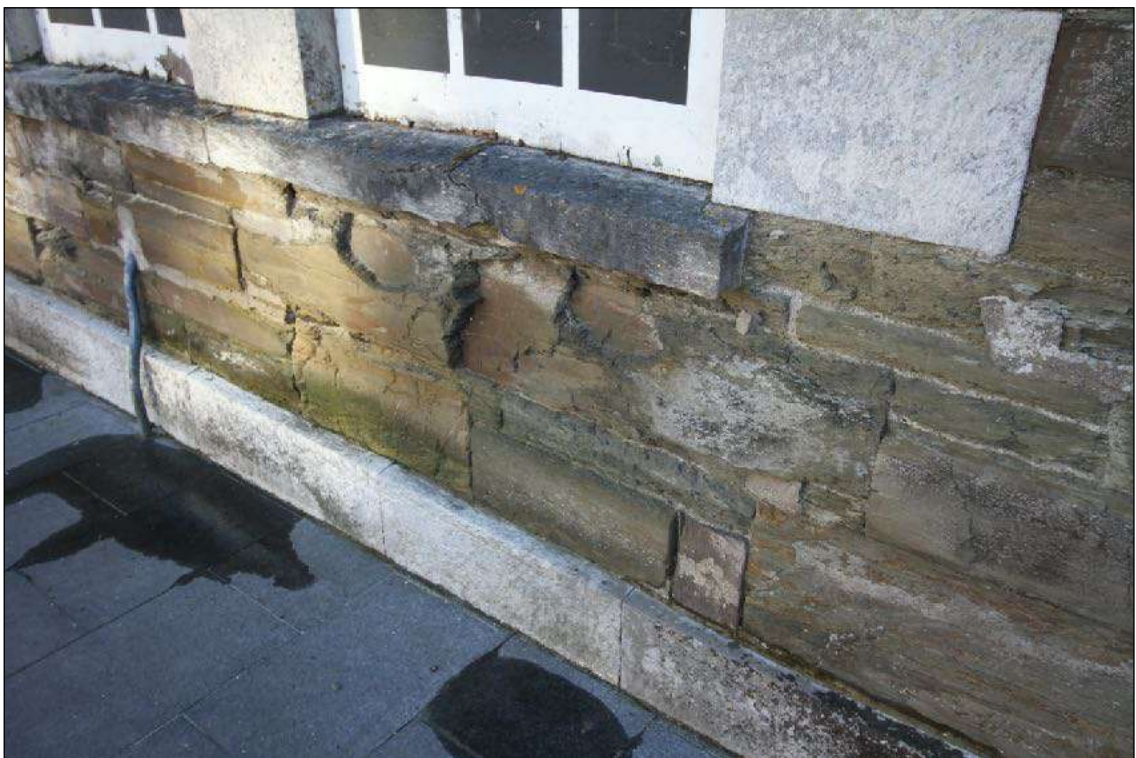
Much of the sand stone in the wall is face bedded and have suffered significant erosion as a result.

Erosion and settlement have lead to mortar joints being open in many areas and exacerbating the problems of water ingress, the associated frost damage, and water being absorbed. Some sand cement pointing repairs also add to the problem and will need to be addressed, by removal and repointing in Lime mortar.

• Fig 28. Eroded pointing and severe erosion in face bedded stones.

The exterior of the building will undergo a complete refurbishment, with stone walls being re-pointed appropriately with lime mortar pointing, to improve weather resistance and to secure loose material (stone) on the facade. A more detailed study has been prepared to review this remedial work.

All external stonework defects and pointing will be addressed, and this repair work will potentially have a minor impact. The solution to the porous face bedding spalling stonework may impact on the external appearance, and will need careful consideration.

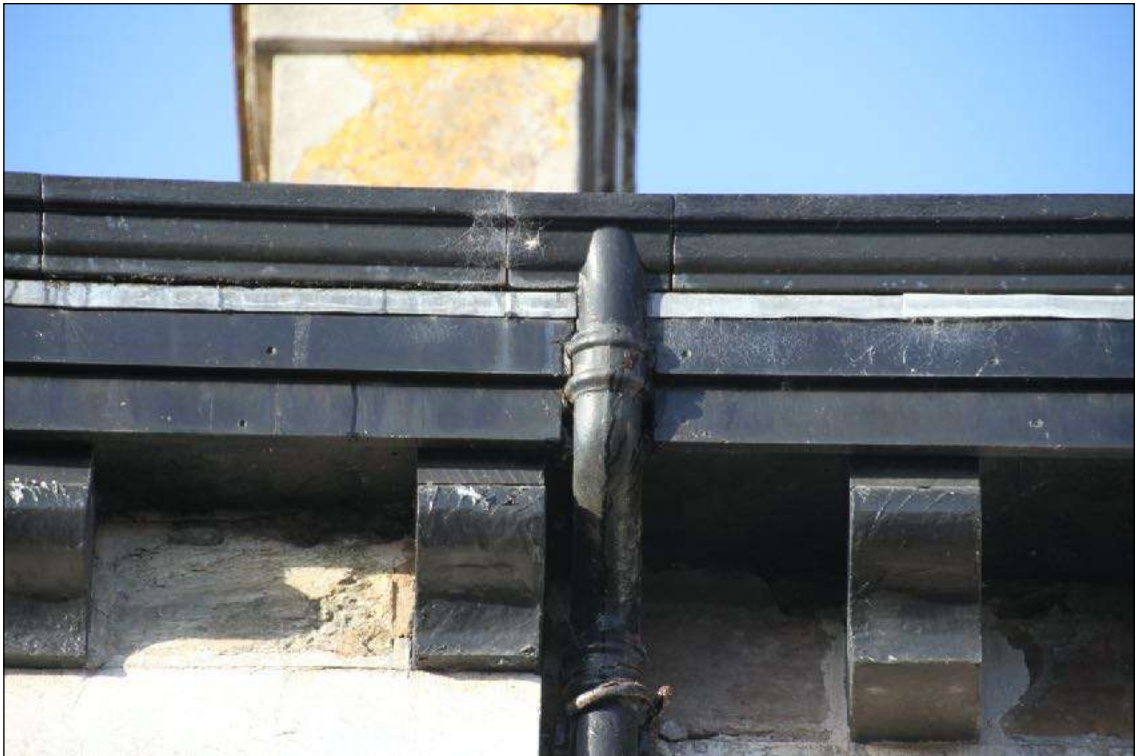
There would need to be a close look at the gutter detail and associated flashings to ensure avoidance of a situation where bimetallic corrosion might result.

• Fig 29. Gutter detail to Courthouse and flashing and possible steel channel detail to be investigated.

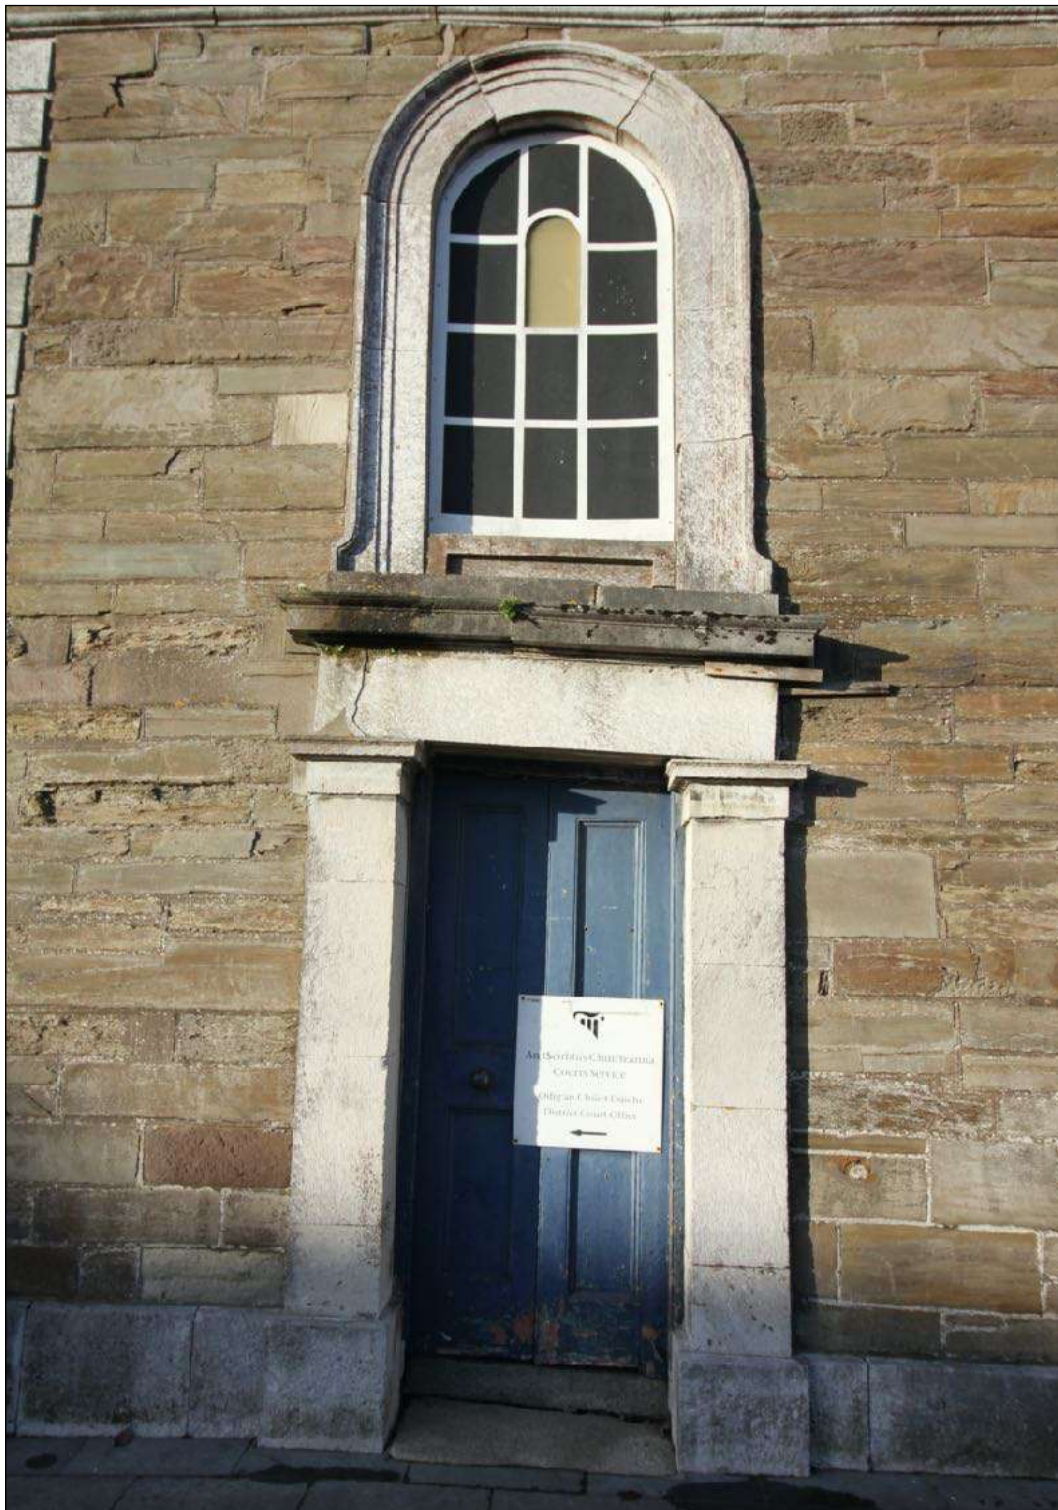
There are many areas where the Courthouse building has significant subsidence and settlement. A previous report by David Kelly partners has recorded the extent of settlement at between 70mm in NW corner and 93mm in NE Corner.

• Fig 31. Settlement in South East corner.

The settlement and movement issues will be addressed. In more detail in Horgan Lynch reports and survey and site investigations will throw more light on the matter.

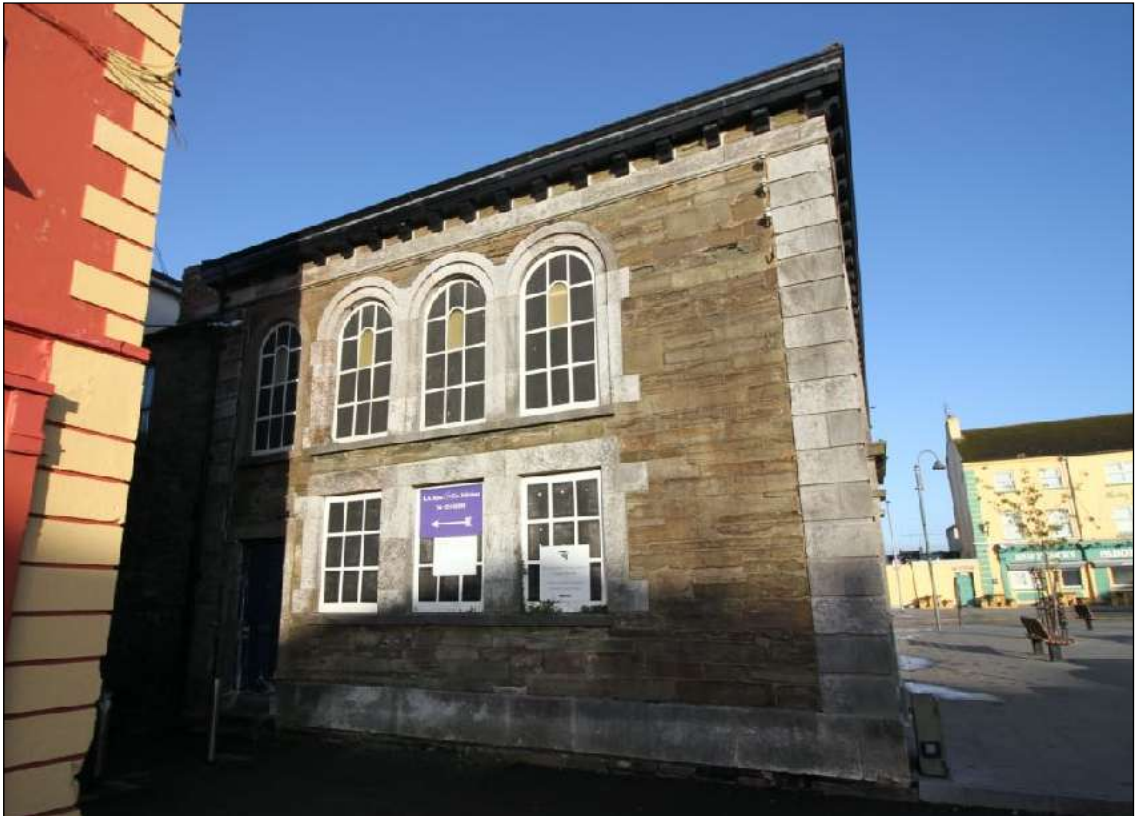
• Fig 32. Southern East gable with many of the same issues as North Eastern front wall.

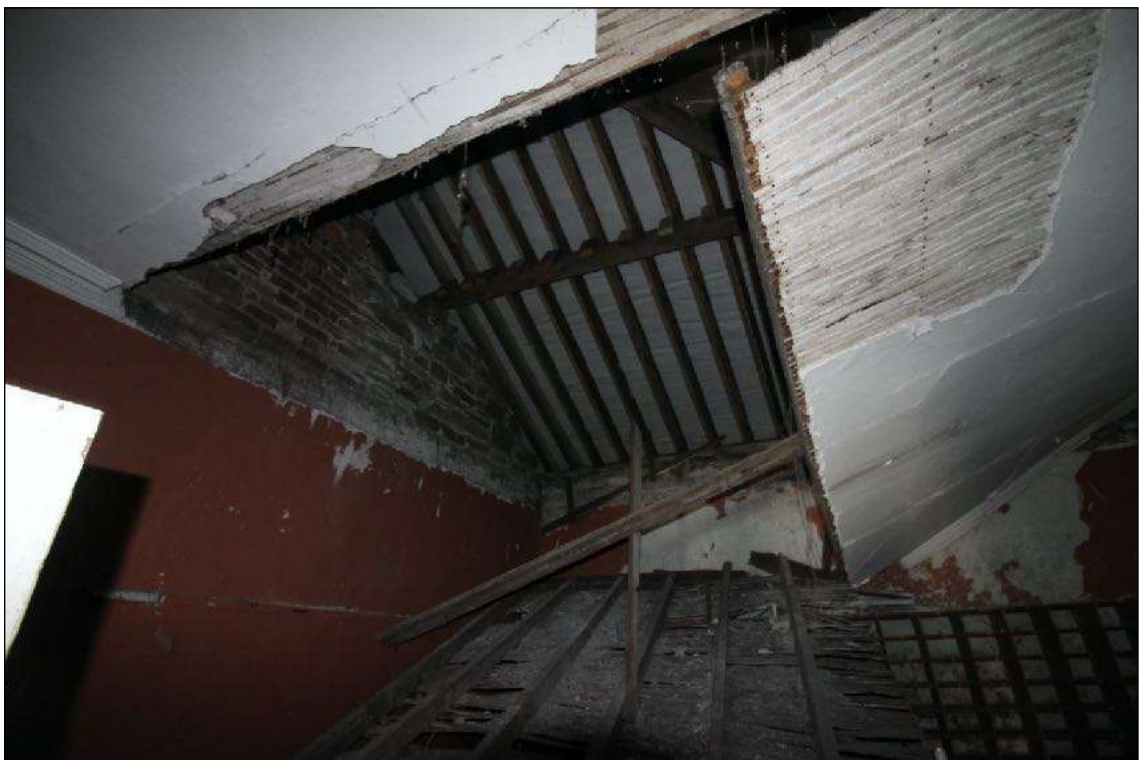
• Fig 104. Room. 20 Collapsed ceiling.

Ceilings generally are lath and plaster as evidenced by the collapsed ceiling in the original office. Cracks in the ceilings generally and deflection, indicates the likelihood that ceiling are separating in parts from joists. In places there is evidence of woodworm attack and also dry rot clearly visible in other locations.

A report specifically into the rot and damp issues would be advisable to establish the extent of issues and likely treatments.

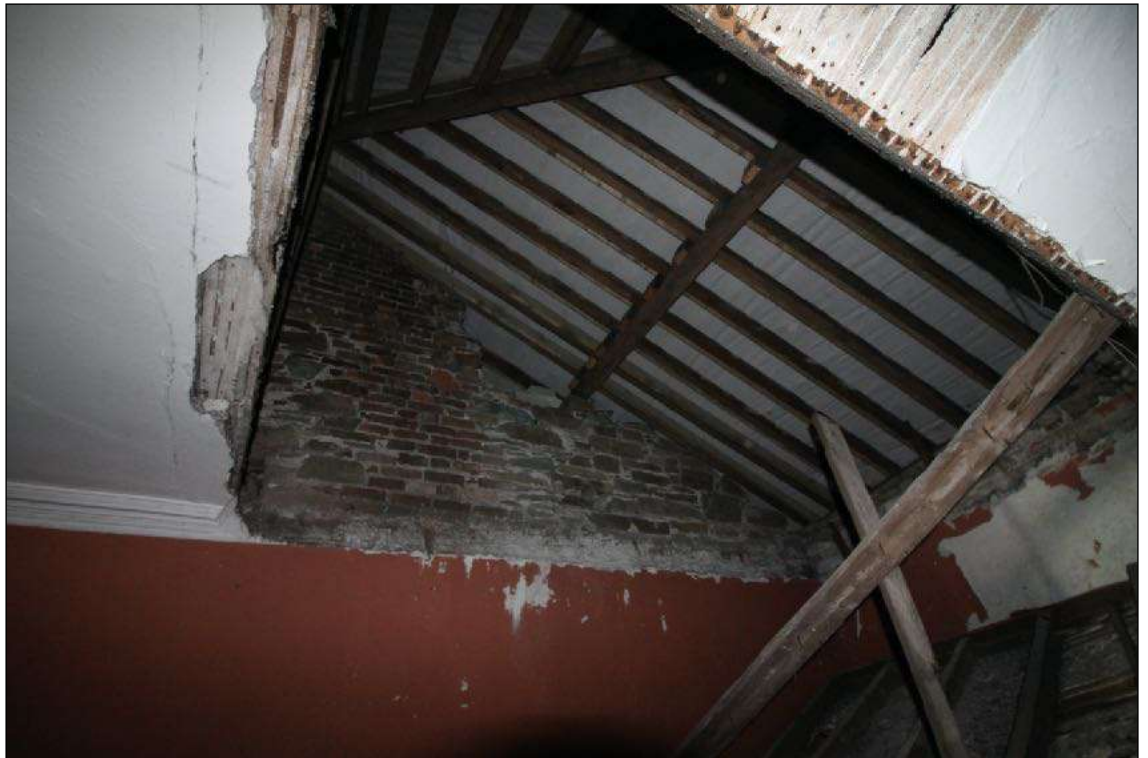
• Fig 105. Room. 20 Collapsed ceiling.

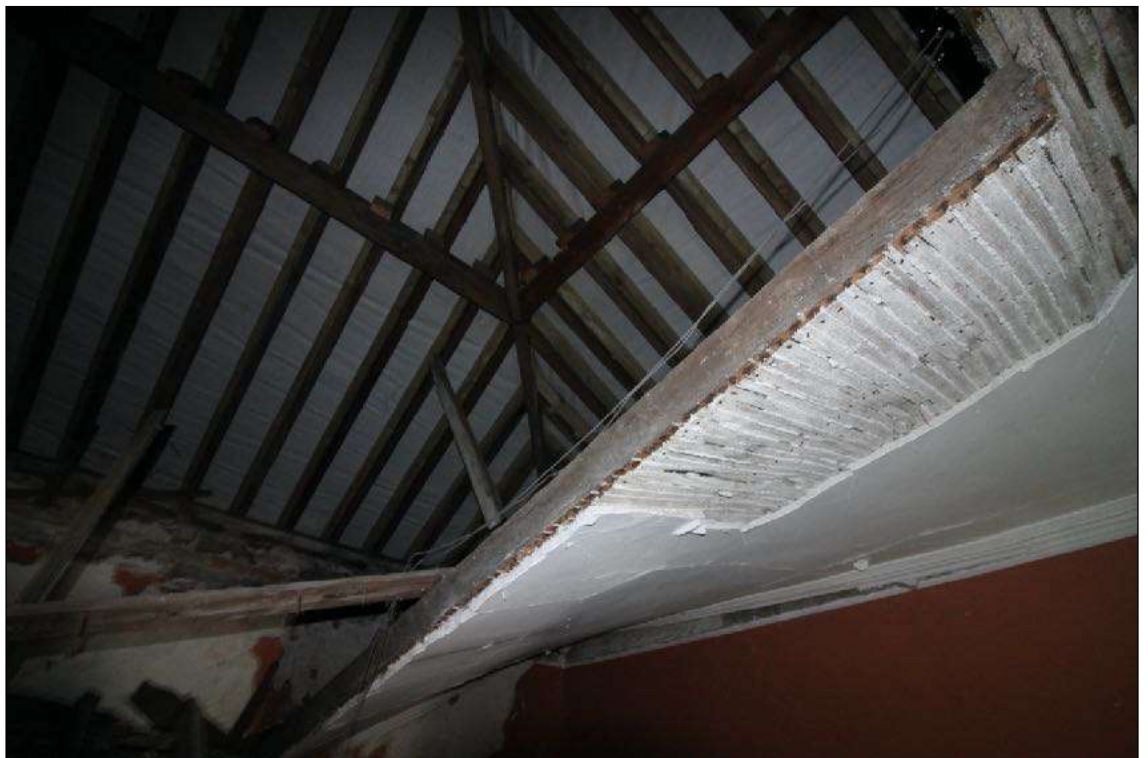
• Fig 106. Room. 20 Collapsed ceiling.

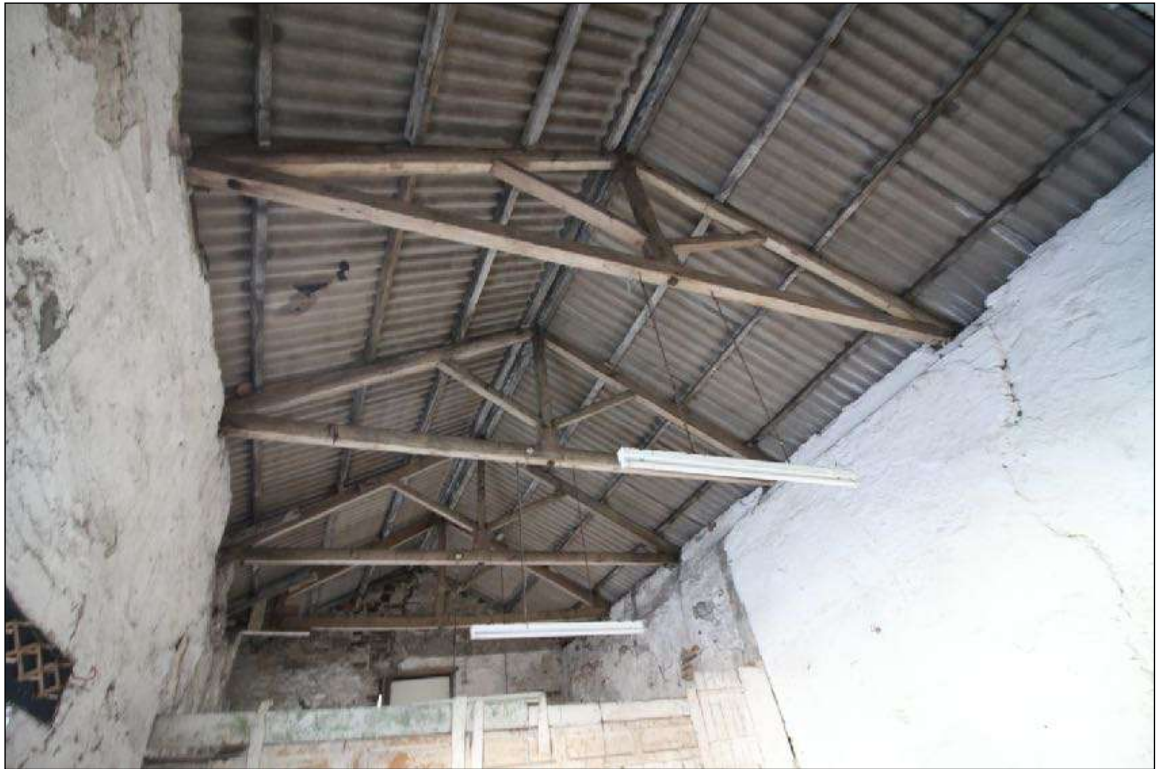
The roof of the Soup kitchen was clearly not part of this same project and is in need of replacement. This roof is most likely to be a typical Corrugated asbestos sheet roof, with some previous repairs in corrugated iron. Survey would be required and asbestos specialist engaged to remove and dispose of.

• Fig 119. Roof structure and corrugated sheets above.

The Soup kitchen roof will need to be replaced. This corrugated roof will have to be removed. The roof will be re-slatted. A full assessment of structural timbers will be carried out when works are being undertaken and no sound material will be removed, with repairs as required.
