## Conservation Report

### Old Barrack Road, Bantry, Co. Cork

### Cork County Council

Document Title: Conservation Report

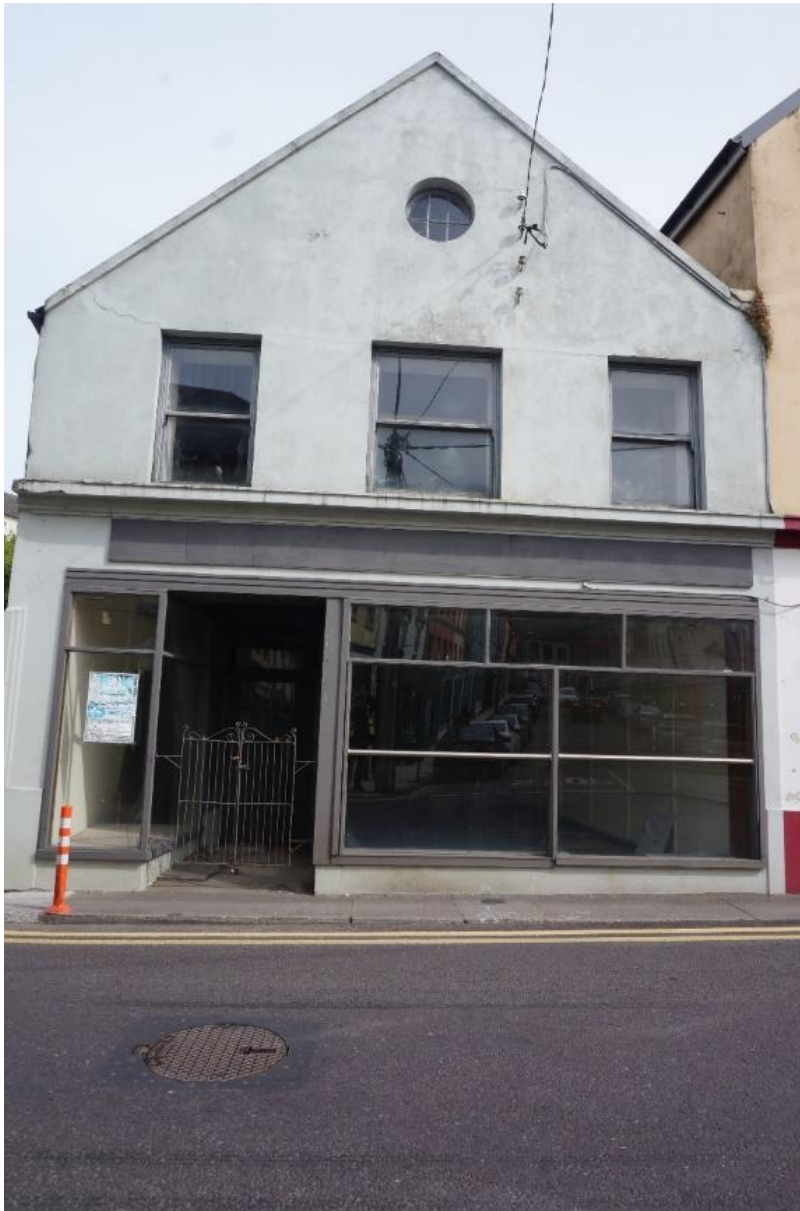
c. 1950's ground floor shopfront joinery.

More intact of the pair with boarded loft floor. Remnants of partition suggest ground floor was later subdivided with retail to one side and stair access to above. Stair joinery intact – simple.

Good.

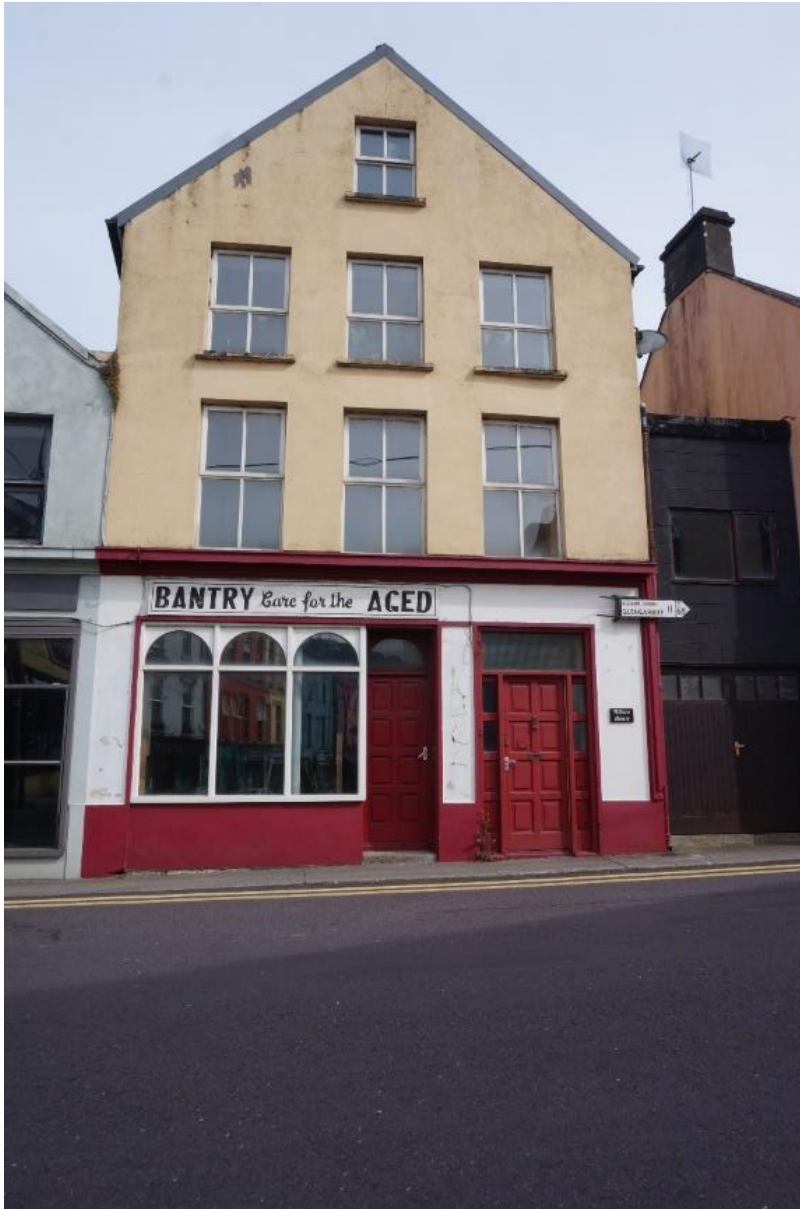
Roof structure and finishes survive including collar trusses with timber purlins each side supporting a battened and slated roof with lime parging to underside. Modern timber top hung casement sashes. Smooth plaster render retaining early 20<sup>th</sup> c. concrete moulded cornice shared with Building A. Former shopfront for Bantry Care for the Aged charity shop remains.

Building interior has been heavily modified c. late 20<sup>th</sup> c with new timber staircase, drylining, and joinery throughout. A decorative cast-iron column supports the shopfront beam.

Good.

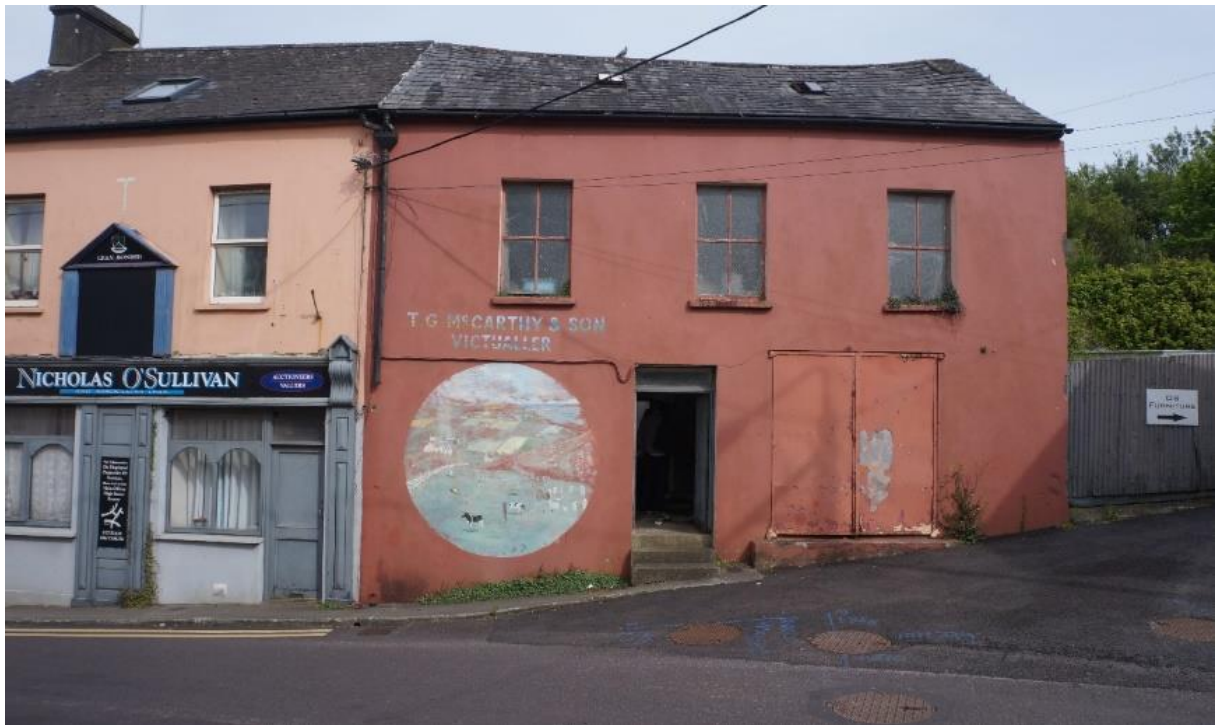
1800s constructed building with 2 entrances, the double doors used to bring animals into the abattoir/victualler. A mural on the façade depicts this narrative and is titled "T. G. McCarthy & Son Victualler", which was the name of the business. Building retains a slated roof to roadside elevation and replacement corrugated metal to rear. Pegged timber truss and purlins survive. Stone masonry walls with smooth plaster external render.

Building is in an extremely poor and vulnerable condition. Most of all the first floor has been lost and the attic floor is at the point of collapse.

- Stabilise structure in the immediate term to prevent further structural deterioration.
- Ensure weather envelope is intact addressing roof allowing temporary repairs to any leaks.
- Permanent works to include:
  - repairs to roof structure to include retention of existing historic trusses and purlins. Allow for new natural slate finishes.

- retain, repair, and consolidate existing stone masonry walls carrying out repairs to buckeyes and distorted areas (particularly beneath first floor window cills). Allow for new external lime render and consider a breathable insulated lime-based Atwater to the internal faces. The existing circular painted mural should be retained, as it provides an illustration of the historical use of the building, contributing to the ACA streetscape.
- reinstatement of first floor in position of floor lost utilising existing joist pockets for new floor joists.
- repair first floor fenestration.
- install new internal partitions and finishes as per design architects' intentions assuming residential use to upper floor.

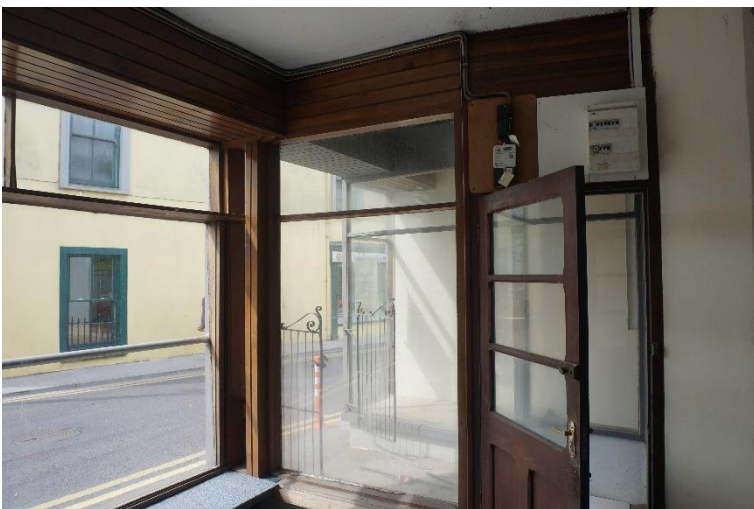
**29**  
Interior of Building A. Note door to retail unit.

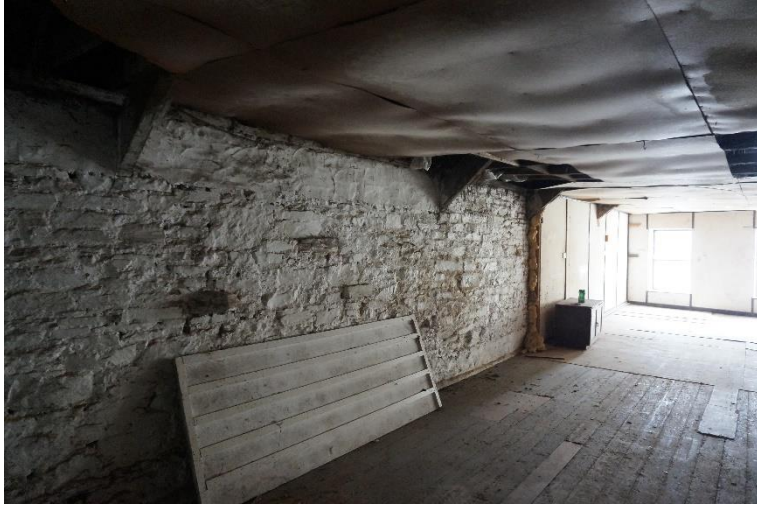
**30**  
Interior of Building A.  
Original stone structure  
exposed, and timber  
floors.

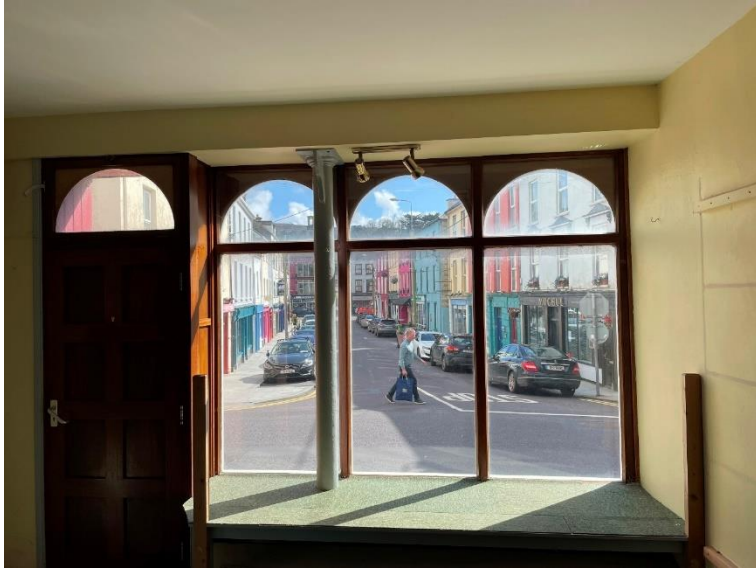
**35**  
Interior of Building B.  
Shopfront, front entrance,  
and cast-iron column.  
(credit: Cork County  
Council)

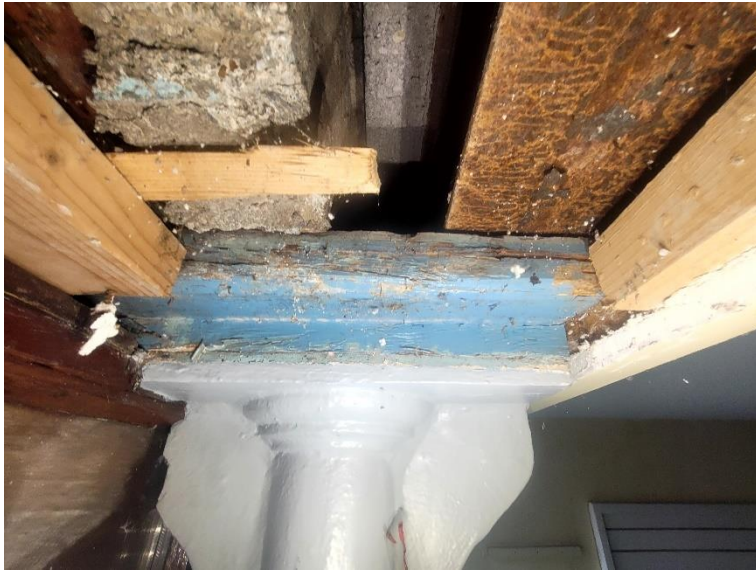
**38**  
Interior of Building B.  
Reveal of alterations and  
cast-iron column. (credit:  
Cork County Council)

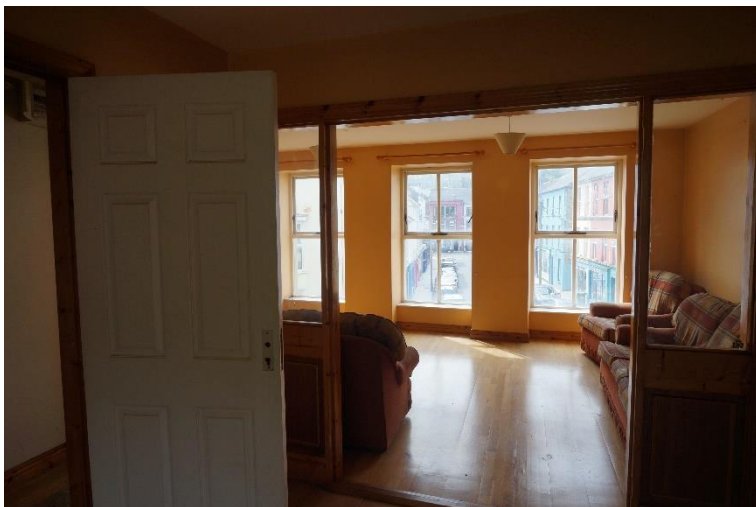
**41**  
Interior of Building B.  
Walls have been dry-  
lined. Not original to build.

- The quality of the work previously completed on these buildings should be analysed, i.e. dry lining of Buildings A, B, and C, to ensure there is no signs of building failure, etc.

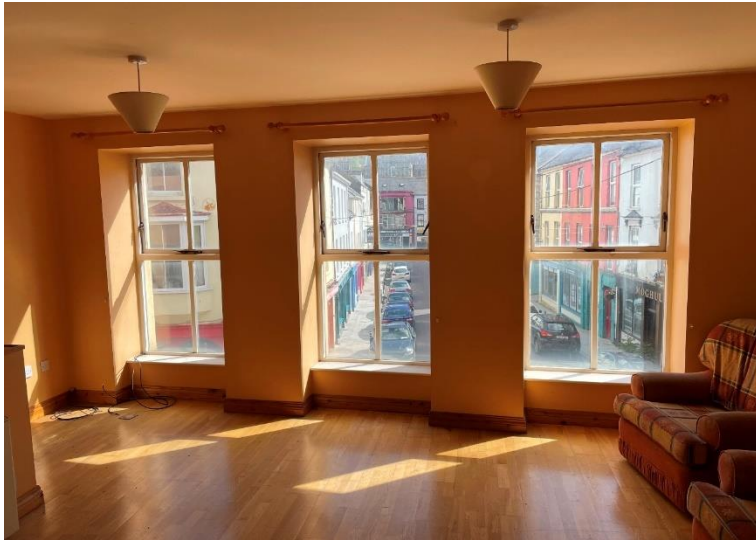
**42**  
Interior of Building B.  
Walls have been dry-lined. Not original to build.  
(credit: Cork County Council)

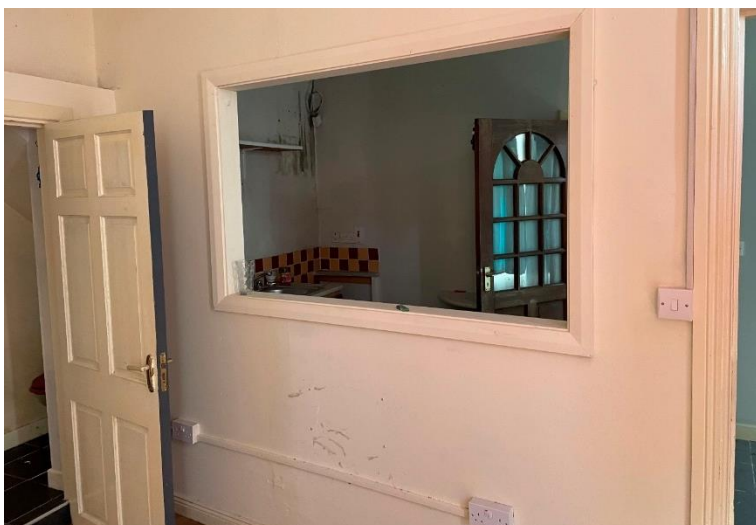
**44**  
Interior of Building B.  
Partition wall with view into kitchen area. Not original to build. (credit: Cork County Council)

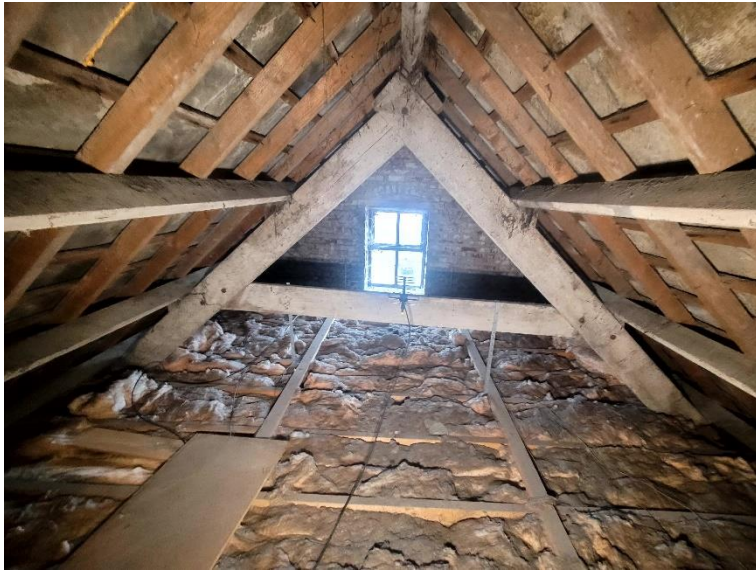
**54**  
Interior of Building B.  
Original roof structure has  
been retained. Evidence  
of parging. (credit: Cork  
County Council)

- Depending on internal building heights, these buildings could be divided into levels with varying access points for universal living situations.
- The condition of the original features, i.e. timber rafters, slate tiles, parging, iron column, pegged collar, should be analysed, with appropriate fixing methods i.e. removal of dry/wet rot from timber and splicing of new timber, re-slatting of roof using existing slate (if in good condition) or sourcing of second-hand or similar slate, etc.

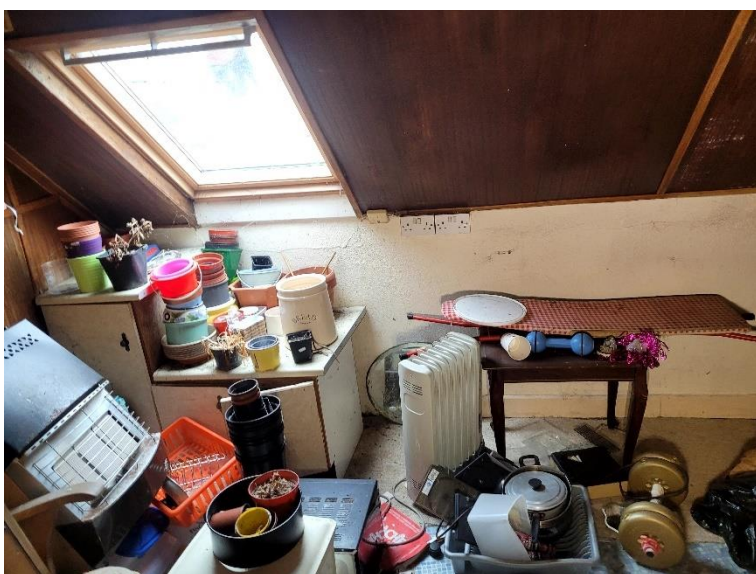
**69**  
Interior of Building C. Attic  
room. Walls have been  
dry-lined. Not original to  
build. (credit: Cork County  
Council)

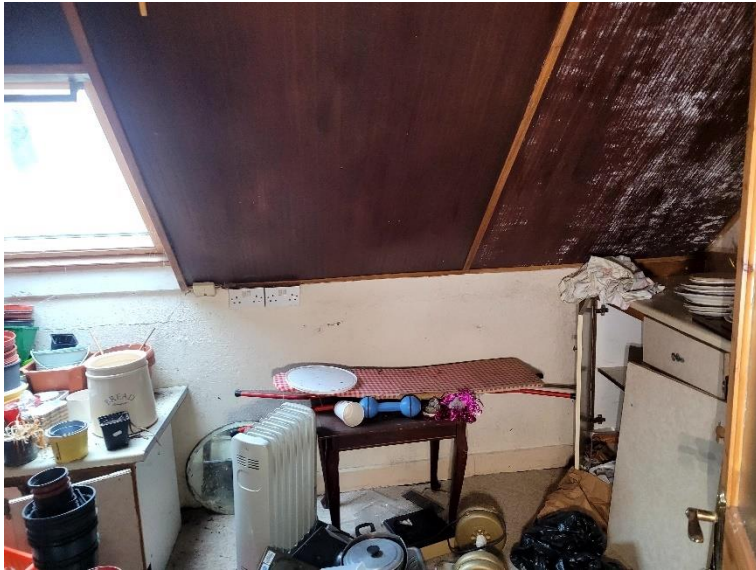
**70**  
Interior of Building C. Attic room. Walls have been dry-lined. Not original to build. (credit: Cork County Council)

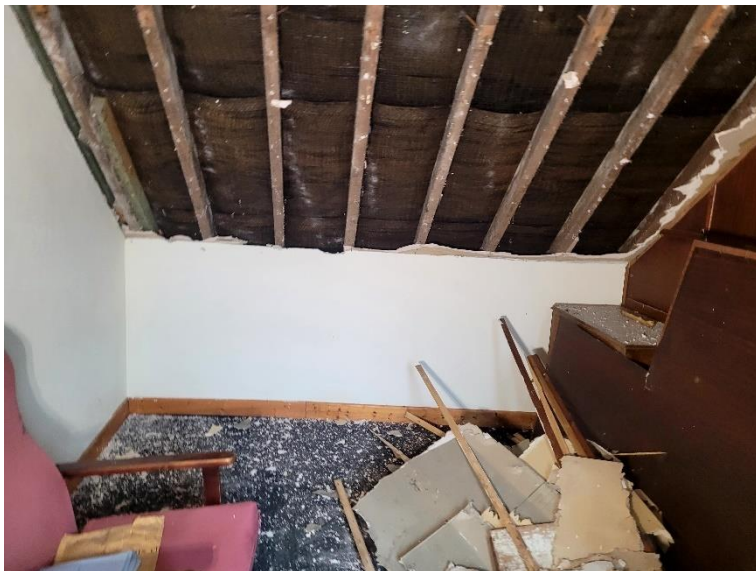
**71**  
Interior of Building C. Attic room. Walls have been dry-lined. Not original to build. Exposed roof rafters. (credit: Cork County Council)

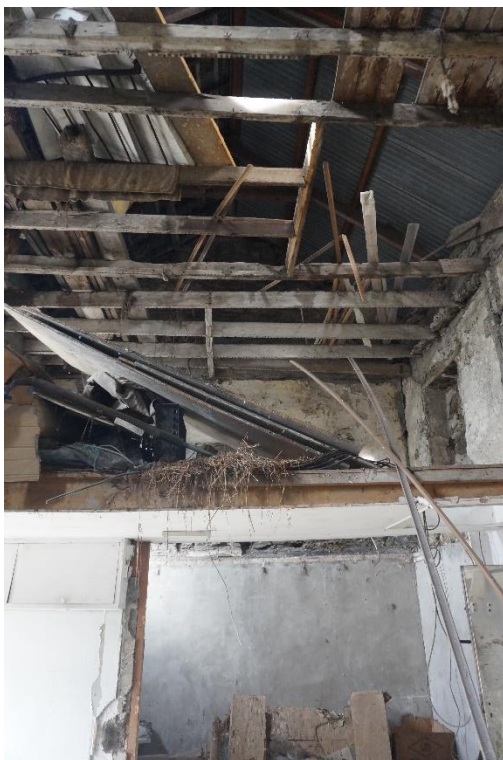
**74**  
Interior of Building D.  
Evidence of timber roof  
joists, some may have  
been replaced. Exposed  
original stone structure.

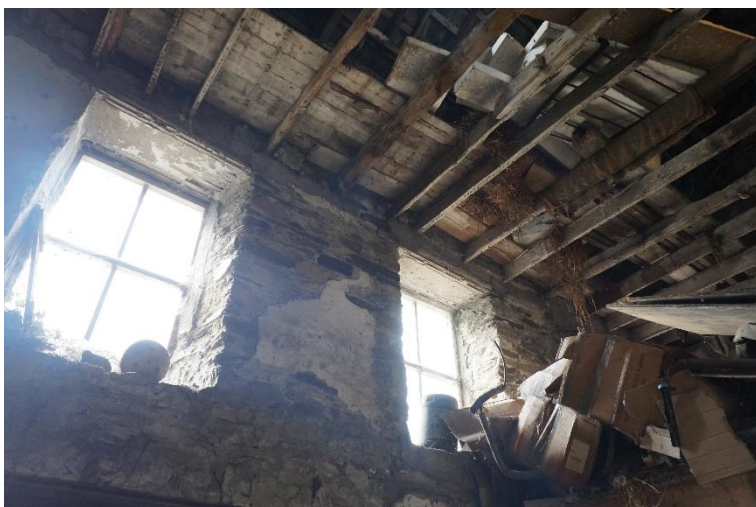
**75**  
Interior of Building D.  
Evidence of timber roof  
joists, some may have  
been replaced. Exposed  
original stone structure.

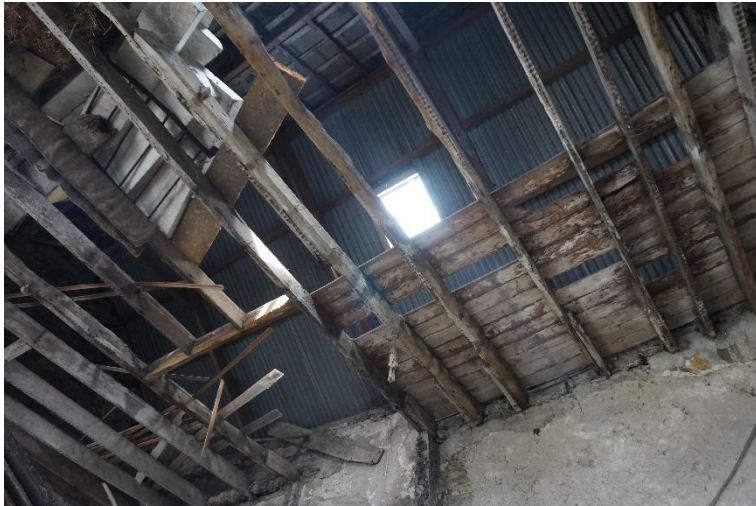
**76**  
Interior of Building D.  
Evidence of original  
fireplace on upper floor  
and location of former  
floor plates and joists.

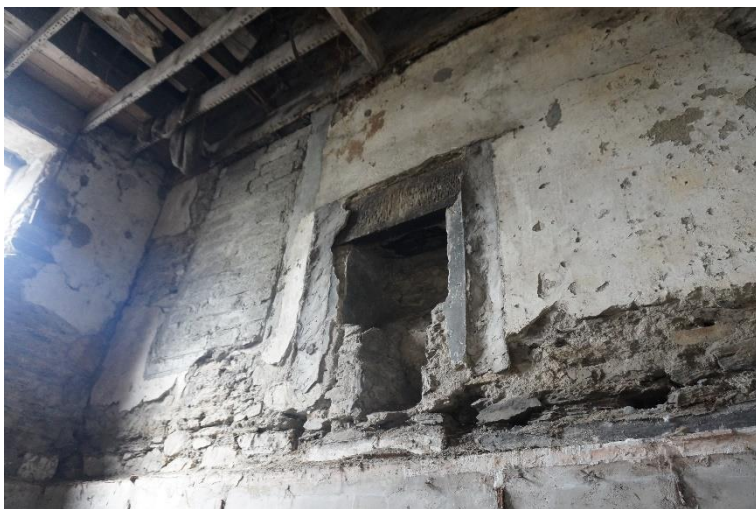
**77**  
Interior of Building D.  
Evidence of original  
fireplace on upper floor  
and location of former  
floor plates and joists.

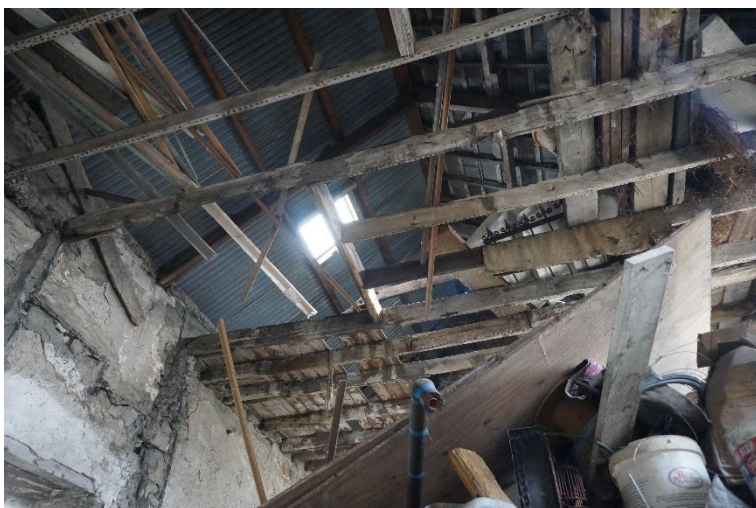
**78**  
Interior of Building D. On  
left corrugated metal is  
used while original slate  
roof material is visible on  
right.

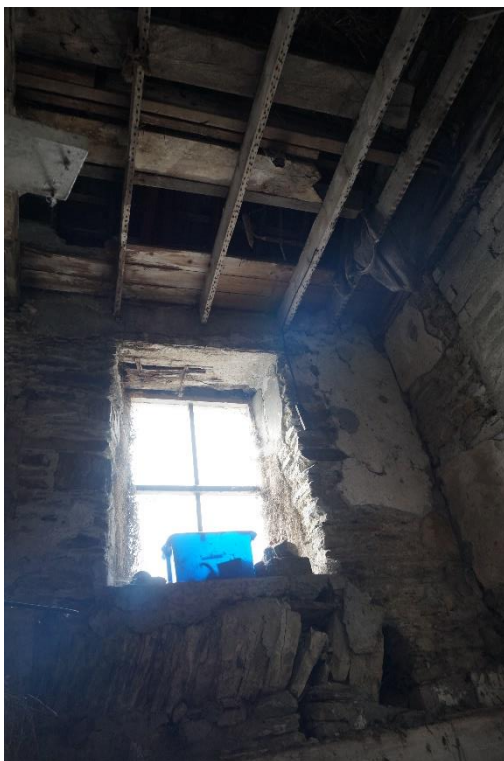
**81**  
Interior of Building D.  
Original stone structure is  
exposed. Timber roof  
joists.
