CUNNANE STRATTON REYNOLDS

**TREE SURVEY**

**Passage West,  
Co Cork.**

**June 2023  
(Updated August 2024)**

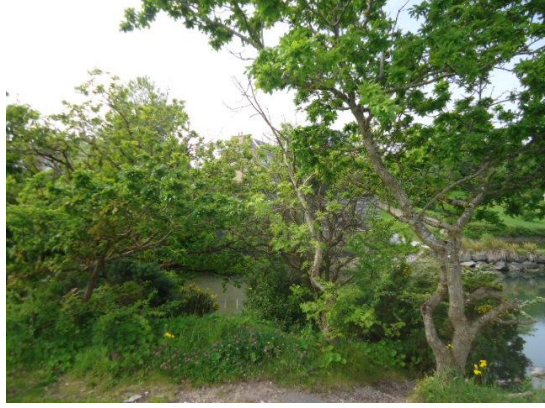
T574

574	Quercus robur	3	1/1/1/1	110	1.32	0m	Y	20+	Fair	Fair		C1	epicormic stress growth
575	Quercus robur	4	3/2/2/1	125/80	1.78	0m n/s	Y	20+	Fair	Fair		C1	epicormic stress growth
576	Acer pseudoplatanus	8	2/2/2/2	210/200	3.48	0m n/s	Y	40+	Good	Fair		B2	
577	Acer platanoides	5	2/2/1/1	200	2.40	1m s	Y	40+	Good	Fair		B2	
578	Acer platanoides	6	2/2/1/2	170	2.04	0m n/s	Y	40+	Good	Fair		B2	
579	Acer saccharum	8	3/3/2/2	250x2	4.23	0m n/s	MA	10<	Poor	Fair	Remove Ivy	C1	ivy obscured
580	Acer pseudoplatanus	11	5/5/4/4	360/440/460	8.77	1m all	MA	20+	Good	Fair	Remove Ivy	B1	root damage / girdled
581	Acer saccharum	10	3/3/4/3	360	4.32	0m w	MA	40+	Good	Fair	Remove Ivy	B1	
582	Acer pseudoplatanus	12	3/3/4/3	380	4.56	2m e/w	MA	10+	Fair	Fair	Fell	U	decay cavity at 2m/0m
583	Acer pseudoplatanus	11	3/3/3/3	360	4.32	2m all	MA	40+	Good	Fair		B1	
584	Acer pseudoplatanus	11	4/4/3/2	320/240	4.80	1m w	MA	10+	Good	Fair	Fell	C1	decay cavity at 2m se

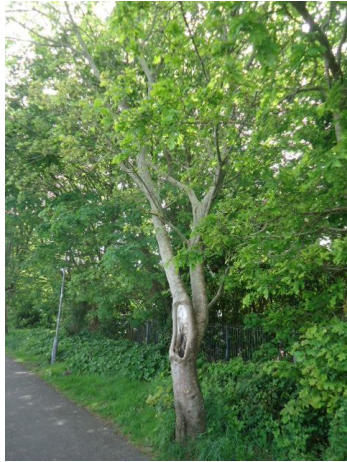
T582

3.2 Category 'U' trees are recommended for immediate removal, (fell or monolith to safe height), on general management grounds, irrespective of site development – one such tree (T582) was identified as such during this survey.

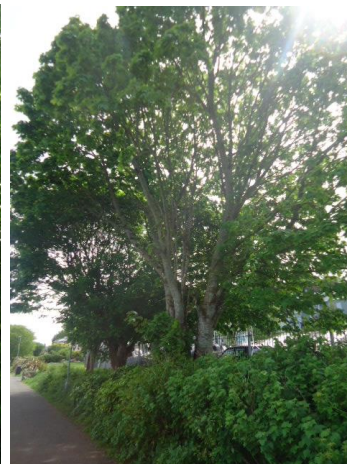
T585

585	Acer pseudoplatanus	13	5/5/2/5	540/500	8.83	1m e/w	MA	20+	Good	Fair		B1	compression fork at 1m
586	Acer pseudoplatanus	11	4/4/4/4	600	7.20	2m all	MA	10+	Fair	Poor	Fell	C1	decay cavity 1m ne
587	Acer pseudoplatanus	10	3/3/3/3	459	5.51	2m all	MA	10+	Fair	Poor	Fell	C1	decay cavity 1m n
588	Carpinus betulus	8	2/2/2/2	390	4.68	1m all	MA	20+	Good	Fair		B1	
589	Carpinus betulus	8	2/2/2/2	400	4.80	2m all	MA	20+	Good	Fair		B1	
590	Carpinus betulus	9	3/3/3/3	420	5.04	3m all	MA	20+	Good	Fair		B1	
591	Carpinus betulus	8	3/3/3/3	370	4.44	3m all	MA	20+	Good	Fair		B1	
592	Carpinus betulus	8	3/3/3/3	350	4.20	3m all	MA	20+	Good	Fair		B1	
593	Carpinus betulus	8	3/3/3/3	340	4.08	2m all	MA	20+	Good	Fair		B1	
594	Carpinus betulus	9	3/3/3/3	470	5.64	3m all	MA	20+	Good	Fair		B1	
595	Carpinus betulus	9	3/3/3/3	510	6.12	3m all	MA	20+	Good	Fair		B1	
596	Carpinus betulus	8	3/3/3/3	350	4.20	3m all	MA	20+	Good	Fair		B1	
597	Carpinus betulus	9	3/3/3/3	390	4.68	3m all	MA	20+	Good	Fair		B1

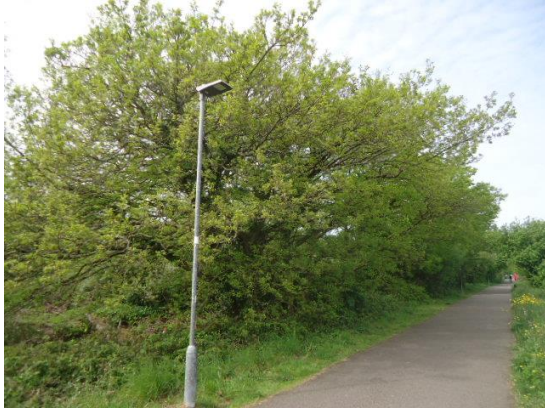
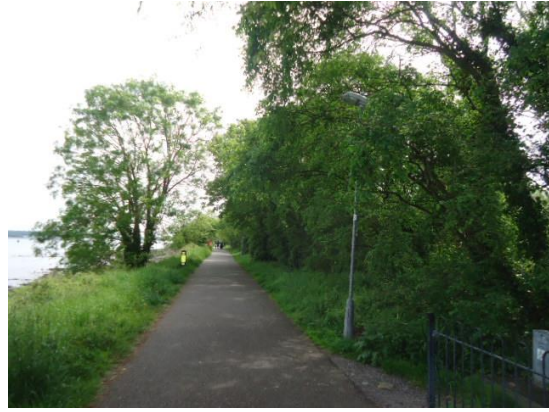
Typical view of woodland vegetation that exist as intermittent groups along the route.

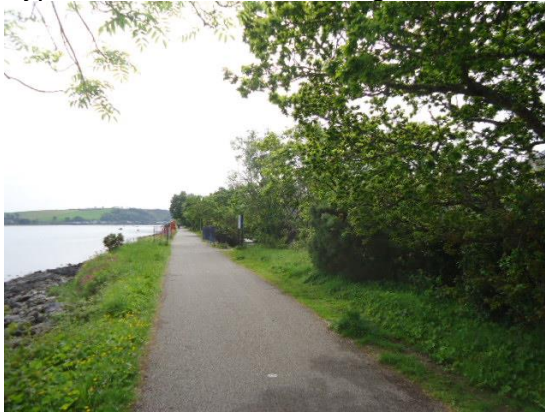
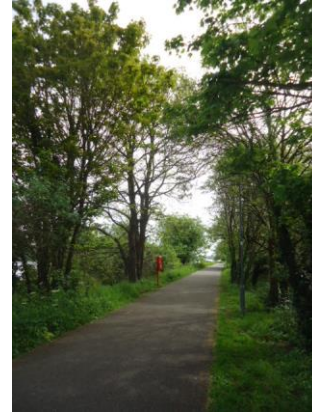
Typical view of woodland vegetation that exist as intermittent groups along the route.
