Peter Haferkamp
ISA Certified Arborist
CERT ID: UI-1332A

Tree Report at Park, Knocknagree, Mallow, County Cork

02.05.2024

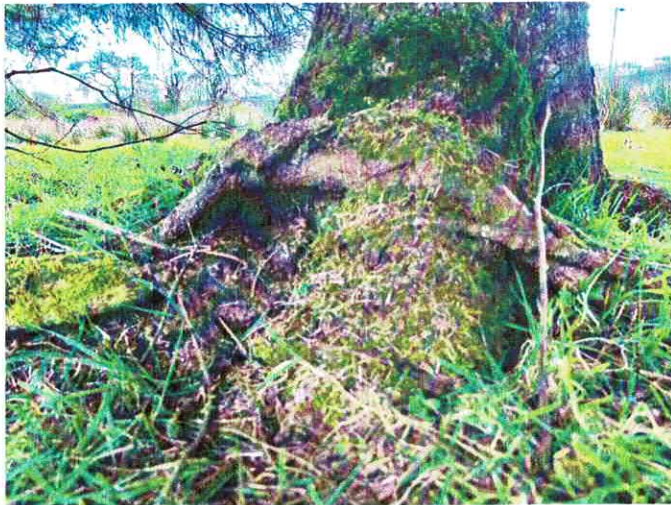
Root competition lead to girdling roots and exposed surface roots. See picture to the left.

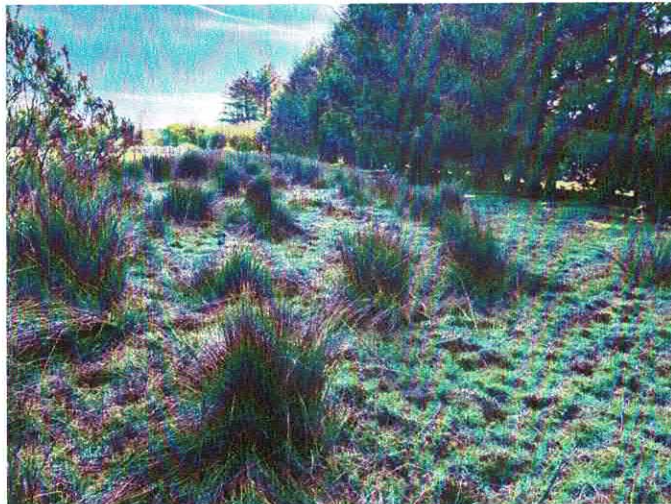
The ground and soil conditions are wet, waterlogged ground even indicated by the abundant presence of rushes up to the drip line of the trees, see Picture to the left.

Evidence of livestock suggest soil compaction and damage to upper layer of roots.

Some surface damage to roots was identified probably due to hoof or teeth marks.

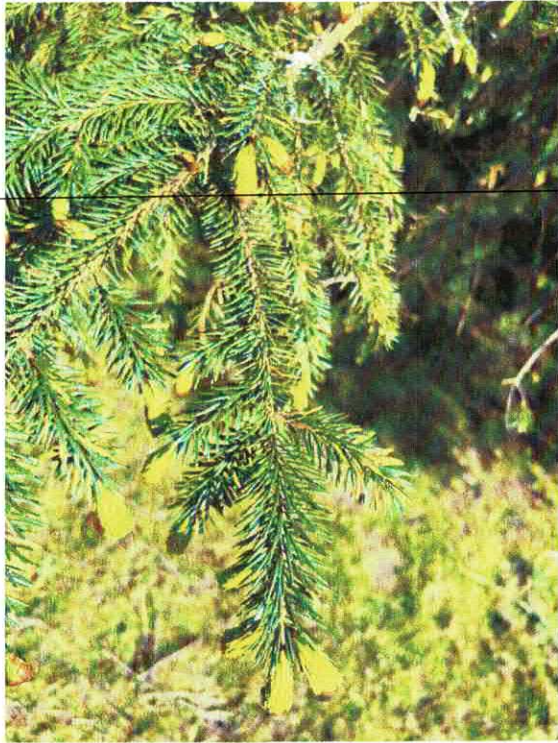
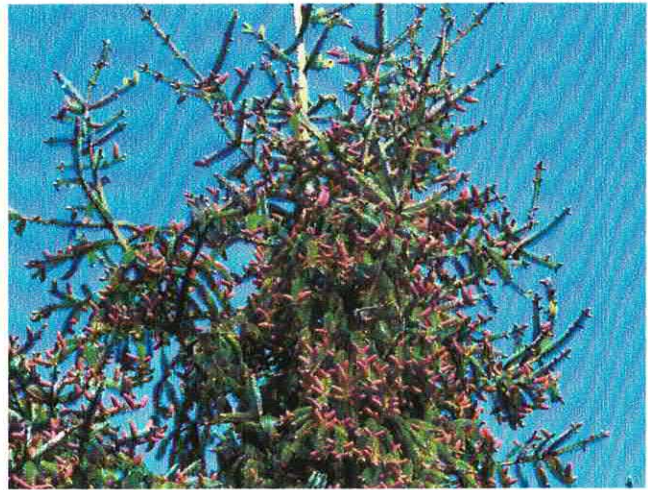
The Spruce trees show good vigour and vitality and up to 4 to 5 needle years were identified. Good development of cones this year. See pictures below and left.

This suggests good establishment and further growth and development. No evidence of decay, pest infection or fungal bodies were discovered on the visits.
