Carrigtohill Flood Risk Assessment Study

Groundwater Flood Risk Assessment

July 2012

Peter Conroy
On behalf of Cork County Council

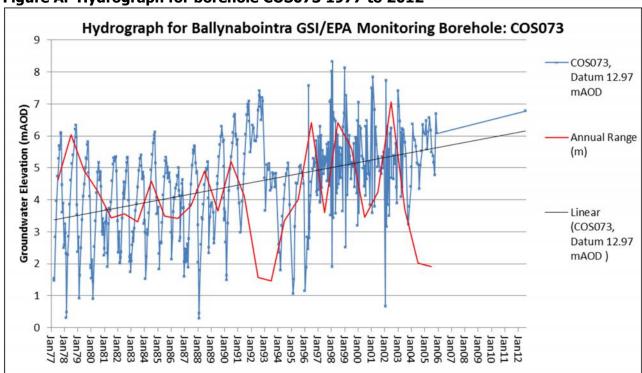
Figure A. Hydrograph for borehole COS073 1977 to 2012

dewatering rates increased). On the ground at the quarries, the dewatering activities had a clear impact on groundwater level in the vicinity of the quarry pits with water levels reduced to -15 mOD at the Milebush pit and -22 mOD at the Ballyvodock West pit.

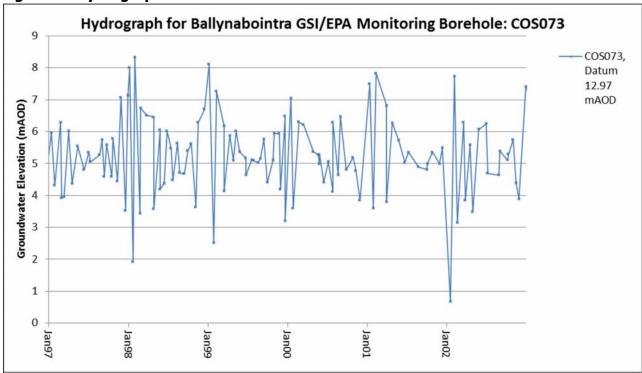
Figure B shows that the over short time periods the groundwater elevation can be highly variable, e.g. the change in water level of 7.06 m in 2002 occurred as a rise in level between 18 January

and 02 February 2002. The level then dropped again by 4.58 m to 3.15 mOD by 19 February 2002. This is typical of the flashy response of groundwater levels in karst aquifers under the influence of rapid recharge from point sources such as swallow holes. It is likely that if the full GSI chart record for borehole COS073 were digitised the water level flashiness would be demonstrated to occur over days or even hours, rather than the weeks demonstrated by the current dataset. The flashiness in these systems usually occurs in response to extreme rainfall events. In the case of the level at borehole COS073 it is possible that intermittent pumping from a quarry sump may have generated "artificial flashiness" at swallow hole KF16.
