Bantry Mill Culvert Upgrade Project

Archaeological Impact Assessment

Cork County Council

October 2024

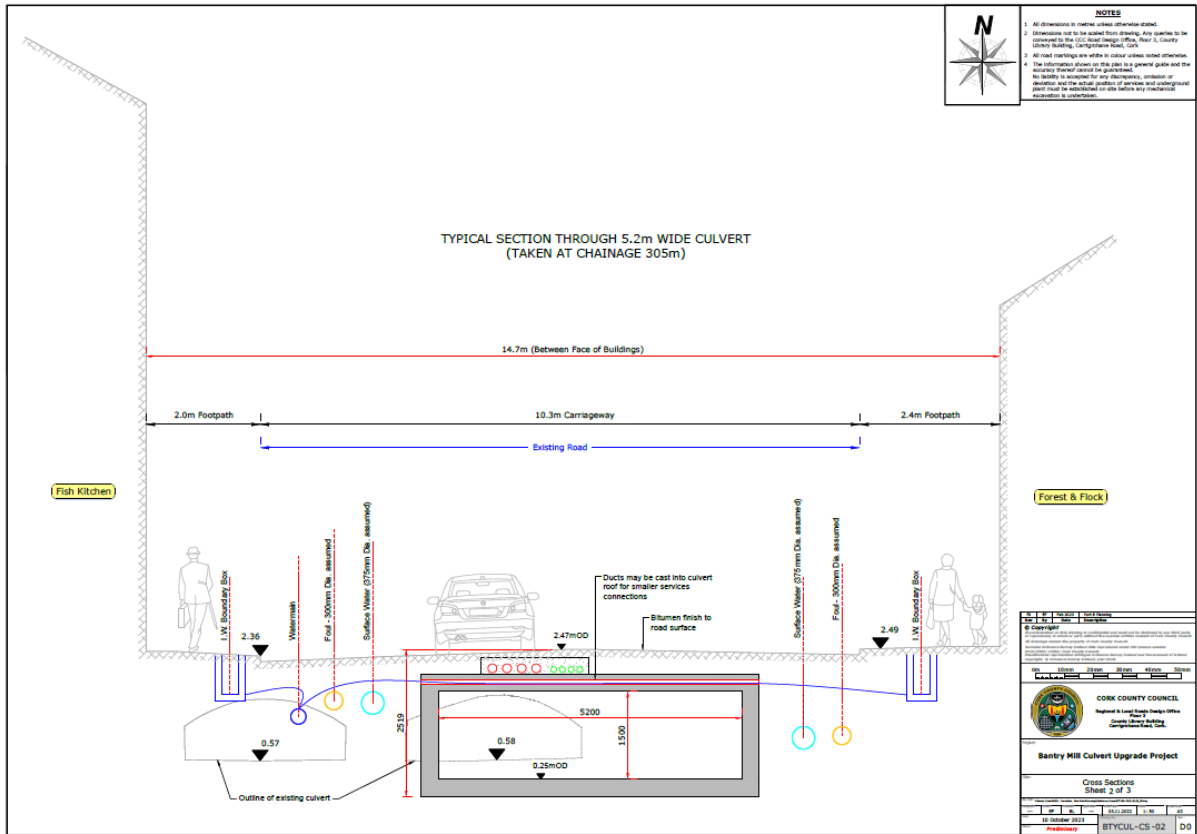
Figure 9: Cross section showing proposed works and existing culvert.

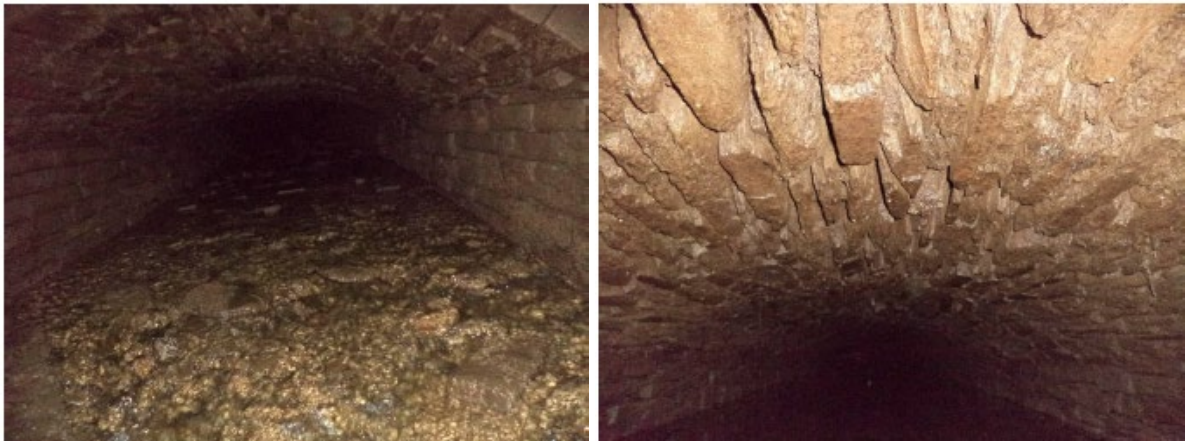
Section A: a single span masonry arch culvert measuring 137m in length carrying the Mill River from the site of Bantry Mill (now Bantry Library). The Scart Stream discharges, via twin stone culverts through the southern abutment into this section of the culvert. It is in adequate condition. There are a number of areas of open jointing, minor scour damage in areas and circumferential cracking.

Section B: a twin span masonry arch measuring 220m in length. The Alley Stream culvert discharges into the northern twin culvert. It is in very poor condition. The stonework is open jointed with little or no mortar visible. There are several areas of dropped stones, a number of circumferential cracks and areas where the arch has partially collapsed in both spans. A number of areas of the pier and abutment have also partially collapsed or been severely scoured.

Plate 1: Image of interior of culvert (MWP, 2018). Plate 2: Image of interior of culvert (MWP, 2018).

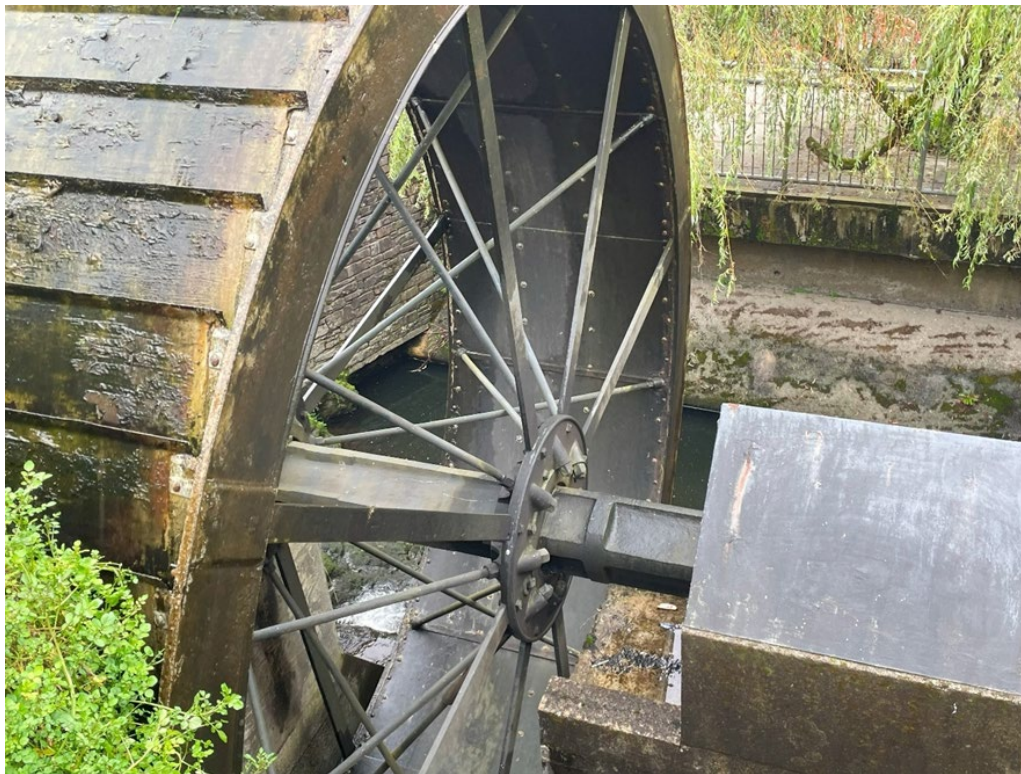
Plate 4: View of culvert inlet behind replica mill wheel on site of former mill.

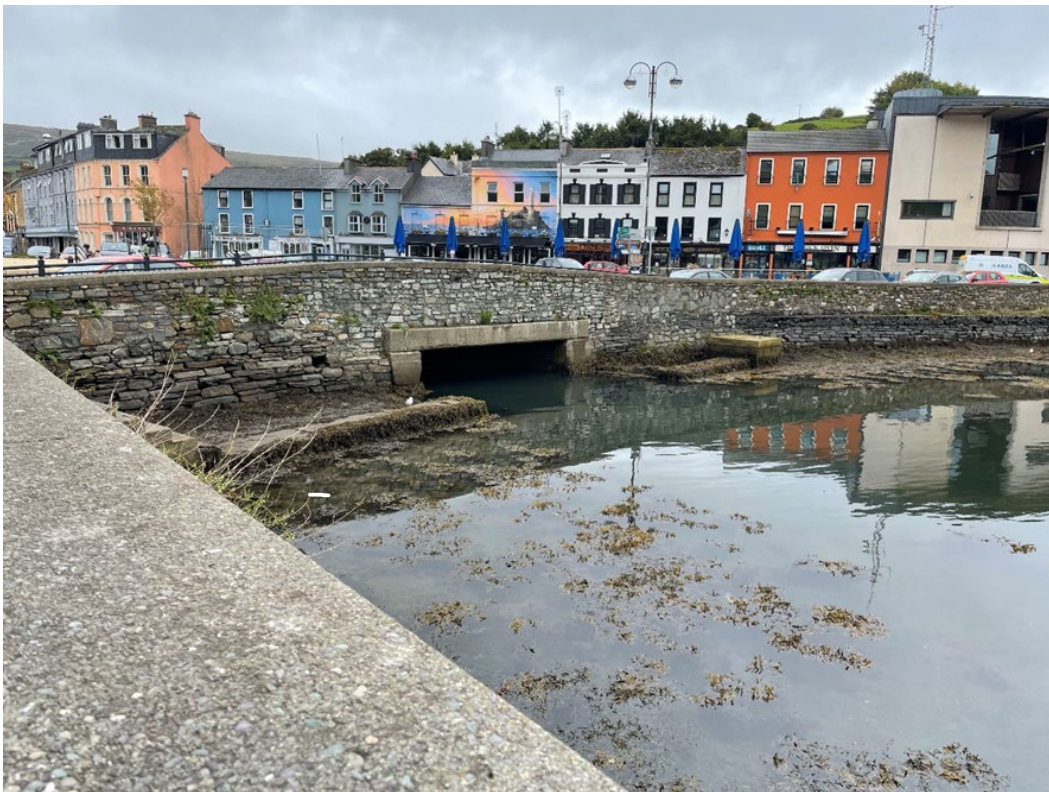
Plate 6: View of culvert visible from harbour, taken from south.
