Carrigtohill Flood Risk Assessment Study

Groundwater Flood Risk Assessment

July 2012

On behalf of Cork County Council

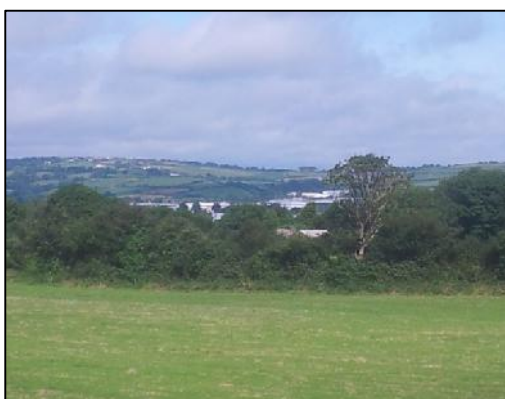
Photo 1 View northeast from Ballintubrid West

The Carrigtohill catchment is located on the south coast approximately 15 km east of Cork City centre. Carrigtohill town lies in the southern third of the catchment approximately mid-way between the eastern and western catchment boundaries at approximately NGR 182300E, 73000N. The catchment has the typical east-west oriented ridge and valley landscape of southeast cork. The northern two thirds of the catchment sits on the sandstone ridge north of Carrigtohill, while the southern third occupies the limestone valley at the base of the ridge. The catchment extends east to west approximately 6.5 km from Killacloyne to Ballyadam townlands along the N25 road, and north to south approximately 6.5 km from Ballynakilla to Barryscourt townlands. The catchment is shown on Figure 1. Photos of the catchment are shown in Photos 1 and 2 below.

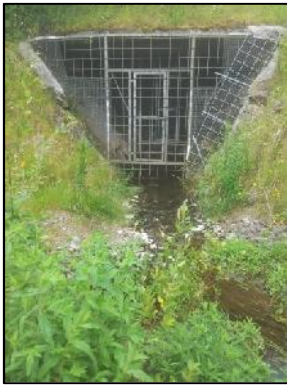
Photo 3 Swallow Hole KF15 at Cúl Ard Housing Estate, Terrysland

Two of the caves (1707SWK001 & 002) and a swallow hole (1707SWK004) occur at the disused quarry in what is now the Cúl Ard housing estate in the Terrysland townland. The swallow hole was observed during the site visit and is adjacent to south side of Fearann na Carraige street on the west side of a ruined castle/lime kiln and receives inflow from stream HEP 4. A second swallow hole (KF15) was observed in the southwest wall of the disused quarry during the site visit. KF15 currently receives the outfall from the constructed reedbed which has been installed in the quarry floor (Photo 3).

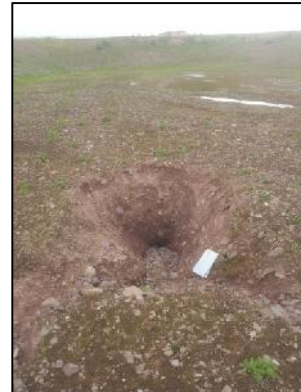
Photo 4 Swallow Hole KF14 at base of attenuation pond at IDA site in Ballyadam

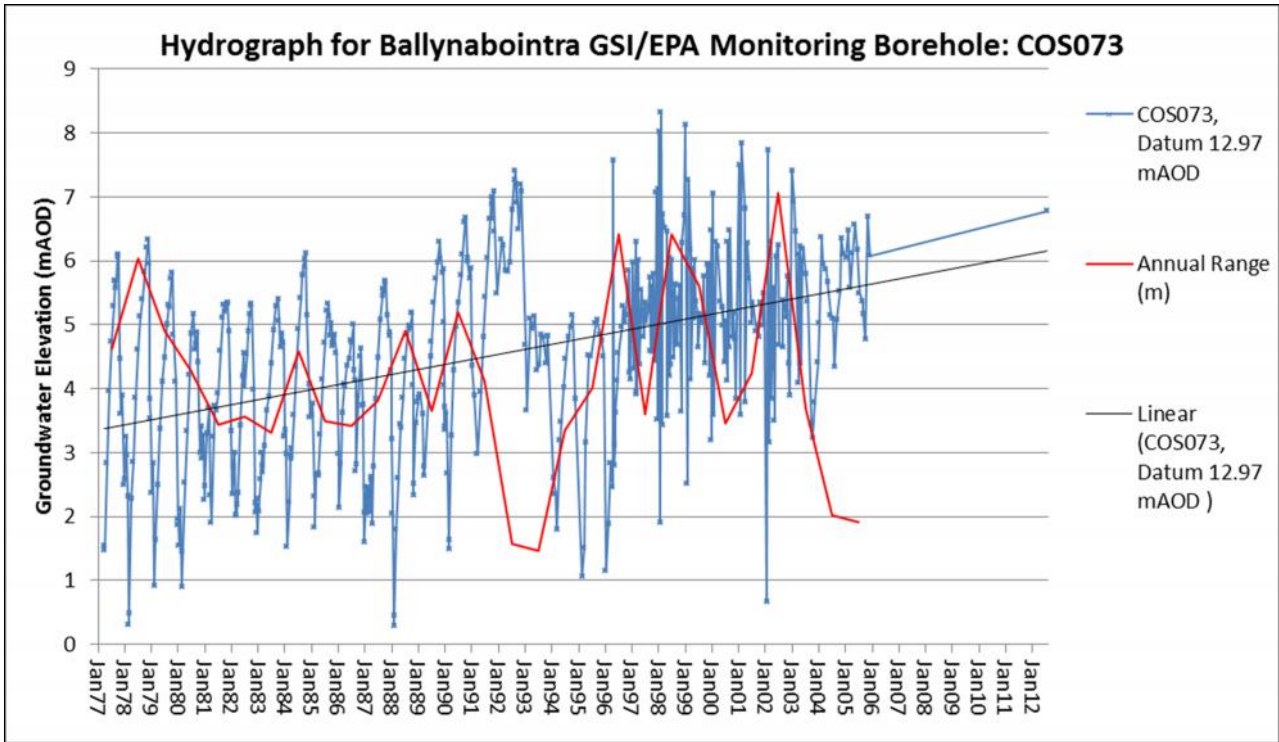
Figure A. Hydrograph for borehole COS073 1977 to 2012

dewatering rates increased). On the ground at the quarries, the dewatering activities had a clear impact on groundwater level in the vicinity of the quarry pits with water levels reduced to -15 mOD at the Milebush pit and -22 mOD at the Ballyvodock West pit.

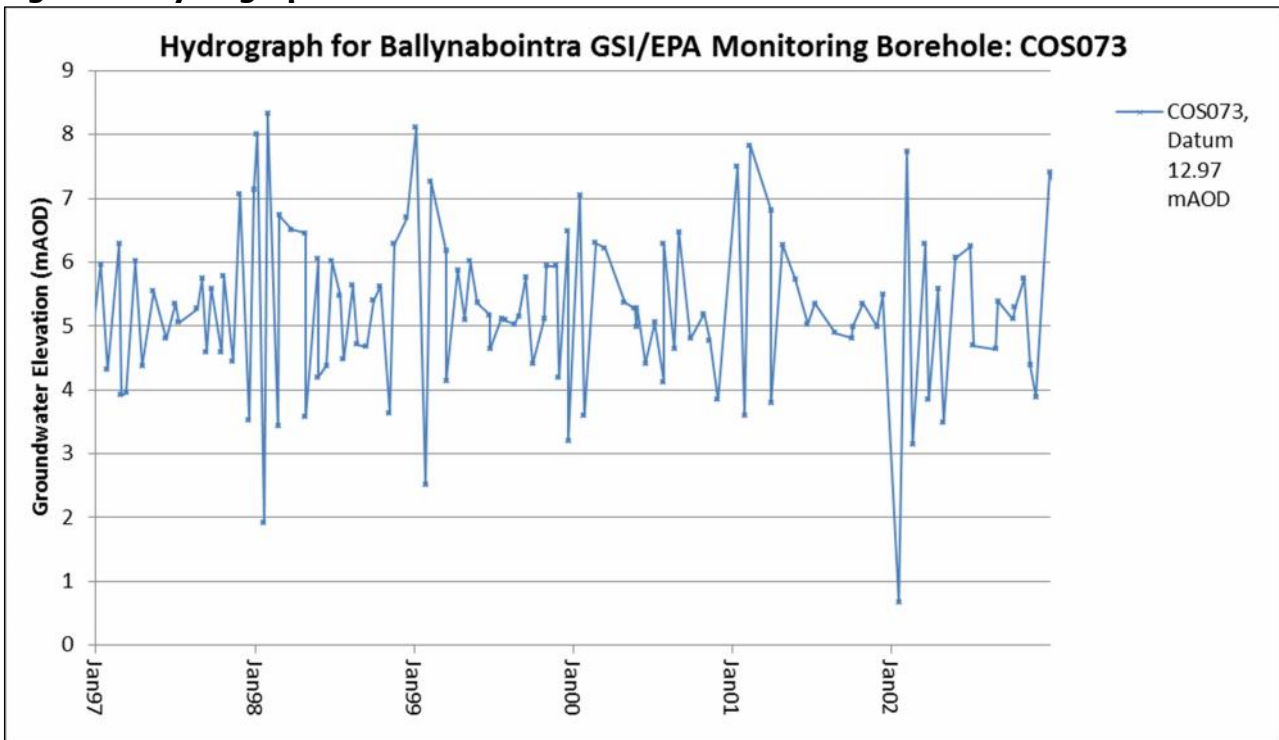
Figure B. Hydrograph for borehole COS073 1997 to 2002

Figure B shows that the over short time periods the groundwater elevation can be highly variable, e.g. the change in water level of 7.06 m in 2002 occurred as a rise in level between 18 January

and 02 February 2002. The level then dropped again by 4.58 m to 3.15 mOD by 19 February 2002. This is typical of the flashy response of groundwater levels in karst aquifers under the influence of rapid recharge from point sources such as swallow holes. It is likely that if the full GSI chart record for borehole COS073 were digitised the water level flashiness would be demonstrated to occur over days or even hours, rather than the weeks demonstrated by the current dataset. The flashiness in these systems usually occurs in response to extreme rainfall events. In the case of the level at borehole COS073 it is possible that intermittent pumping from a quarry sump may have generated "artificial flashiness" at swallow hole KF16.

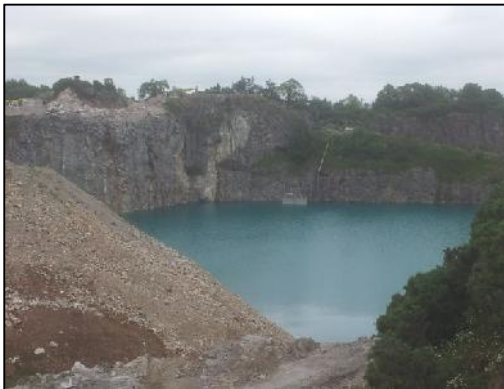
Photo 5 Rising water level at Lagan Cement Milebush Quarry (North Pit; 17/07/2012)

There are no data available on the current water level in the flooded quarry pits at Lagan Cement Milebush and RoadstoneWood Ballyvodock West quarries. Photos of the flooded pits are shown in Photos 5 and 6.

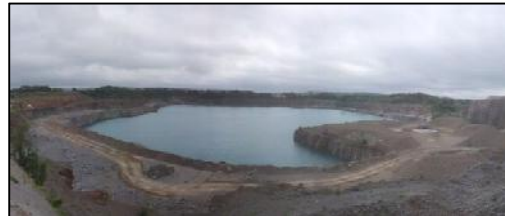
Photo 6 Stabilised water level at RoadstoneWood Ballyvodock West Quarry

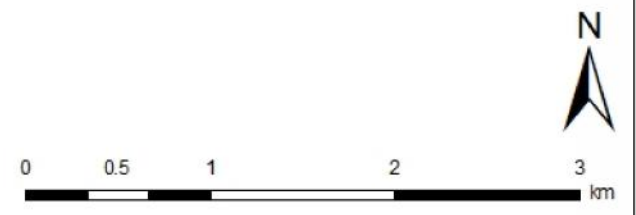
Figure 2A Data Points and Locations of Interest within the Western part of the Study Area

- Carrigtoohill Surface Water Catchment Boundary
- - - Boundary of Locally Important Gravel Aquifer (Lg)
- Approximate Boundary of Quarry Sites
- Approximate Boundary of Flooded/Dewatered Bedrock Quarry Pits
- + Borehole
- + GSI Well Database Point (Location Accuracy 50m)
- GSI Well Database Point (Location Accuracy 50 to 1000m, as indicated by blue circle)
- Enclosed Depression
- + Turlough
- + Swallow Hole
- + Spring
- + Cave

The location of the study area is shown on Figure 1. The relevant features from the desk study datasets are shown in Figure 2 and in Tables A to E.
