Carrigtohill Flood Risk Assessment

Main Report (Hydraulics)

Cork County Council

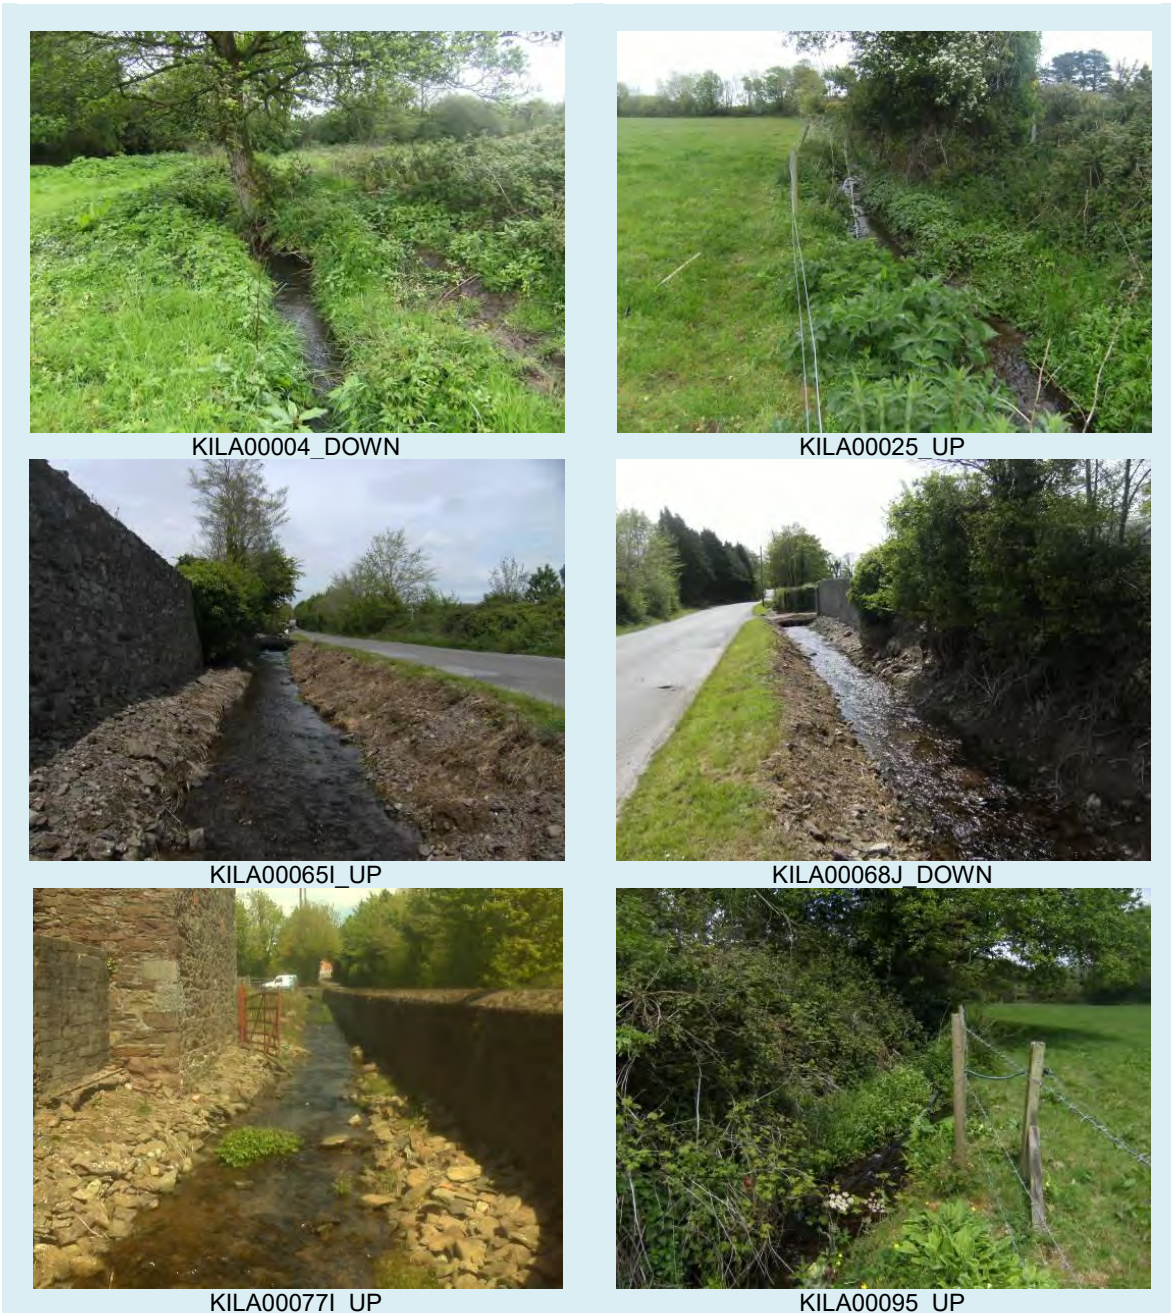
Photo 2-3 Kilacloyne Stream Typical Channel

The following photos give an indication of the size and nature of this channel. At the upstream extent the channel measures approx 1m wide but along its full length the Kilacloyne reach is typically 2m wide with a depth (to top of bank) of approx 0.6 to 0.7m.

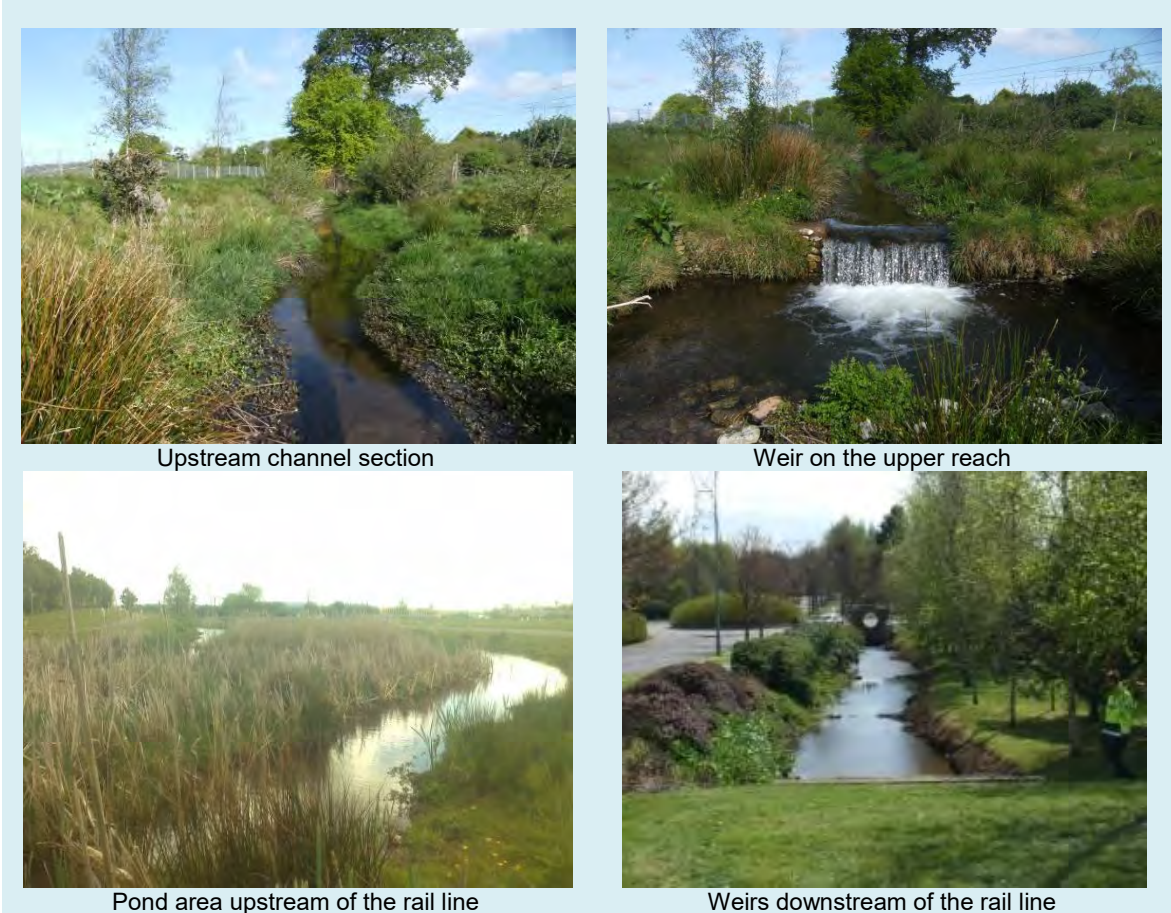
Photo 2-7 Tibbotstown Stream Channel Photos

Downstream of the rail line the channel flows through a number of culvert and weir structures, passes under the N25 Road and discharges into Slatty Pond. Photos to illustrate the general character of the watercourse are presented below. More information on the structures and how they have been represented in the hydraulic model can be found in the Model Check File in Appendix D.

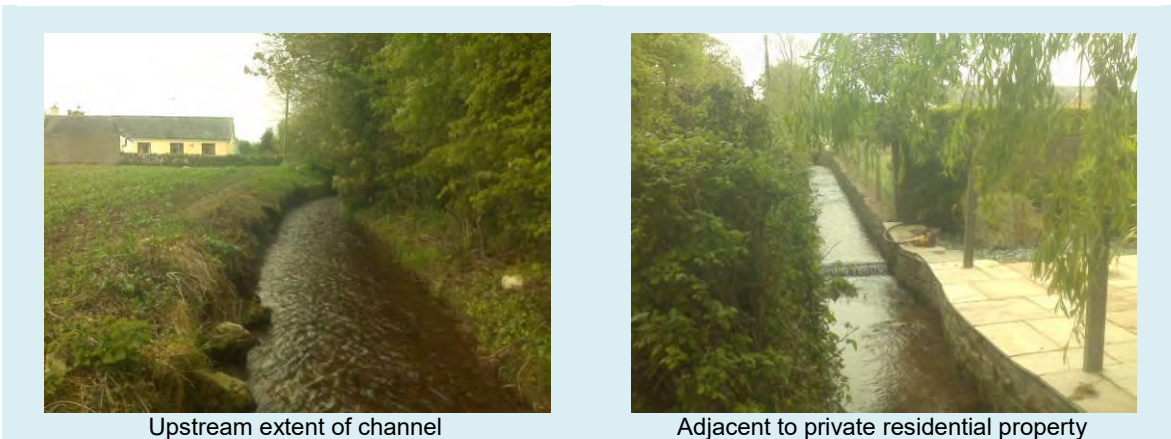
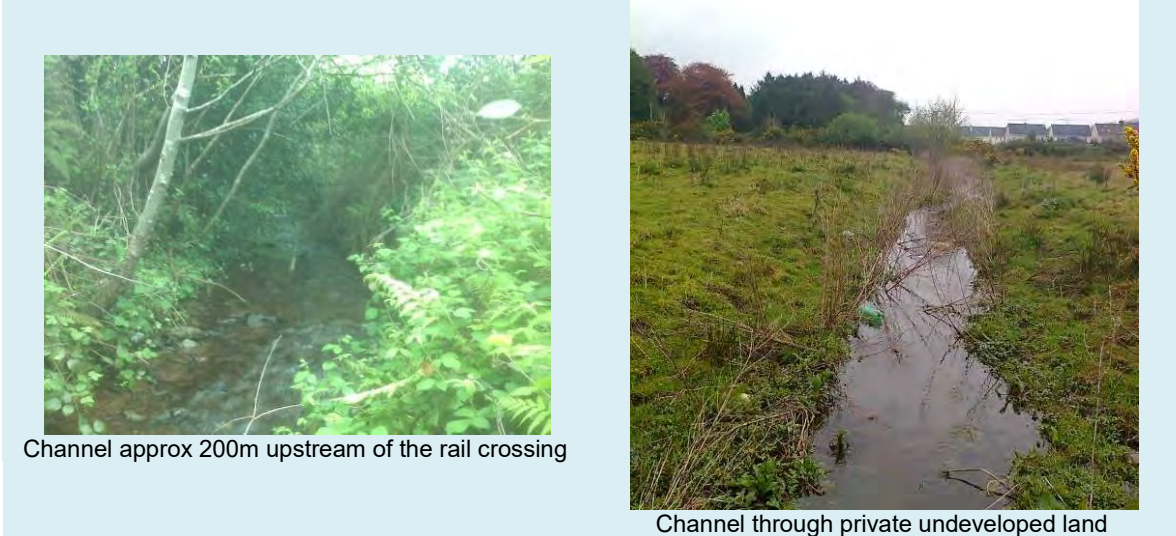
The Woodstock Stream flows in a south westerly direction alongside a local third class road, under the rail line, through private residential land, into a long culvert at the junction near the railway station and the Bog Road, through private land to Carrigtohill Bridge and on further downstream under the N25 road embankment and into Slatty Pond.

The following photos give an indication of the general size and nature of the Woodstock Stream.

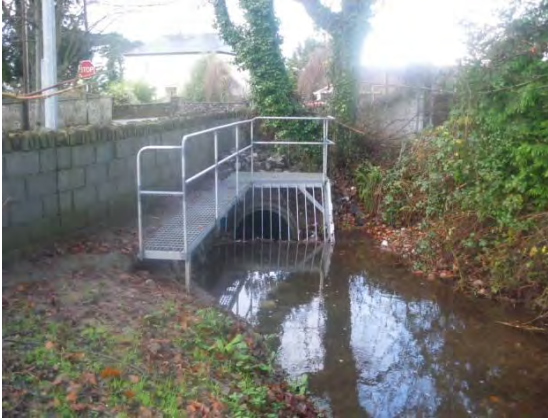
Model Ref. / Location	Description / Photo
WOOD003331 Culvert along Church Road	<p>A circular pipe acts as an inlet to an old stone arch culvert. A section of this old stone culvert collapsed in August 2012 following a period of heavy rain. The repair work included the addition of a trash screen at the inlet.</p>

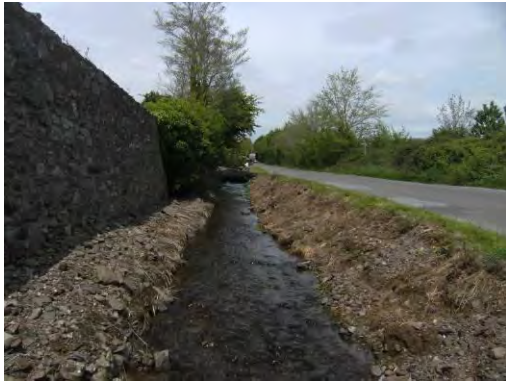
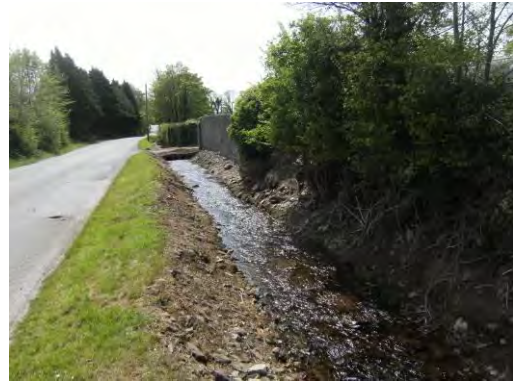
Figure 8-5 Kilacloyne Stream

A section of the Kilacloyne Stream that flows alongside the local third class road is straightened and maintained.

Sections of these watercourses have been altered or modified in some way from that expected of a natural watercourse. These sections of watercourse are described below and photographs are provided in Figure 8-5 to Figure 8-8.

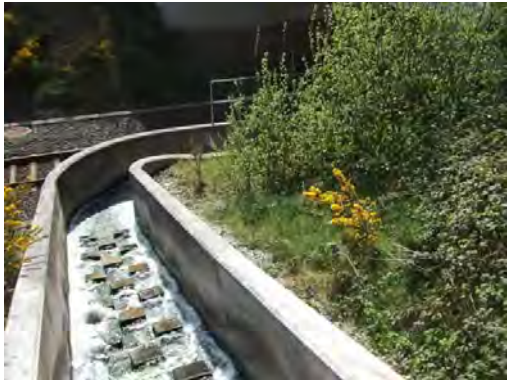
Figure 8-6 Rail Diversion Channel

A diversion channel constructed along the rail line comprises concrete walls. A gravel bed and boulders are incorporated into the channel design.

Rail channel at upstream end (cascade)

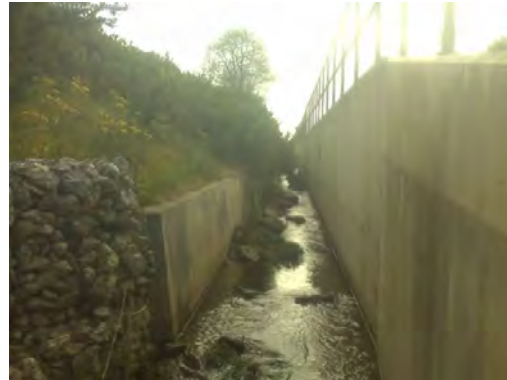
Rail channel at downstream end

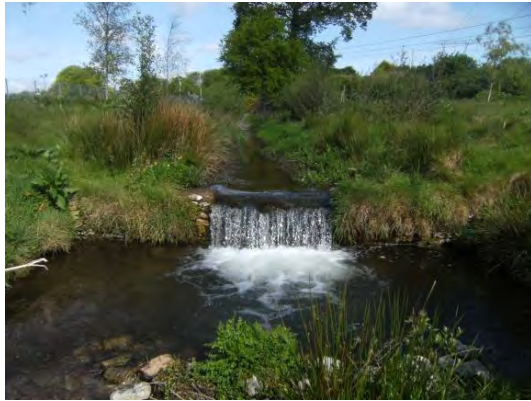
Figure 8-7 Tibbotstown Stream

A number of man-made weirs have been put in place on the Tibbotstown Stream downstream of the rail line.

One of two similar weirs upstream of the rail line

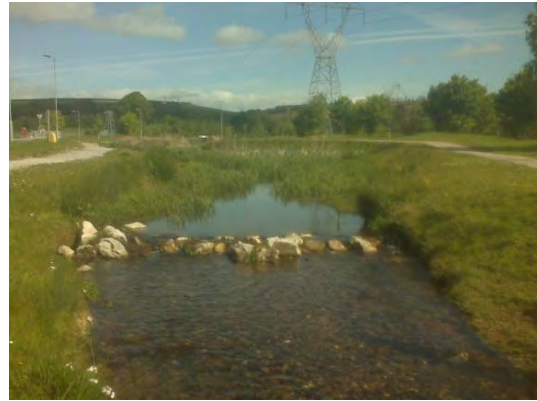
pond / sedimentation area upstream of rail siphon

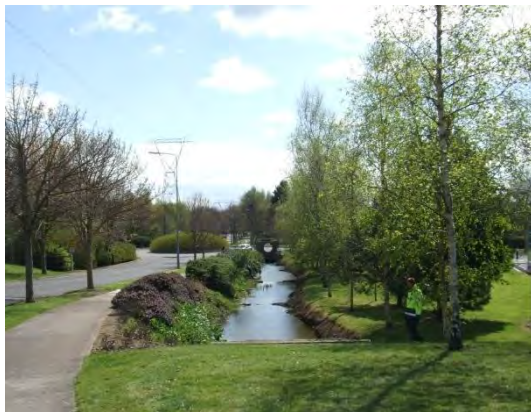
Series of weirs downstream of rail line (looking downstream)

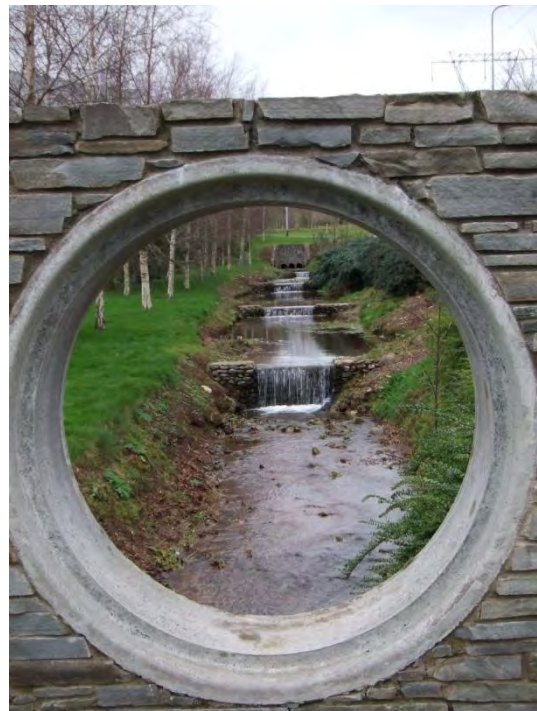
Same series of weirs downstream of rail line (looking upstream)

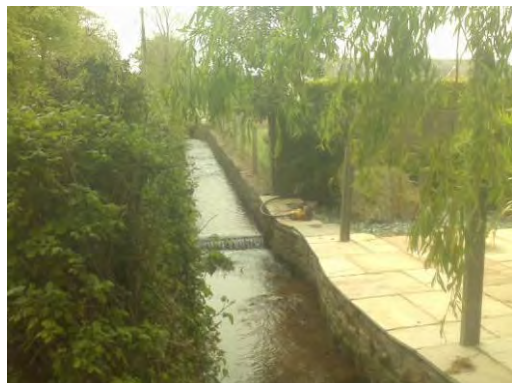
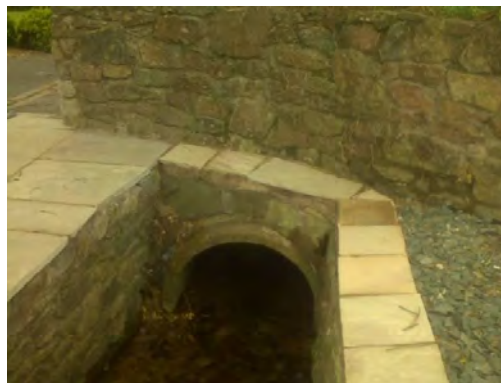
Figure 8-8 Woodstock Stream

In other areas, landscaping and paving associated with private residential property have altered the natural river banks of the Woodstock Stream.

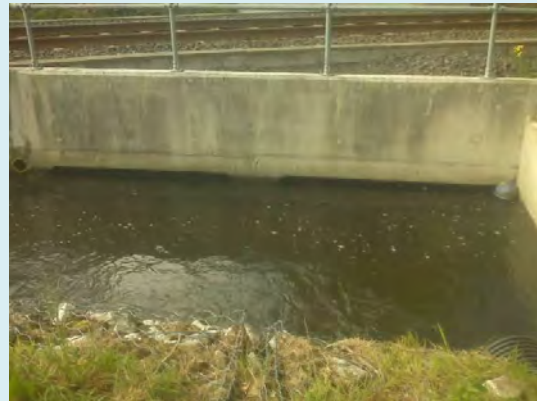
Survey indicates that silt has built up at the culvert entrance. It is noted that this culvert is located at a 90° bend in the watercourse. The approach angle, observations on site and survey data indicate that this culvert is important in terms of hydro-geomorphology.

Plan showing culvert and stream alignment

Photo of inlet

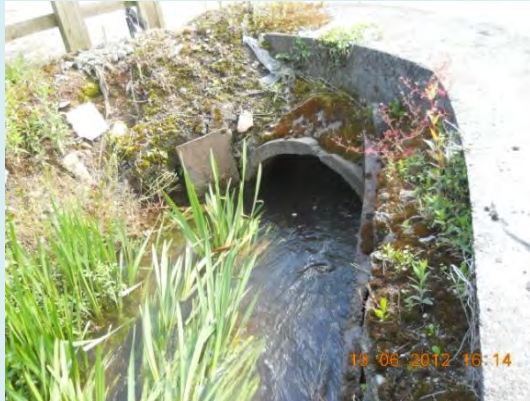
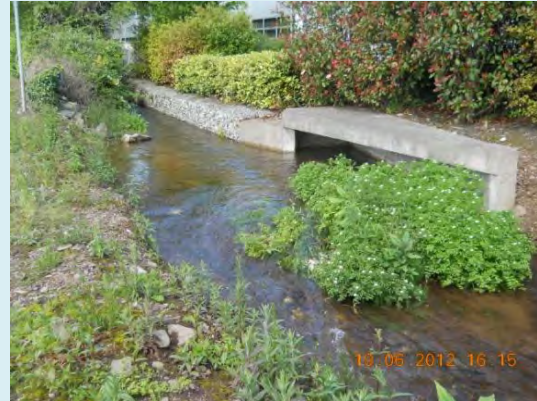
This culvert is located downstream of the sink point at the Irish Rail culvert and while erosion is not an obvious issues at this location, it is noted that the culvert inlet is poorly constructed and flow is not directed into the culvert which could lead to erosion of the bank in high flow conditions. It was also observed on site that there is evidence of localised sedimentation at a potential Fota Retail Park drainage outfall.

Poor culvert inlet

Localised sediment at outfall

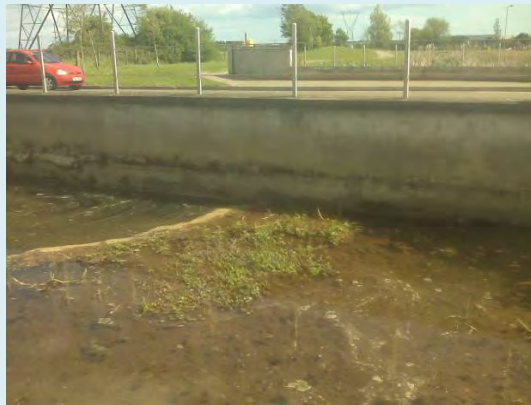
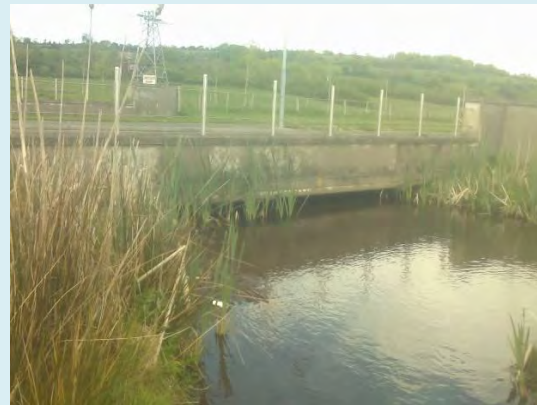
Culvert to east of Gilead (TIBB001661)

Survey confirms silt has built up at this culvert restricting the culvert height at the inlet to 0.76m. IDA have confirmed that regular monitoring and maintenance works are carried out here. This is an important structure in terms of sediment transfer.

Upstream Face

Downstream Face

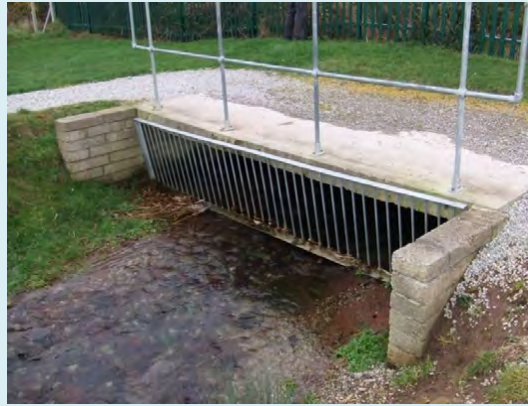
3 way split at rail line (TIBB00150I)

Site observations and survey data suggests that deposition occurs upstream of this structure. This minimises sediment entering the siphon arrangement that exists just downstream of this culvert inlet shown below. It is important that this is monitored on an ongoing basis.

Inlet to 3-way split

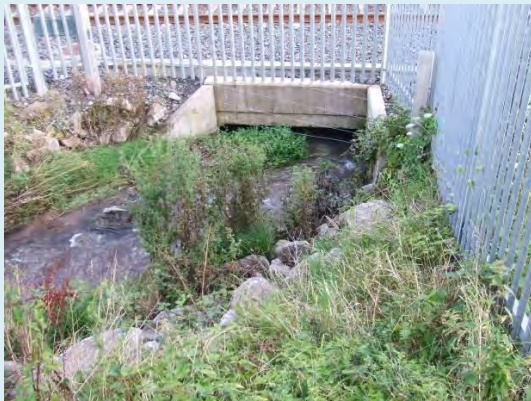
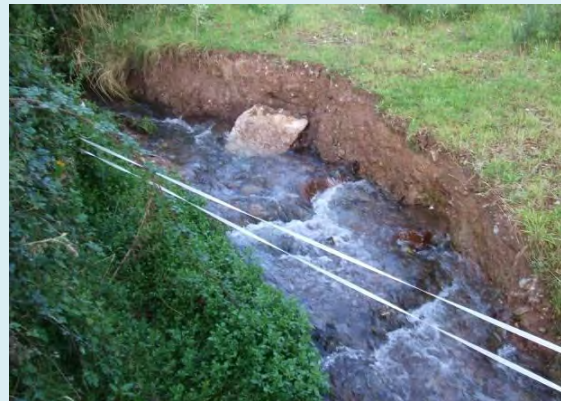
Irish Rail culvert C7 (WOOD00350)

Site visit confirms erosion on the left bank immediately upstream of this culvert. The survey data indicates that the culvert is severely silted with an effective height of 0.36m on the downstream face, whereas the Irish Rail construction drawings indicate that a 1m high culvert with 100mm gravel bed was included for in the design. This demonstrates that there are hydro-geomorphologic factors at play here and the situation should be monitored and managed.

Upstream Face

Evidence of erosion upstream

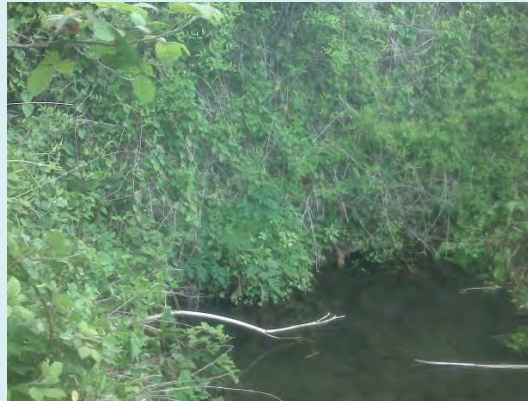
Carrigtohill Bridge (Culvert_7)

Based on the survey and site observations the channel is heavily vegetated and overgrown at this location. This overgrowth can result in reduced flow capacity and should be monitored on a regular basis.

Location of Downstream Face

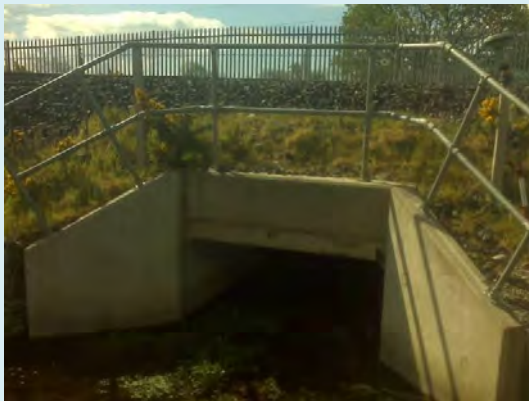
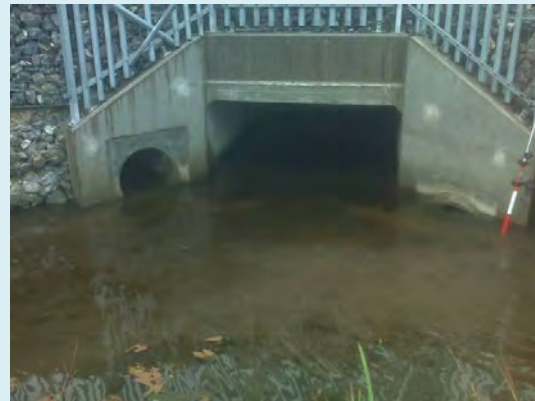
Irish Rail culvert C9 (POUL0097I)

Based on the Irish Rail drawings this culvert was designed to include a 300mm gravel bed above the culvert invert. The surveyed invert levels indicate that this has not been retained however there are no indications of erosion or scour at this location.

Upstream Face

Downstream Face

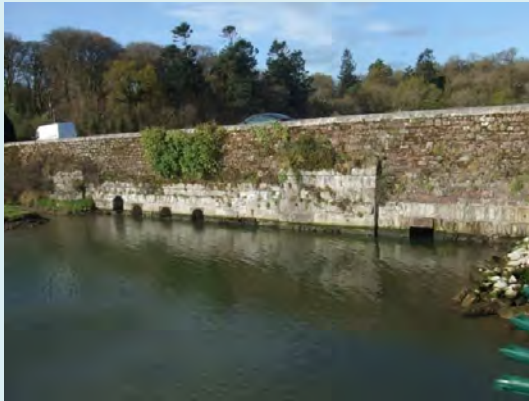
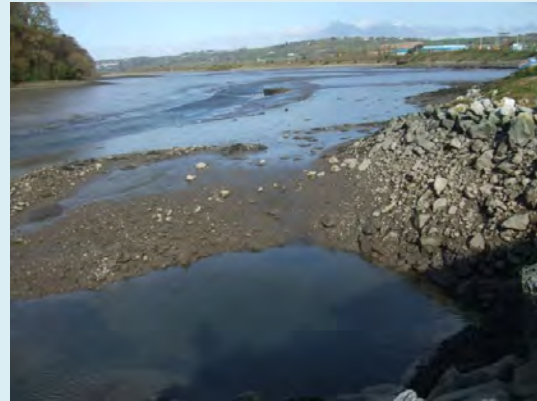
The introduction of the pumps at Slatty may have an impact on hydro-geomorphology of the channel downstream of Slatty Bridge. A reduction in flow through the bridge openings may result in an additional build up of silt on the downstream tidal side.

The photos below show the upstream face of the bridge and the second photo illustrates the geomorphology of the channel looking downstream from the pump outfall.

Upstream face of Slatty Bridge

Immediately downstream of Slatty Pump outfall

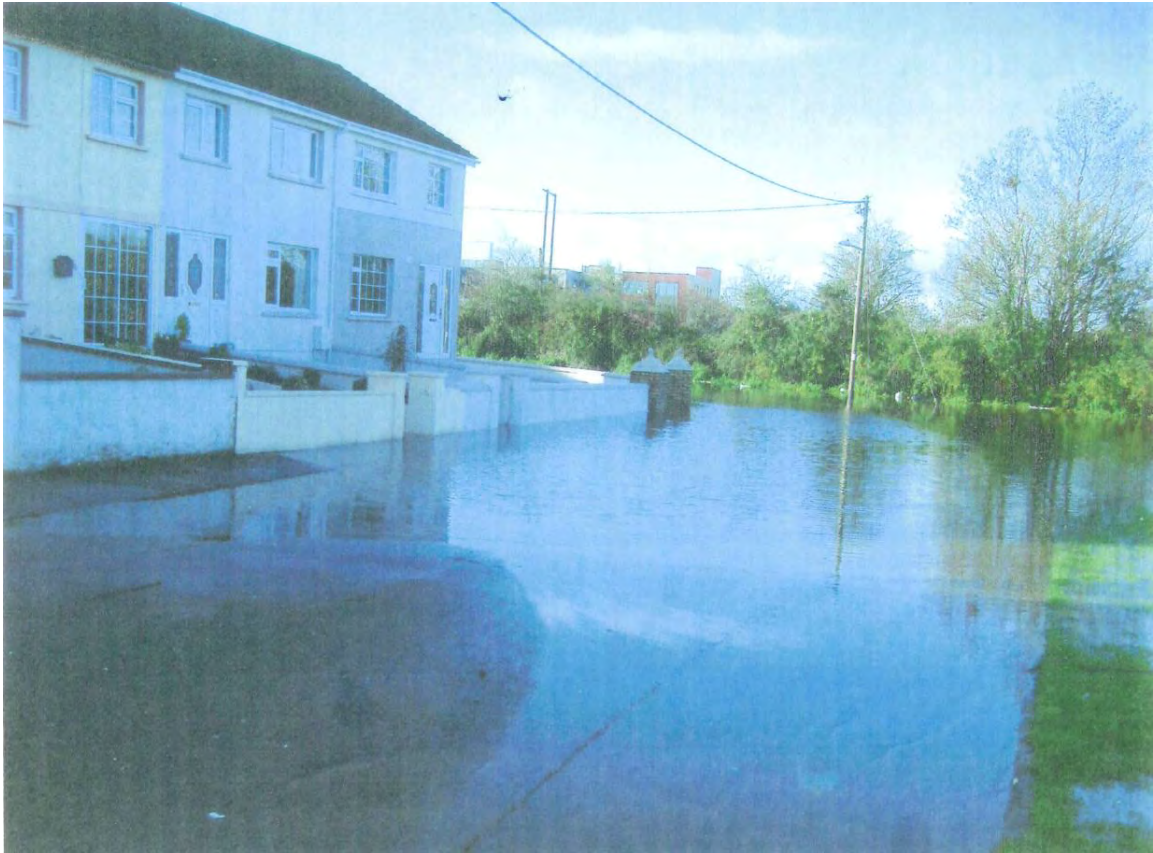
Photo 9-1 Flooding at Ryan Aherne Place in 2009

Area 5 has been highlighted in the hydro-geological assessment as an area at risk of groundwater flooding. Cork County Council have confirmed ongoing flooding issues in this location which has required the installation of mobile pumps.

A photo recording flooding at Ryan Aherne Place, to the east of Castlake is shown in Photo 9-1.

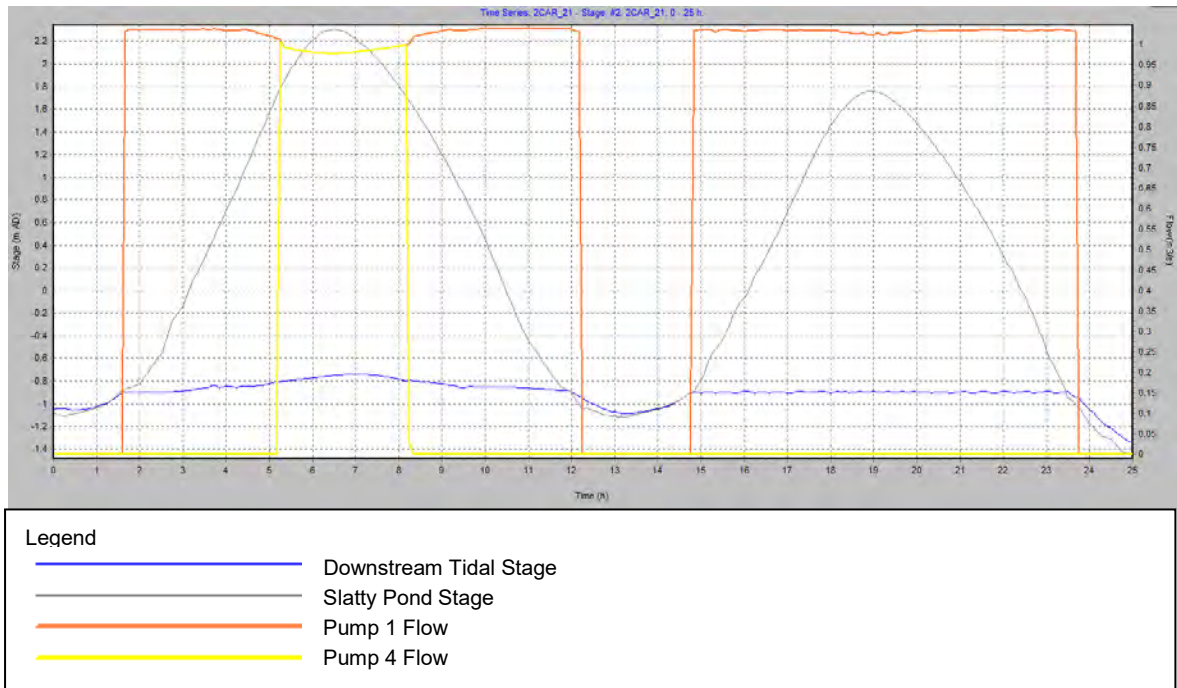
Figure 10-17 Pumped Flow during 50% AEP Fluvial Event

All four pumps are activated during the first tidal cycle. During the second rising tide, Pump 1 is on, Pump 2 kicks on and off and Pumps 3 and 4 are not activated. During this lower return period event, Pump 1 stays on for approx 20 hours out of 24 hours over two tidal cycles. Pump 4 stays on for approx 3 hours of the first 12 tidal cycle and remains off during the second tide cycle.

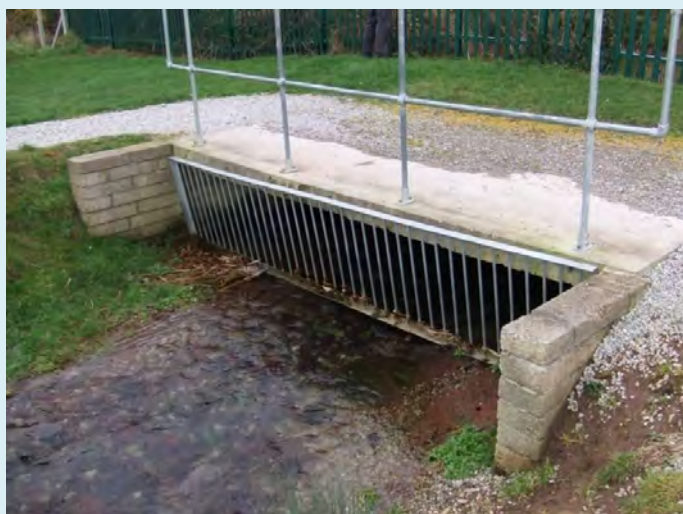
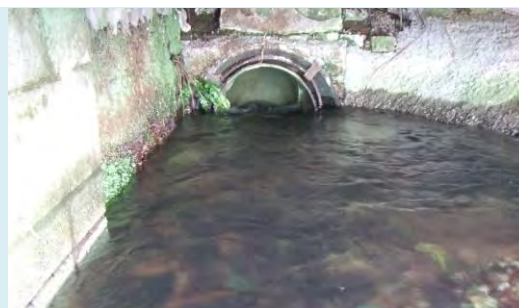
Photo 10-19 3 Way Split Structure

Information was also obtained from IDA. This included drainage drawings indicating the location of the main surface water network in the area. Interpretation of available information and observations on site led to the conclusion that the IDA siphon feeds into the surface water network. Investigation on site and consultation with IDA confirmed that flow from the stream can enter the surface water network via the IDA siphon and this flow is conveyed downstream into the surface water attenuation tank. It is assumed that this IDA siphon was intended as an overflow only, however based on the site investigation it appears that this flow route is regularly active and as a consequence the attenuation tank remains full. This tank has an overflow outfalling to the stream. Based on the available information the IDA siphon has been included in the model as a 600 diameter siphon unit that discharges directly to the stream further downstream (at the location of the tank outfall). It is assumed that the tank does not provide any attenuation as it is continuously taking flow from the stream and therefore is always full.

Irish Rail Siphon

The model results indicate the following split in flows. The majority of flow, 55% enters the Irish Rail cascade; 23% enters the Irish Rail Siphon and the remainder (22%) enters the IDA siphon. This split is based on the size and invert levels assumed in the model representation and is consistent for fluvial events of varying magnitude / AEP.

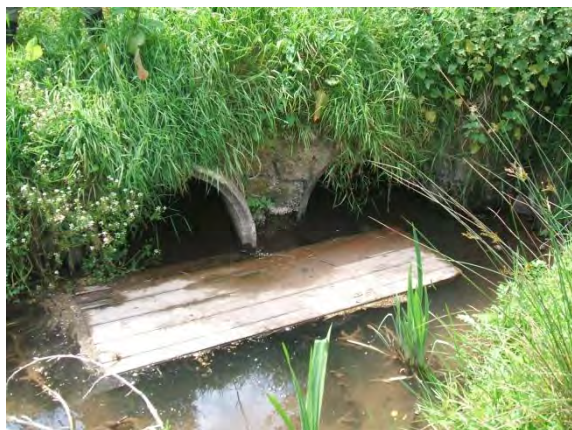
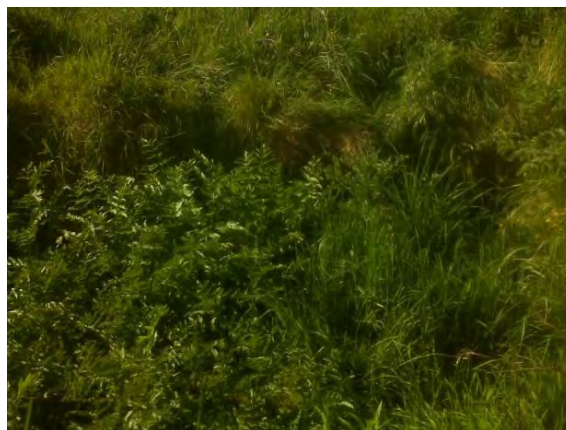
Photo 10-22 Carrigtohill Bridge

Flooding occurred at this location in November 2009 and was reported on by RPS. This report indicates that the culverts at Carrigtohill Bridge are twin 900mm diameter pipes. It is reported that these culverts are under capacity and played a contributory factor in the flooding that occurred in 2009. The culvert crossing is in the ownership of Gable Developments.

June 2007

June 2012
