Bat Survey and Assessment

Old Barrack Road Phase 2

Bantry

Draft Report prepared for Cork County Council

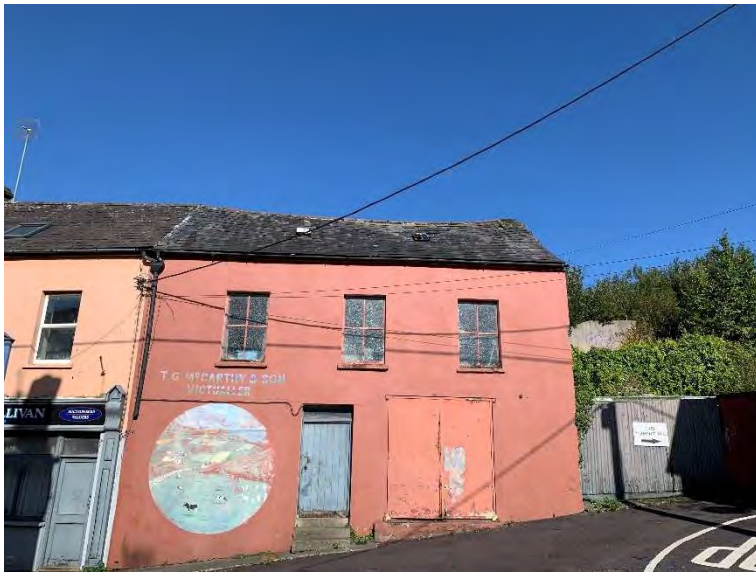
Plate 3-1: Building 1 and partial view of Building 2

2-storey disused building constructed of stone with a slate tile roof to the south (Plate 3-1) and corrugated iron to the north. Externally, the walls have been rendered on the southern elevation and partially rendered on the northern elevation; the eastern gable end is unrendered stone. The windows and doors are intact with the exception of one window on the northern elevation, which is missing.

There are potential access points to the building for bats via a missing window on the northern elevation, holes in the roof and gaps between the stonework on the eastern elevation. There is potential for bats to roost on the wooden beams of the roof. However, the structure would be exposed to wind and rain and would not provide the sheltered conditions required by roosts of high conservation status. This building is considered to be of low suitability for roosting bats.

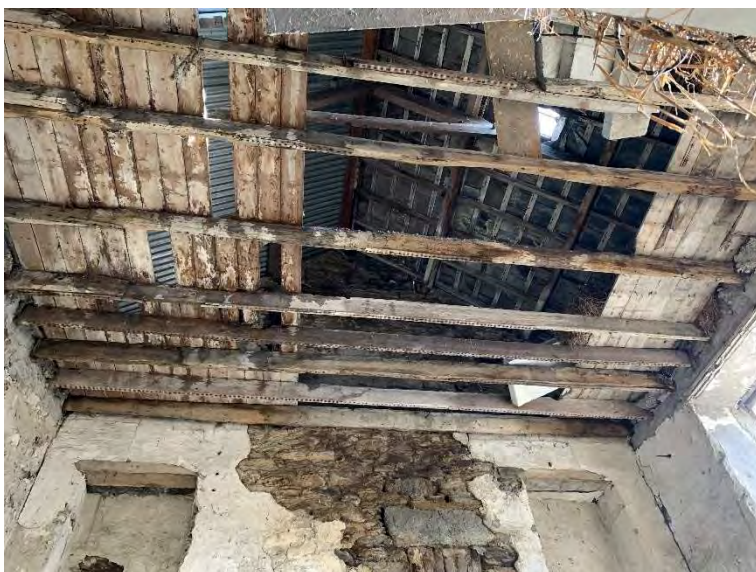
Plate 3-2: Remaining ceiling and roof of building 1

Internally, the ceiling has collapsed so that there is no roof space and the roof is unlined (Plate 3-2). Swallows and pigeons nest within the building.

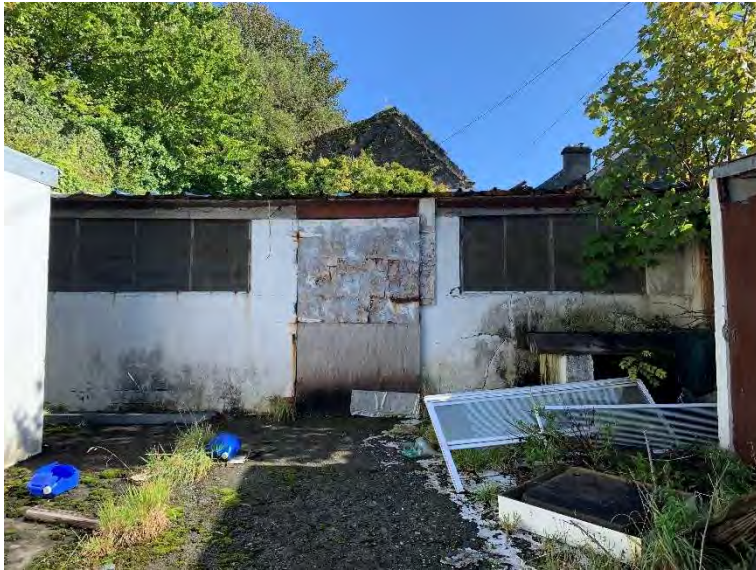
Plate 3-3: Easternmost outbuilding in yard of building 1

Outbuildings within the yard of Building 1 comprise two flat roof structures with rendered walls. The roof of the easternmost outbuilding (Plate 3-3) is constructed of metal sheeting with wooden beams. There is no roof space internally. The second outbuilding is an old processing room (Plate 3-4) with a flat felt lined roof.

The easternmost outbuilding supports potential access points under the corrugated roof and gaps around the door. However, there is no roof space and roosting habitat would be limited to the wooden ceiling beams. The structure does not provide the appropriate conditions required by roosts of high conservation status. This building is considered to be of low suitability for roosting bats.

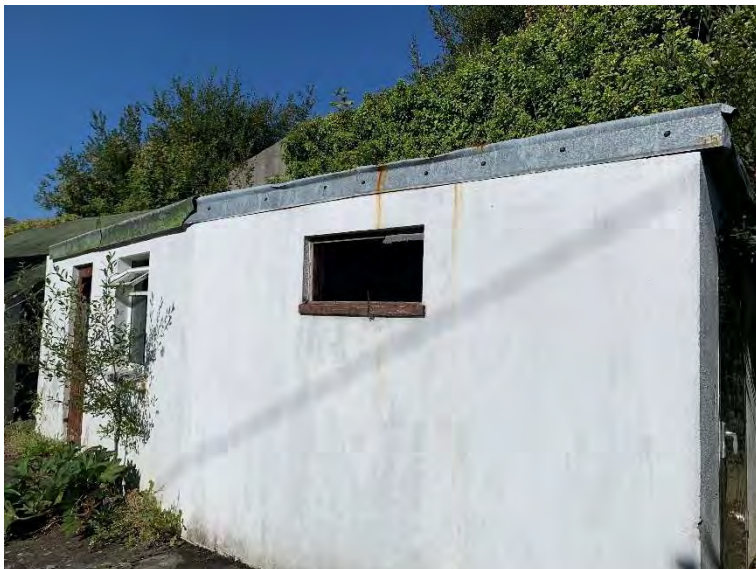
Plate 3-4: Processing room in yard of building 1

The processing room supports potential access points for bats under the flat roof material. There is potential for bats to roost between the flat roof material and the roof felt, however the thermal properties of the sheet metal roof would be poor (i.e. would get very hot on sunny days but would lose heat rapidly) and the building does not provide the appropriate conditions required by roosts of high conservation status. This building is considered to be of low suitability for roosting bats.

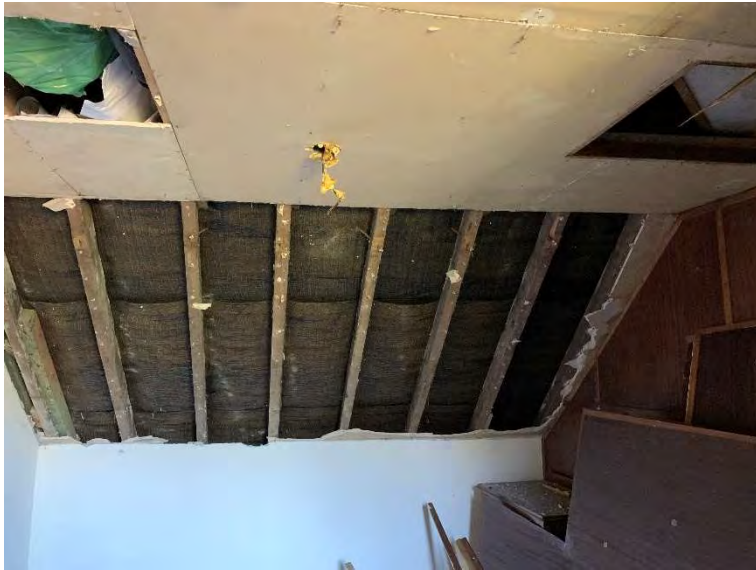
Plate 3-5: Roof space within building 2- small and cluttered

2-storey disused building with rendered walls and a slate tile roof with a single chimney. Internally, the roof space has been converted into a bedroom leaving a very small space between the ceiling and the roof (Plate 3-5). The roof tiles are lined with felt.

No potential entry/ exit points for bats were observed within the roof, however parts of the northern elevation were not visible from ground level. Internally, the roof space is small and cluttered, however the potential for bats to roost between the roof tiles and roof membrane cannot be ruled out. This building is considered to be of moderate suitability for roosting bats.

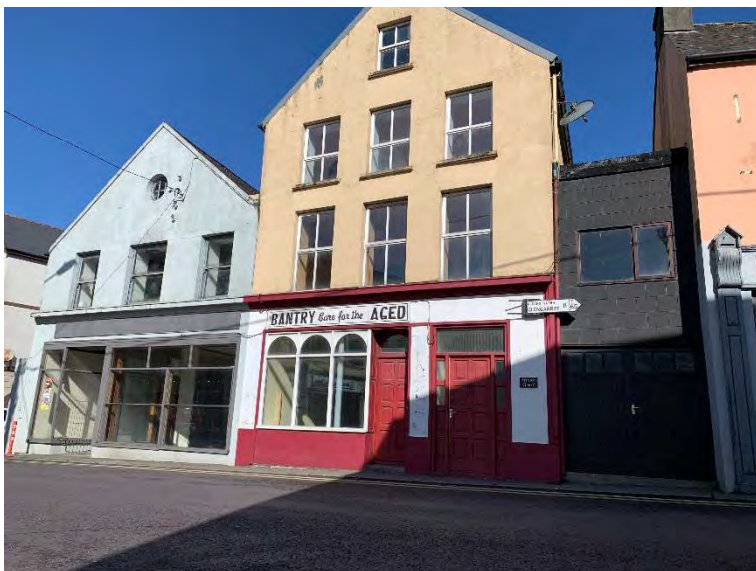
Plate 3-6: Building 3 and building 4, with a partial view of building 2

3-storey disused building oriented so that the southern gable end of the building is facing the N71 (Plate 3-6). The slate tile roof is partially visible from ground level. The walls are rendered, and the windows and doors are intact (Plate 3-7).

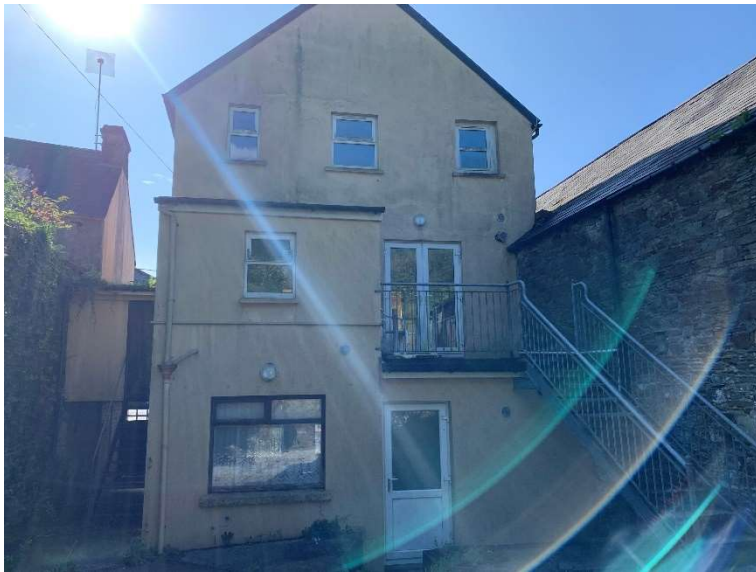
Plate 3-7: Rear (northern elevation) of building 3

Internally, the ceiling is intact and there is a roof space. The roof tiles are unlined and there is a window present within the roof space on the southern elevation.

Internally, the roof tiles are unlined and there is a window within the roof space on the southern elevation, which increases the light level within the roof space. The building does not provide the appropriate conditions required by roosts of high conservation status and is considered to be of low suitability for roosting bats.

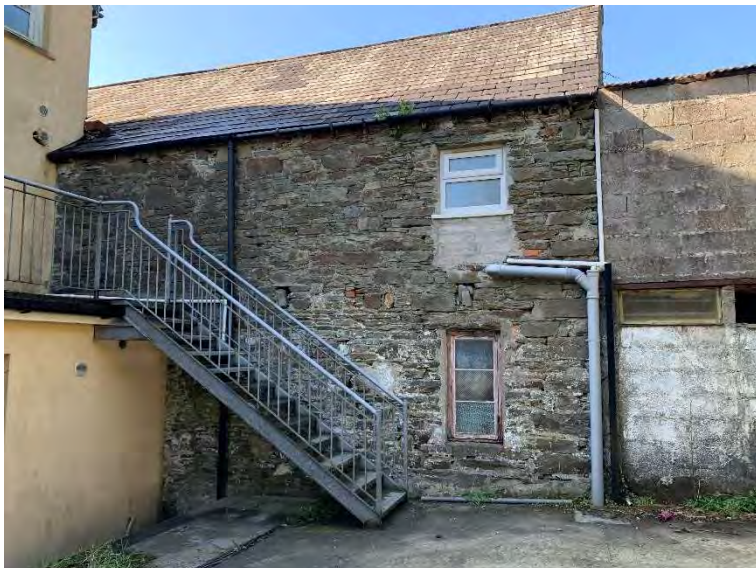
Plate 3-8: Stonewall and slate roof on eastern elevation of building 4

2-storey disused building oriented so that the southern gable end of the building is facing the N71 (Plate 3-6). The walls of the southern gable end and western elevation have been rendered, the eastern elevation is constructed of stone and has not been rendered (Plate 3-8). The roof is constructed of slate tiles and the windows and doors are intact. A block extension is present to the rear (north) of the building and a stone wall is present adjacent to the northern end of the extension (Plate 3-9).

There are potential entry/ exit points for bats via raised roof tiles and small gaps between the stonework. Internally, the roof tiles have been lined with plastic sheeting and there is ingress of light via a window on the southern elevation. This building is considered to be of low suitability for roosting bats.

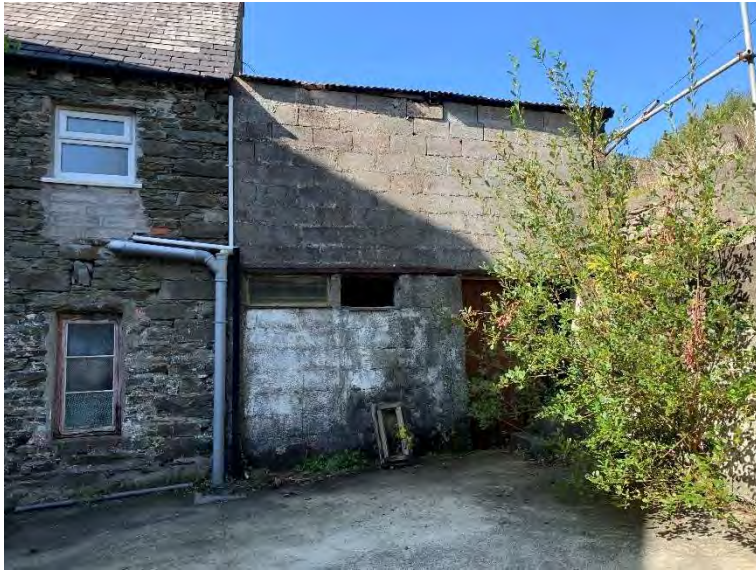
Plate 3-9: Block extension to north of building 4

The block outbuilding supports potential entry/ exit points via a missing window and a gap between the outbuilding and a stone wall to the north. Internally, the ceiling is lined by boards and the beams are exposed. This building is considered to be of moderate suitability for roosting bats.

A dead brown long-eared bat was present on the ground within the ground floor of building 4 and a small pile (c.40 no.) of lesser horseshoe bat droppings were present underneath a lip where two ceiling boards meet in the extension to building 4.

Three lesser horseshoe bats were recorded emerging from the block outbuilding attached to building 4 during the surveys undertaken on 21st and 28th September 2023. The lesser horseshoe bats light sampled under the cover present between building 2 and building 3, foraged briefly in the yard of building 3 and then flew from the site in a northerly direction.

Building 4 supports low suitability for bats within the roof space of the main building. The block outbuilding attached to the northern gable of building 4 supports potential roosting habitat on the wooden ceiling beams and the gap between the rear wall of the building and the stone external wall. The outbuilding to building 4 is considered to be of moderate suitability for bats due to the presence of one or more potential roost sites that could be used by bats due to the protection, shelter and conditions they would provide and the presence of a small number of droppings.

The proposed development includes the demolition of the outbuilding. Prior to demolition works, the outbuilding will be re-examined immediately prior to the commencement of works to assess whether bats are present. An internal building inspection and a dusk or dawn emergence/re-entry survey for evidence of bat usage immediately prior to the commencement of works will be undertaken and a passive monitor will be left recording within the outbuilding all night. In the event that no evidence of bat usage is found during the survey, works can commence with no timing restrictions. Should bats be found within the building, demolition of the extension shall occur between 1st September and 31st October or 1st March and 30th April to avoid disturbance to bats.

The outbuilding to Building 4 supports a roost for a small number of lesser horseshoe bat all year round. The proposed development includes the demolition of the extension, which is on poor condition. An alternative roost for lesser horseshoe bat will be incorporated into the design of Building 4. The new alternative roost will be constructed in advance of the demolition of the outbuilding, subject to consultation with NPWS.
