### Ecological Impact Assessment

Cork County Council

# Passage West Pedestrian and Cycle Route

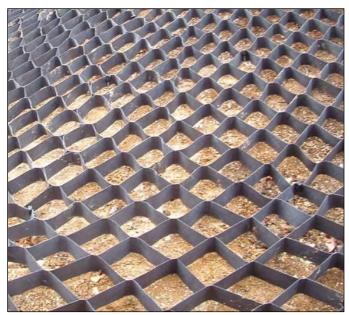
Plate 1-1 - Typical cellular soil confinement system.

The following construction details describe how the path is to be constructed near trees, so as to protect against any potential damage, to tree roots.

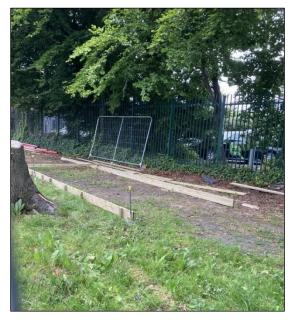
Plate 1-2 - Prepare the proposed pedestrian and cycle path for the cellular confinement system.

- **Step 1a:** The existing tarmacadam layer is to be removed from site to a licenced waste management facility.
- Step 1b: In areas adjoining existing tarmacadam, excavate top soil and sub-soil and store the soil on site for reuse.
- **Step 2:** Set up temporary Heras fencing around trees to protect them during the adjacent path preparation works. Refer to Plate 1-4 and
- Step 3: Install wooden boards to define the edge of the path. Carefully insert stakes. Refer to Plate 1-2.

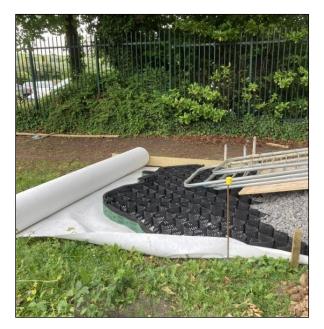
Plate 1-3 - Fill cellular material confinement system to evenly distribute loads across the proposed pedestrian and cycle path.

- **Step 4:** Where appropriate roll out geotextile Cellweb® confinement system to protect tree roots. Refer to Plate1-3.
- **Step 5:** Overlay the existing path & fill areas of **Cellweb**® confinement system with construction material, i.e., Type UGM A for the proposed pedestrian and cycle path. Refer to Plate 1-3.

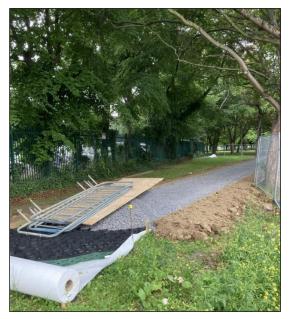
Plate1-4 - Reuse excavated soil to build slope off path.

• Step 6: Use excavated sub soil and top soil to create a slope from the path to existing ground level.

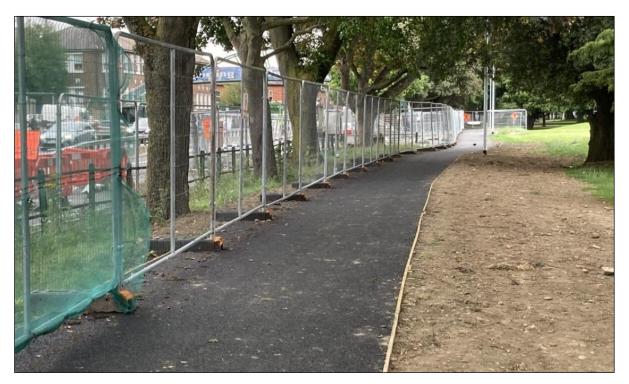
Plate 1-5 - Finish path and reinstate area alongside.

• **Step 7:** Run a roller/compactor over the path and add a layer of porous tarmacadam to seal the path. Reinstate the slope/filled in soil area with riparian grass. Refer to Plate 1-5.

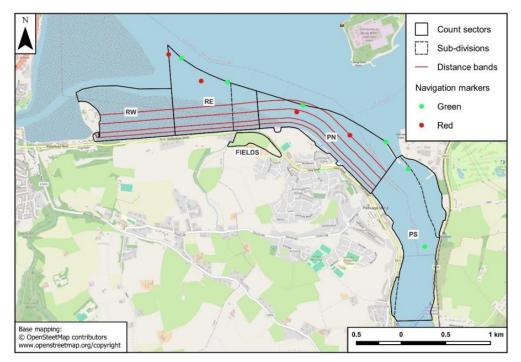
### Figure 2-1 - Survey area and count sectors (taken from Map 2.1 in the Waterbird Survey Report which is presented in Appendix E to this EcIA).

Surveys for waterbirds were undertaken from December 2023 to March 2024 by independent ecologist Tom Gittings PhD MCIEEM. These surveys covered Lough Mahon from the shore to the northern/eastern edge of the navigation channel from Hop Island to Marino Point (including bays/inlets/lagoons) and the full width of the West Passage from Marino Point to the Glenbrook ferry slipway, as well as the fields to the south of the proposed development at its western/northern end, as shown in Figure 3-1 below. The methodology and results of these surveys are detailed in the Waterbird Survey Report which is presented in Appendix E to this EcIA.

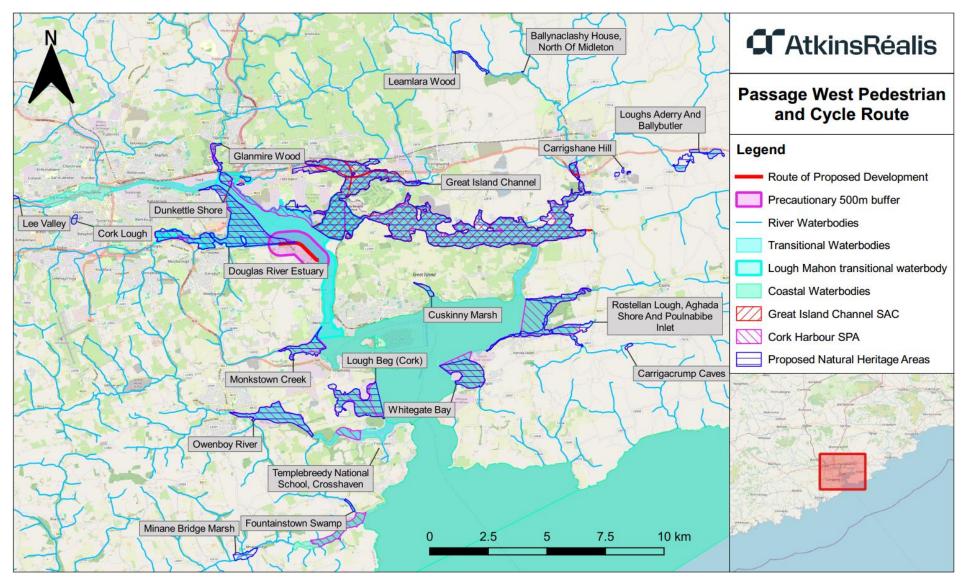
Figure 3-2 - The proposed development and its Zone of Influence in relation to designated sites.

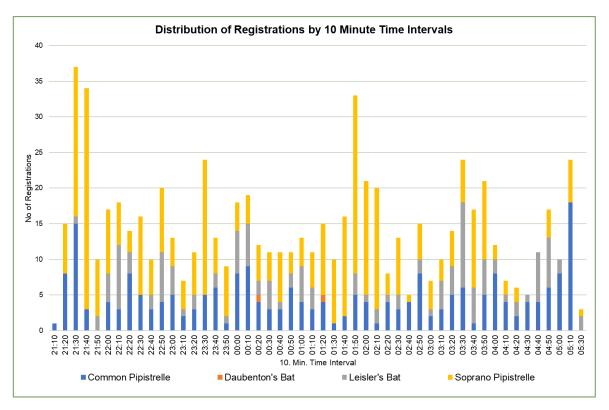
Figure 3.4 - Distribution of all bat registrations recorded by 10-minute time internal and species.

The distribution of registrations overall according to 10-minute time intervals is shows in **Figure 3.4**. The median sunset and sunrise times of the survey were 21:10 and 05:50 respectively. The disturbing of registrations does not indicate the presence of a significant roost proximal to the monitoring location.

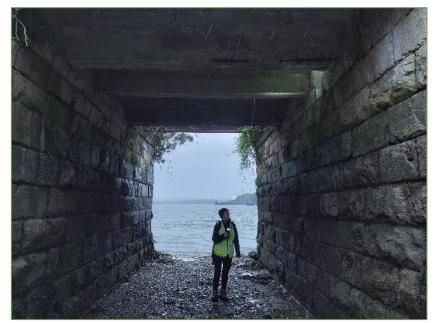
A4. Showing artificial bridge deck (No. 4) and parapet to be replaced with a 300mm wide bridge deck and railing. This deck and parapet were inspected at low tide to aid accessibility for surveyors. Minor crevices were recorded that have low potential as roosting features for crevice-dwelling bats.

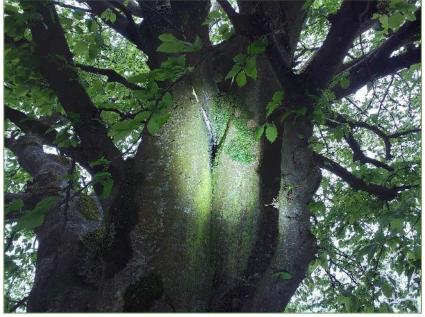
**A5.** Showing a weld presenting a PRF for crevice-dwelling bats at T595.

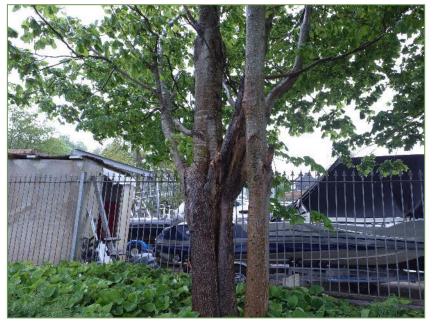
**A6.** Showing a long fissure facing east presenting a PRF for crevice-dwelling bats at T587.

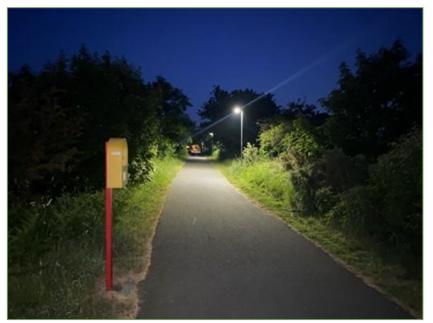
**A8.** Showing artificial LED lighting fixtures as a source of significant light pollution along the Existing Passage West Greenway.

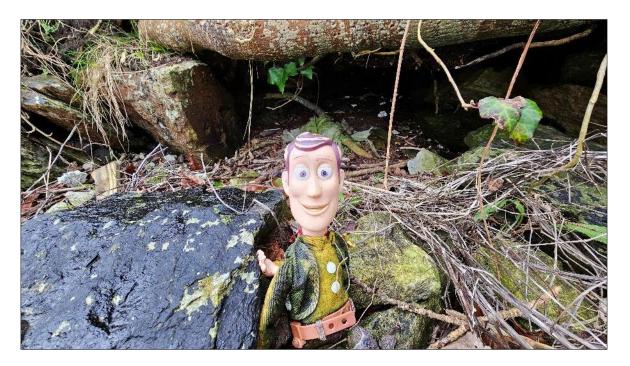
**Plate 3.8** Large crevice under sycamore root system but no otter scent spraint or signs of use, therefore not a holt site (many of these crevices existed at Railway Quay and were examined thoroughly)

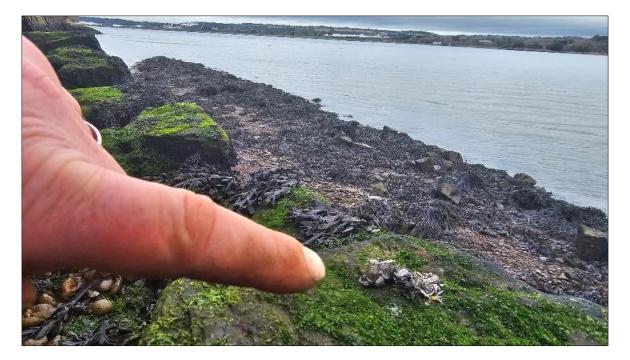
Plate 3.9 Spraint site at Railway Quay, Passage on the high tide mark on historical collapsed pier below quay wall

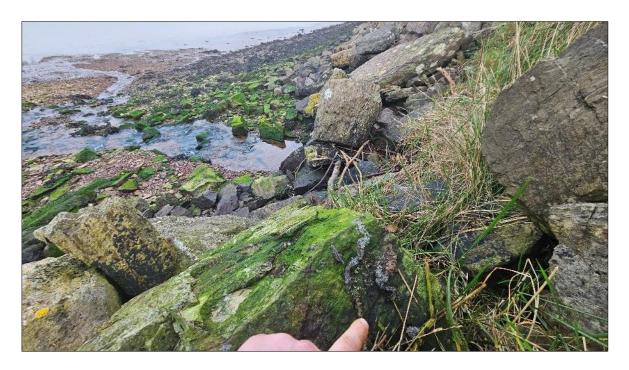
**Plate 3.12** Boulder revetments and freshwater stream with regular spraint site at Railway Quay, supporting the known importance of freshwater sources for coastal otters

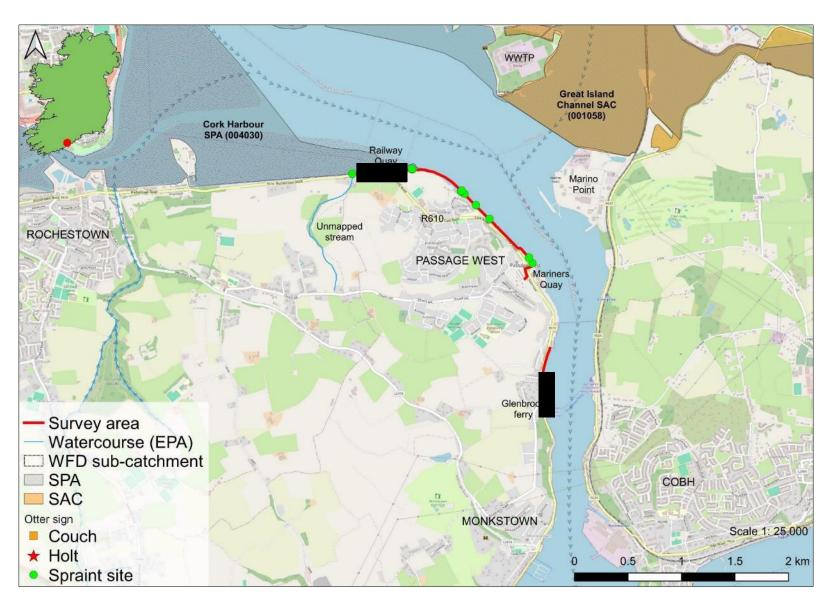
Figure 3.1 Otter sign distribution map showing otter signs inclusive of couch and holt sites in the study area

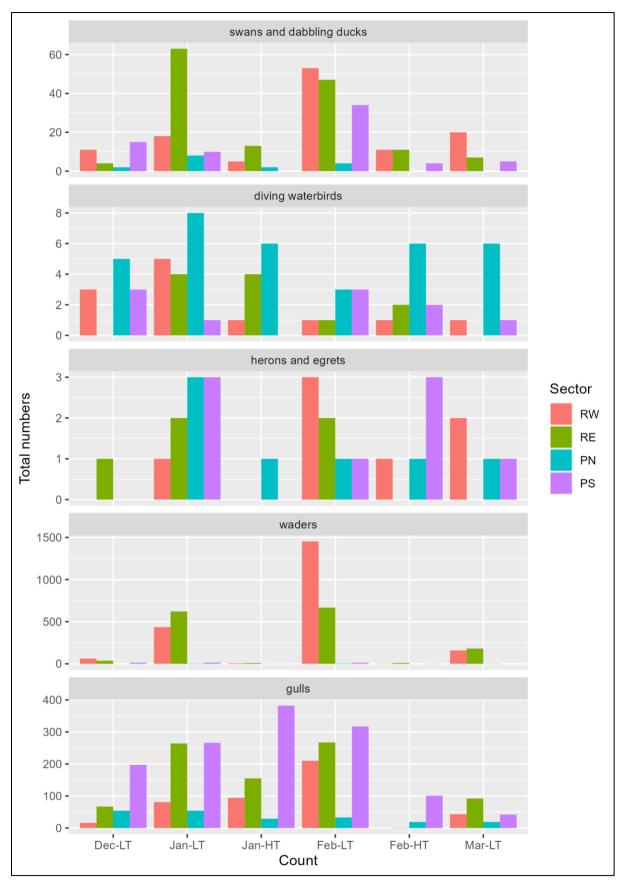
Figure 3.1. Distribution between sectors of the total numbers of waterbird groups recorded on each count.

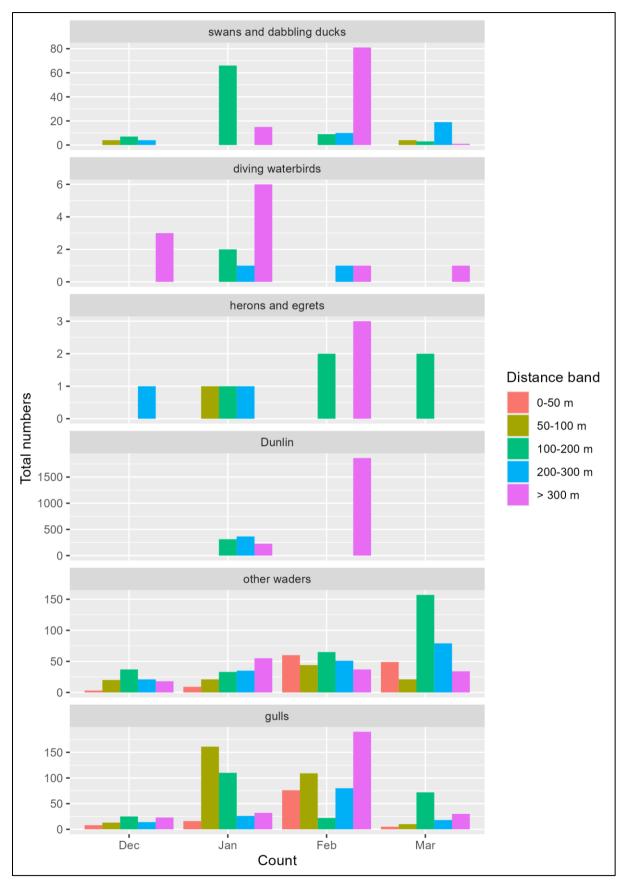
Figure 3.2. Distance band distribution on the low tide counts in the RE and RW sectors.

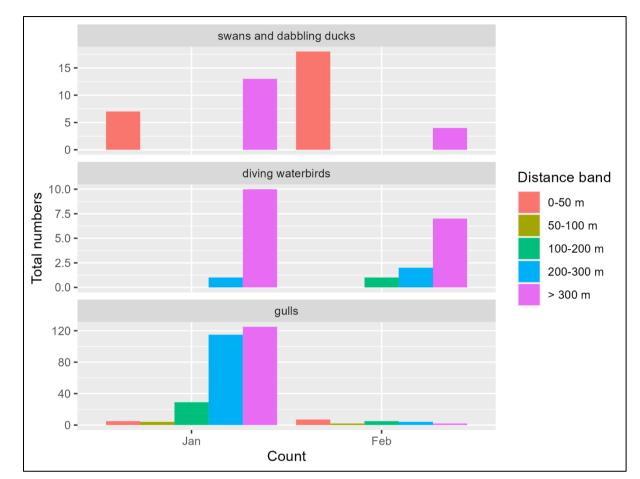
Figure 3.3. Distance band distribution on the high tide counts in the RE, RW and PN sectors.

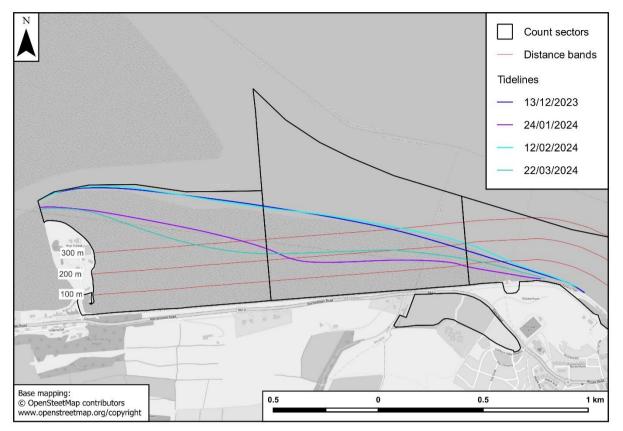
Map 3.1. Tidelines in the RW, RE and PN (western end) count sectors during the low tide counts.
