# Youghal Courthouse.

Youghal, Co. Cork.

**Conservation Report & Heritage Impact Assessment:**

*4th April 2024*

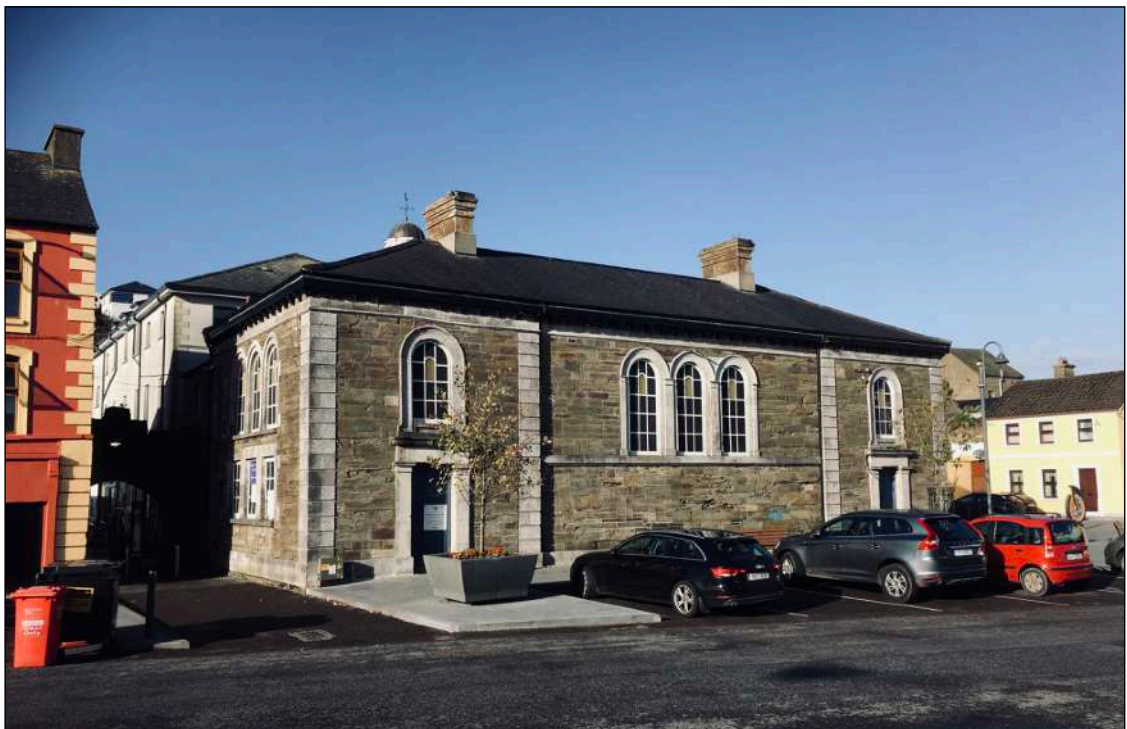
It would appear the OPW had the building re-roofed in 2014, after the building was starting to deteriorate as a result of water ingress.

• Fig 18. Courthouse Re-roofed in 2014 by OPW.

The extent of work carried out should be investigated before any assumptions that all on top is well! A previous comprehensive report indicated that roof repairs involved the repair of the original roof with new rafters paired with original and efforts were made to straighten the roof at the same time. A new roof membrane was added when re-slating. It would be important to establish if this membrane was breathable and or ventilation was provided to the roof space when these works were undertaken.

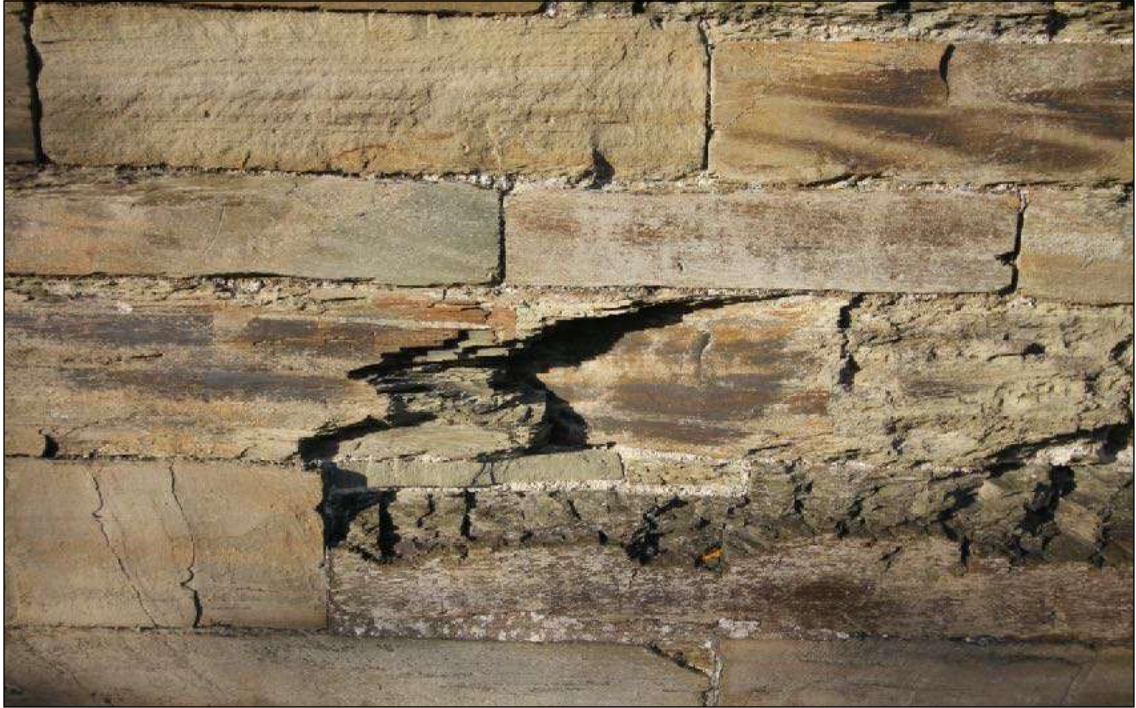
Erosion and settlement have lead to mortar joints being open in many areas and exacerbating the problems of water ingress, the associated frost damage, and water being absorbed. Some sand cement pointing repairs also add to the problem and will need to be addressed, by removal and repointing in Lime mortar.

• Fig 25. Eroded pointing and severe erosion in face bedded stones.

The front walls are coursed snecked sandstone rubble walls with limestone plinth, quoins, string course and window surrounds and eaves cornices. As previously mentioned the local sandstone is face bedding and has suffered from the inevitable effects of moisture and front damage and erosion over the years. Some pointing is cement based and has contributed to the failure in parts of the external skin.

The exterior of the building will undergo a complete refurbishment, with stone walls being re-pointed appropriately with lime mortar pointing, to improve weather resistance and to secure loose material (stone) on the facade. A more detailed study has been prepared to review this remedial work.

All external stonework defects and pointing will be addressed, and this repair work will potentially have a minor impact. The solution to the porous face bedding spalling stonework may impact on the external appearance, and will need careful consideration.

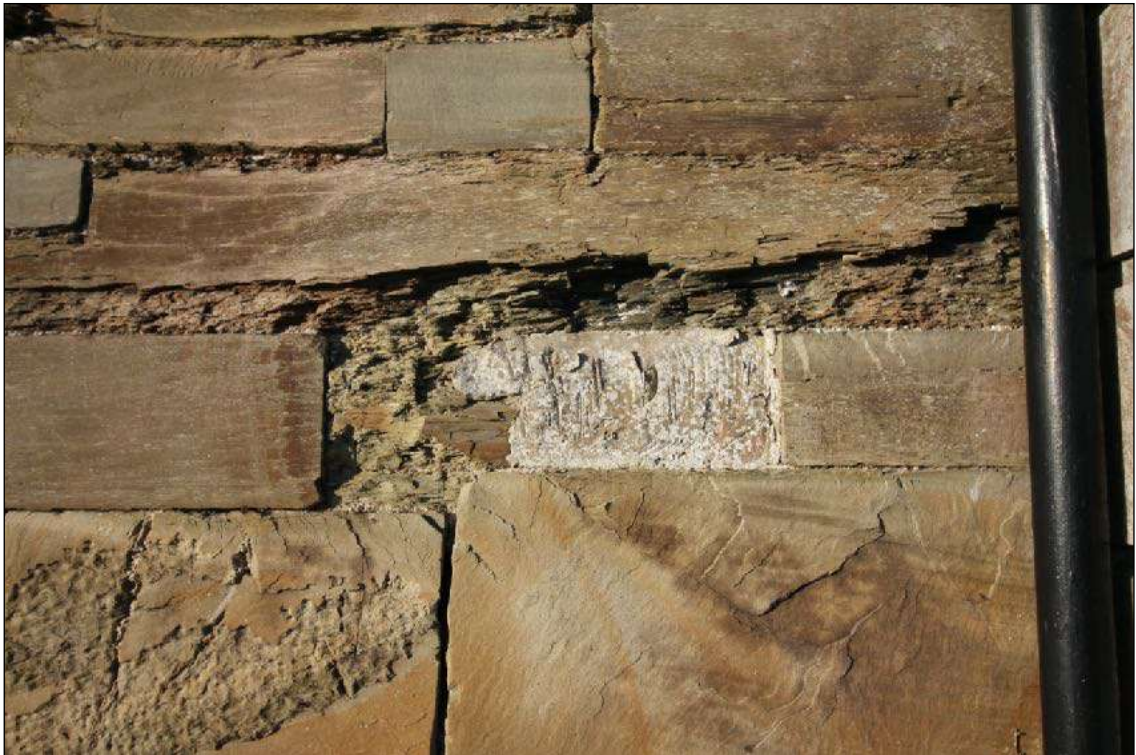
• Fig 27. Eroded pointing and severe erosion in face bedded stones.
