## Conservation Report

### Old Barrack Road, Bantry, Co. Cork

### Cork County Council

Document Title: Conservation Report

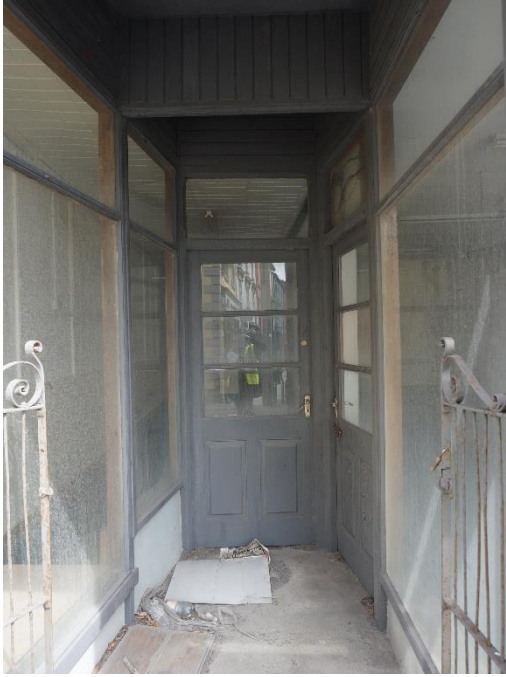
**27**  
Entrance to Building A. Two doors indicate the possibility that the building was divided with living entering the straight on door and business to the right making for a retail-residential unit.

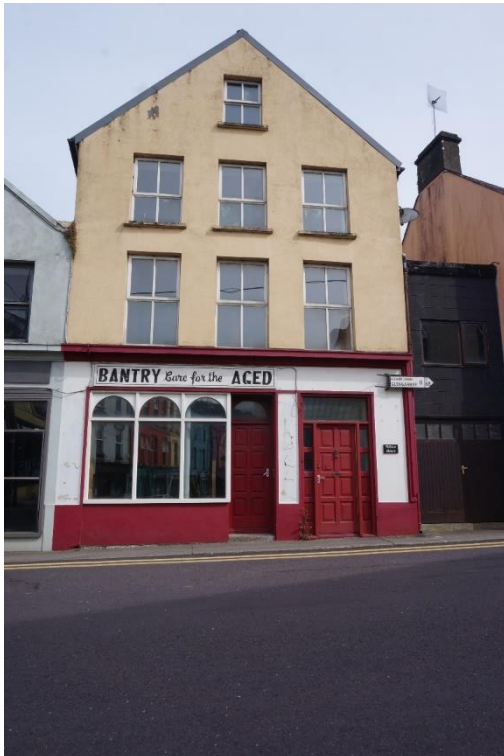
**34**  
Exterior of Building B.

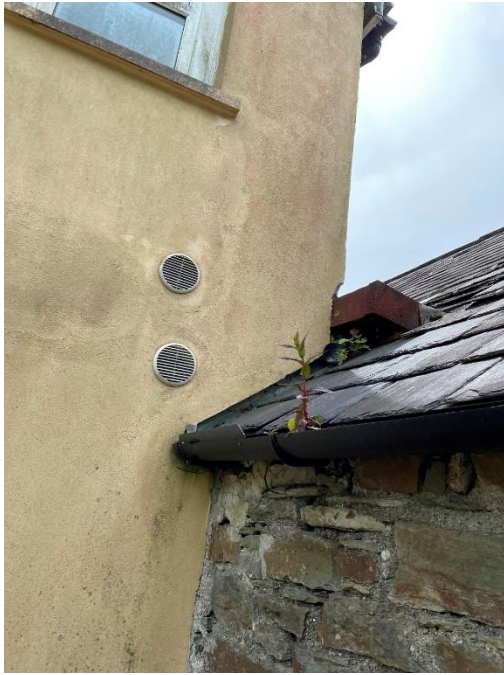
**58**  
Rear elevation of Building  
B. Ventilation detail.  
(credit: Cork County  
Council)

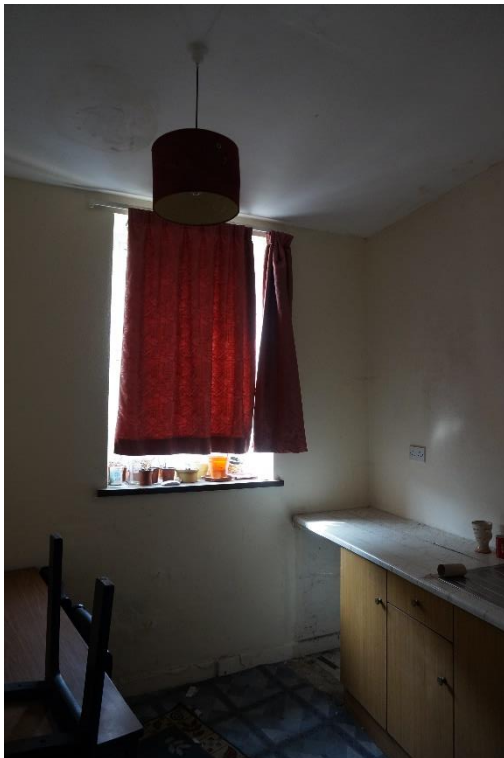
**66**  
Interior of Building C.  
Walls have been dry-  
lined. Not original to build.

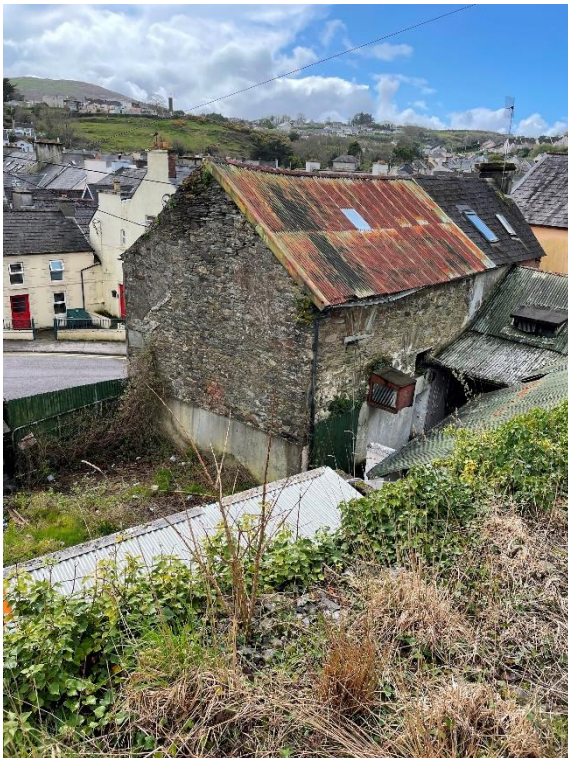
**85**  
Rear of Building D.  
(credit: Cork County  
Council)
