Peter Haferkamp
ISA Certified Arborist
CERT ID: UI-1332A

Tree Report at Park, Knocknagree, Mallow, County Cork

02.05.2024

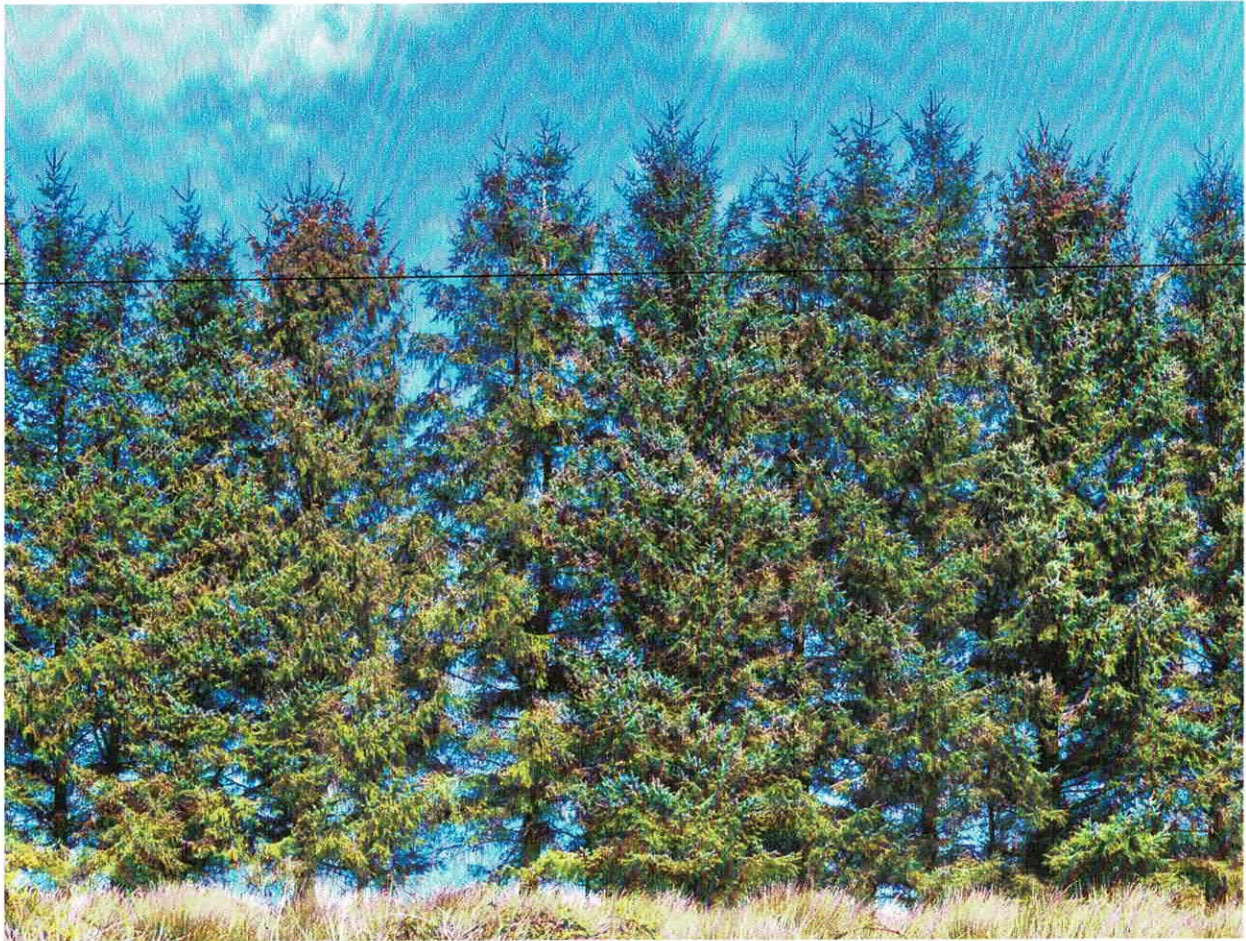
Most trees are at an early stage of maturity (semi-mature) and will provide a good establishment and basis for further landscaping development, provided they are protected and looked after in the process.
