# Youghal Courthouse.

Youghal, Co. Cork.

**Conservation Report & Heritage Impact Assessment:**

*4th April 2024*

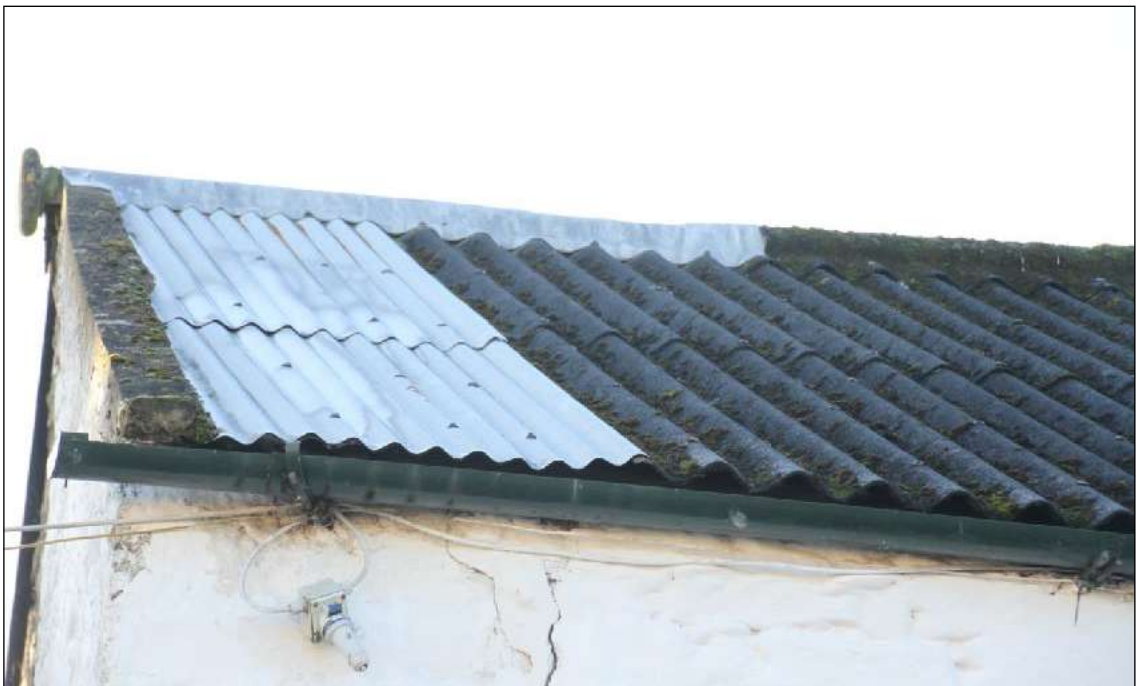
The roof of the Soup kitchen was clearly not part of this same project and is in need of replacement. This roof is most likely to be a typical Corrugated asbestos sheet roof, with some previous repairs in corrugated iron. Survey would be required and asbestos specialist engaged to remove and dispose of.

Rainwater goods to Soup Kitchen are poor and should be replaced with the roof.

• Fig 30. Gutter detail to Soup kitchen and corrugated roof.

The roof of the Soup kitchen needs further inspection at a height to confirm the condition of the timber structure. Asbestos will have to be addressed.

The Soup kitchen roof will need to be replaced. This corrugated roof will have to be removed. The roof will be re-slatted. A full assessment of structural timbers will be carried out when works are being undertaken and no sound material will be removed, with repairs as required.

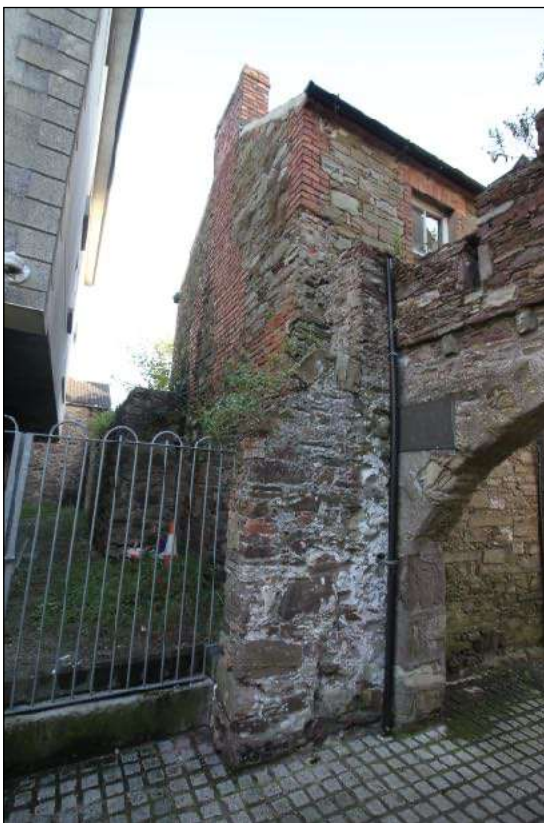
• Fig 33 &34. Southern gable and SW corner with rubble walls and poor pointing, and Cromwells Arch.

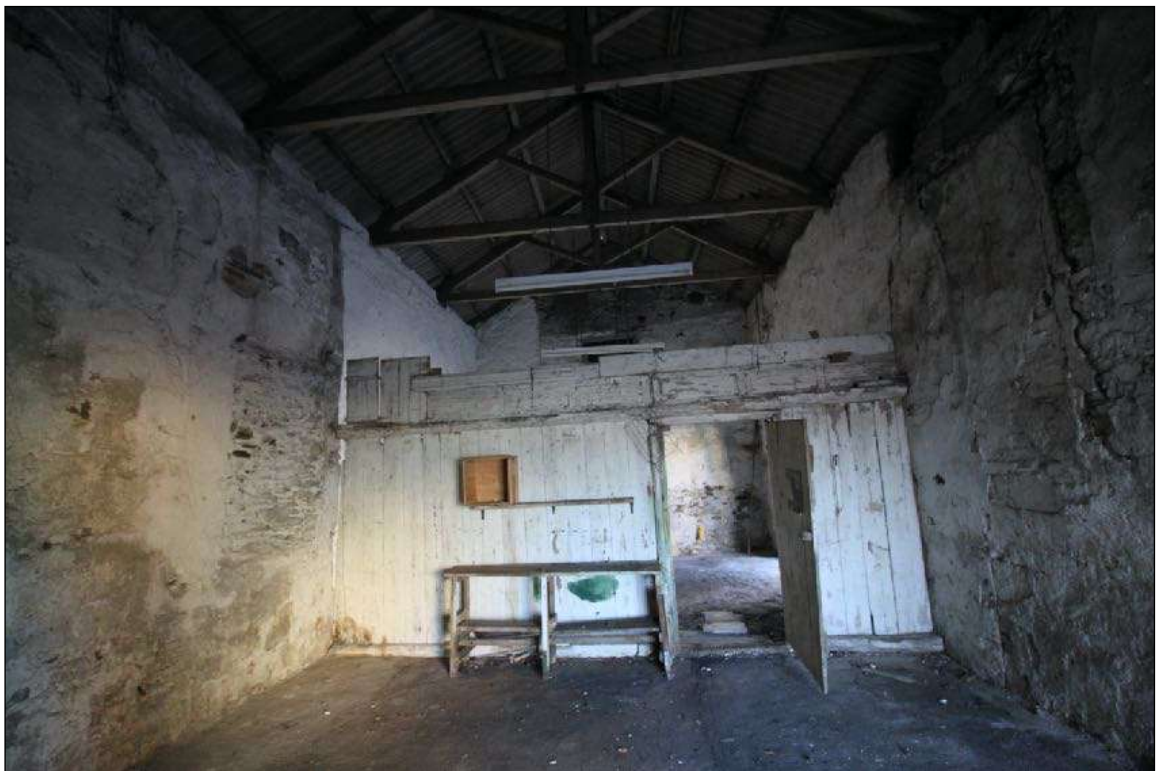
• Fig 119. Roof structure and corrugated sheets above.
