## Conservation Report

### Old Barrack Road, Bantry, Co. Cork

### Cork County Council

Document Title: Conservation Report

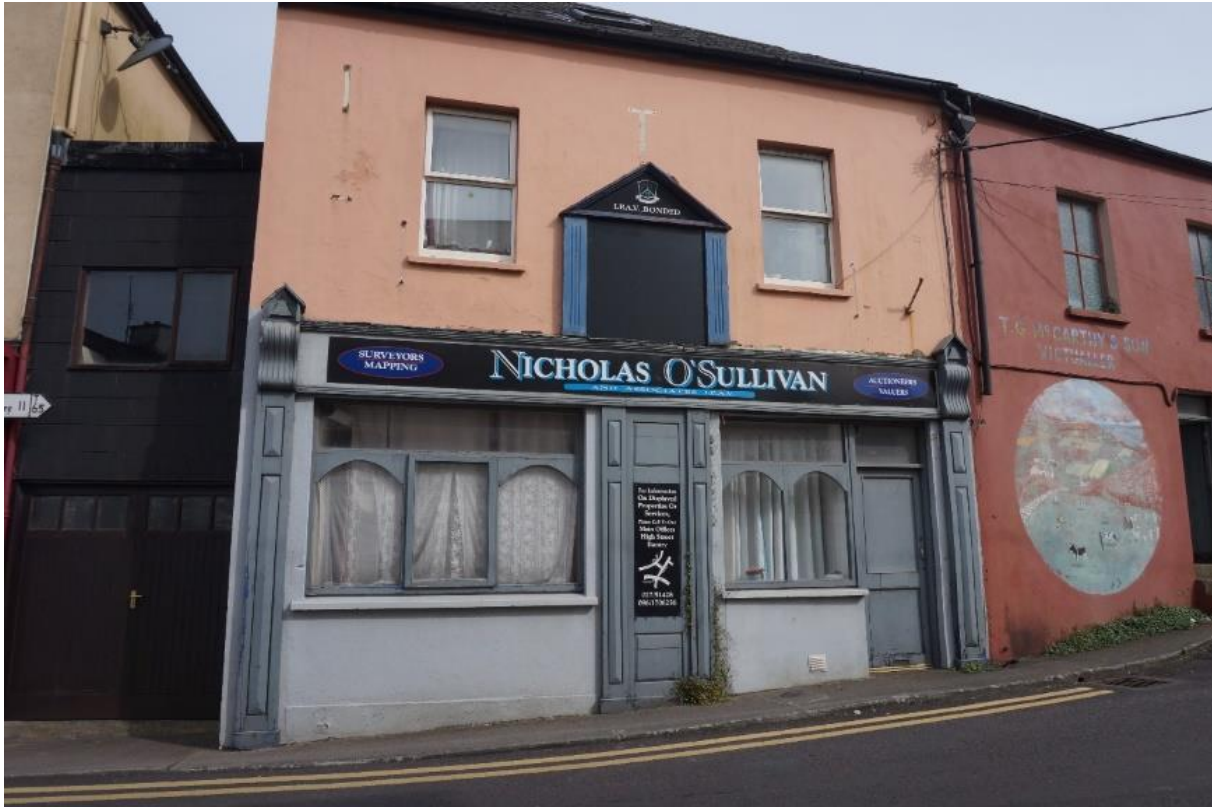
## Building C

Smooth plaster render with a late 20<sup>th</sup> c. shopfront on ground floor, Nicholas O'Sullivan and Associates I. P. A. V. (since moved to Main Street). Modern uPVC windows on first floor.

Substantial alterations to original plan form. It is likely that the interior has been heavily modified as drylining and all modern finishes are present.

Fair. Building envelope appears intact with no signs of water ingress at time of inspection.

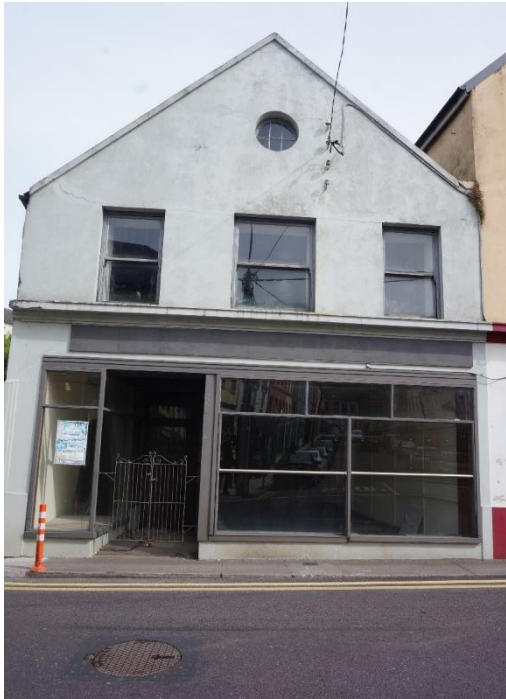
**25**  
Exterior of Building A.

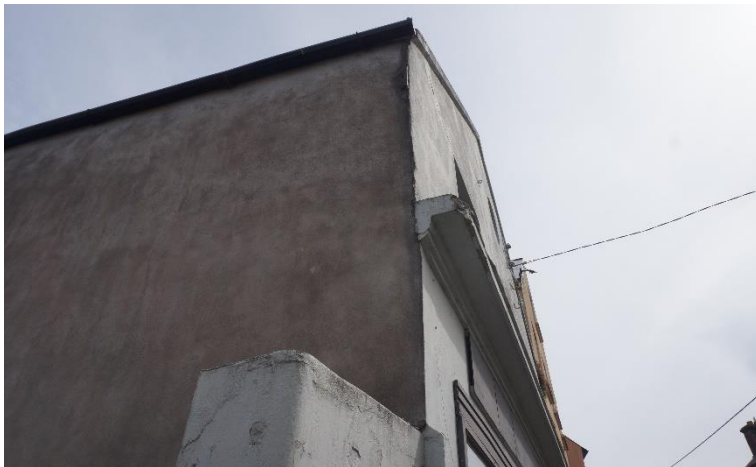
**26**  
External view of Building  
A. There used to be a  
building here built  
between 1914-1936.

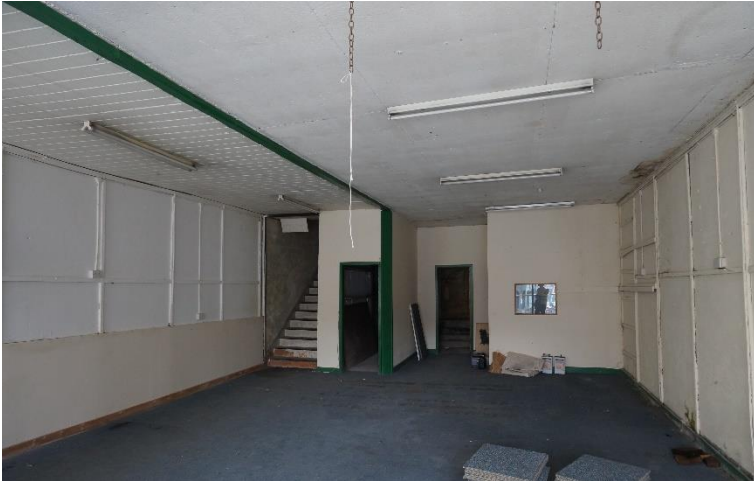
**28**  
Interior of Building A. Note green marks where there may have been a dividing/partition wall.

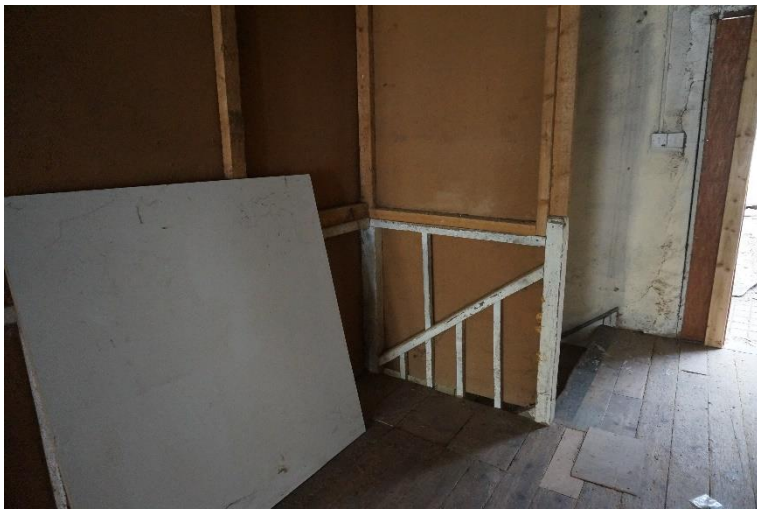
**31**  
Timber rail on upper floor.

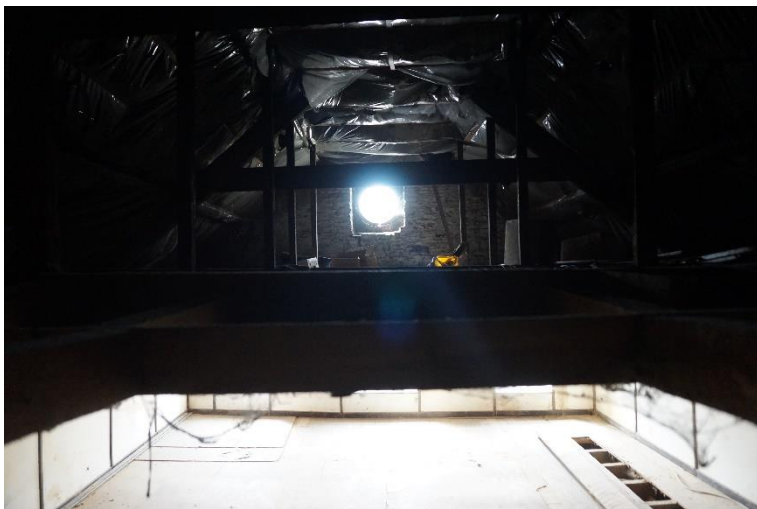
**32**  
Interior of Building A. Roof  
structure.

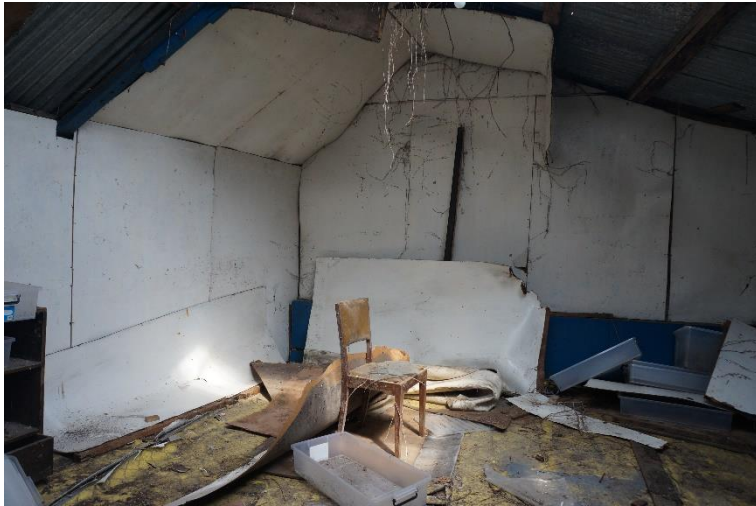
**33**  
Interior of Building A.  
Roof/attic space.

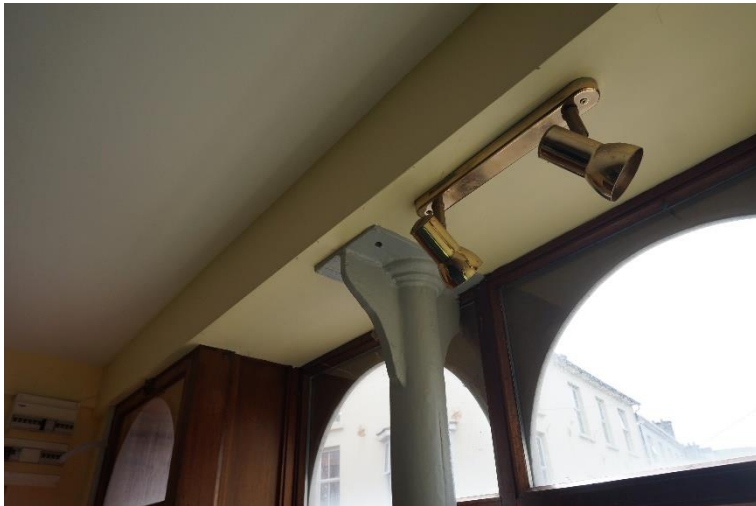
**36**  
Interior of Building B. Note  
original cast-iron column  
has been preserved.

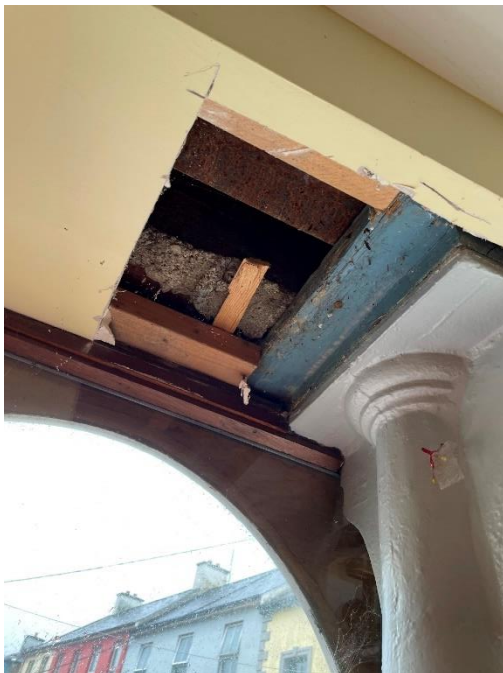
**37**  
Interior of Building B.  
Reveal of alterations and  
cast-iron column. (credit:  
Cork County Council)

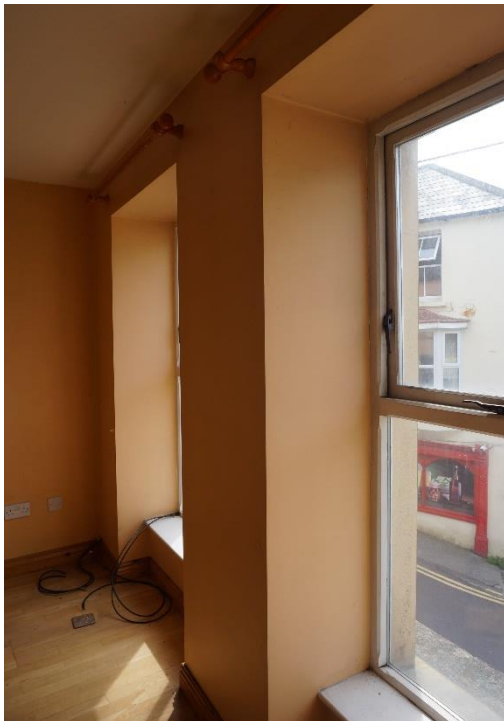
**43**  
Interior of Building B.  
Walls have been dry-lined. Not original to build.

- The quality of the work previously completed on these buildings should be analysed, i.e. dry lining of Buildings A, B, and C, to ensure there is no signs of building failure, etc.

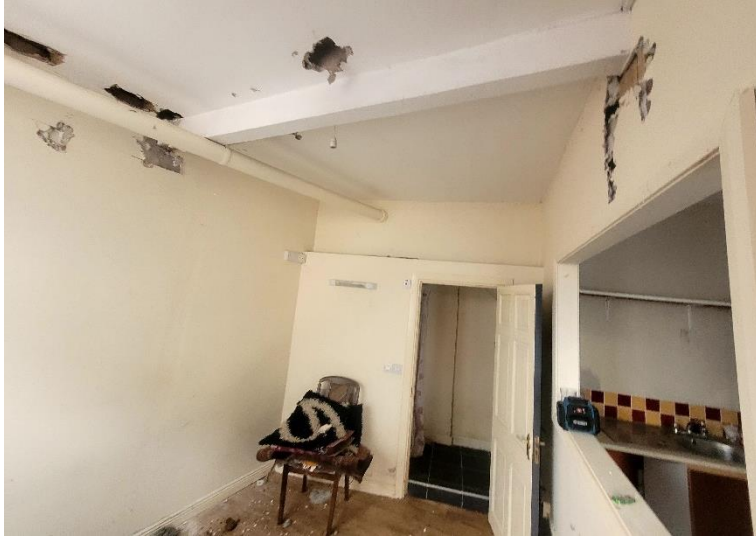
**45**  
Interior of Building B.  
Kitchen area on right. Not  
original to build. (credit:  
Cork County Council)

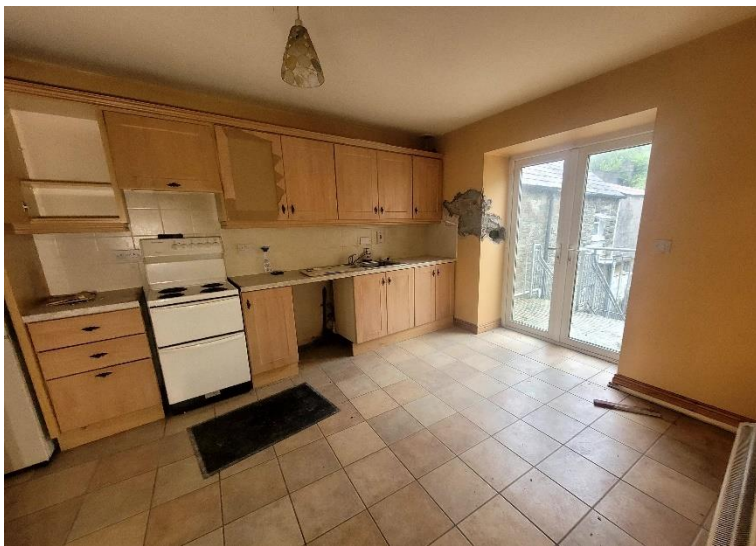
**46**  
Interior of Building B.  
Kitchen area. Not original  
to build. (credit: Cork  
County Council)

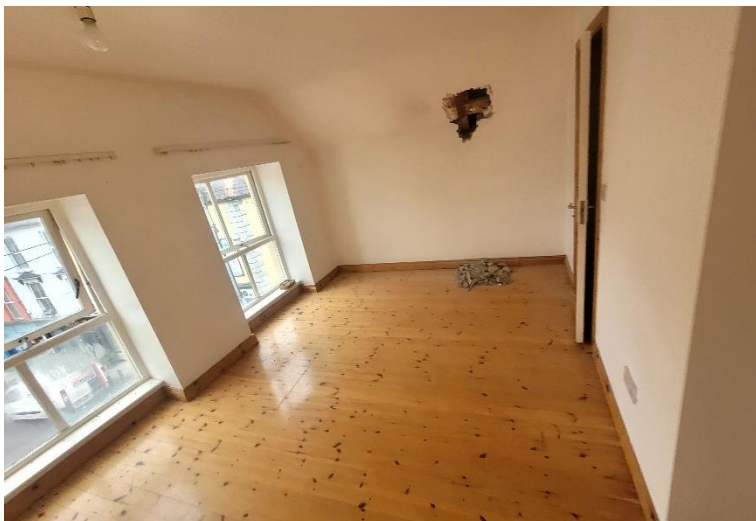
**47**  
Interior of Building B. Not  
original to build. (credit:  
Cork County Council)

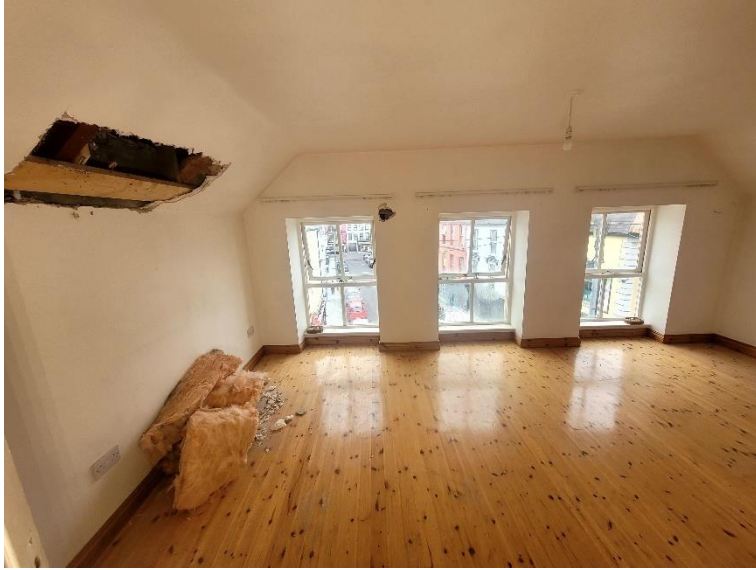
**48**  
Interior of Building B. Not original to build. (credit: Cork County Council)

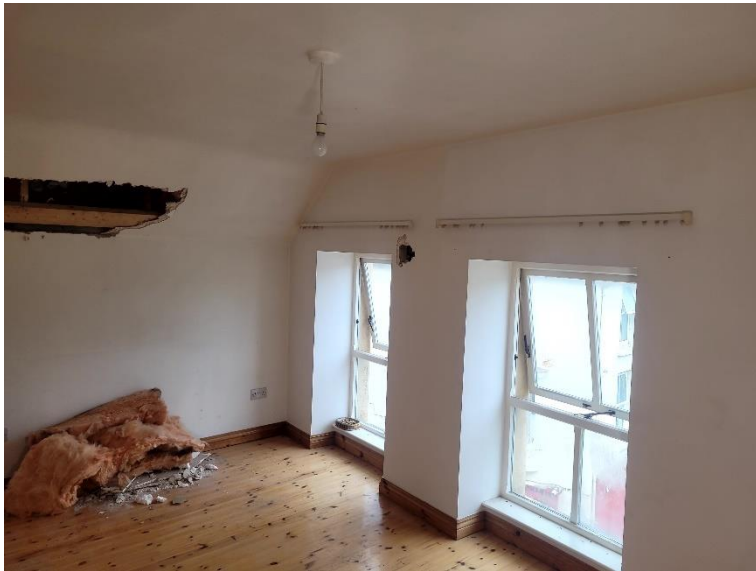
**49**  
Interior of Building B. Not original to build. (credit: Cork County Council)

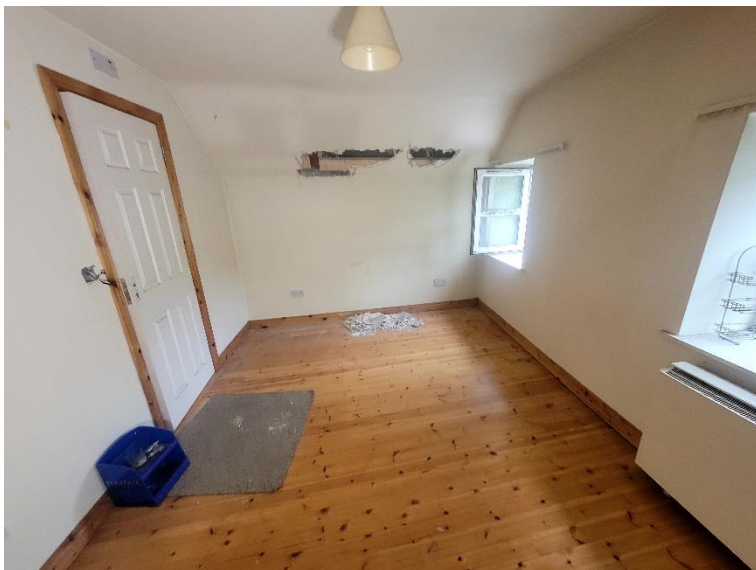
**50**  
Interior of Building B. Not original to build. (credit: Cork County Council)

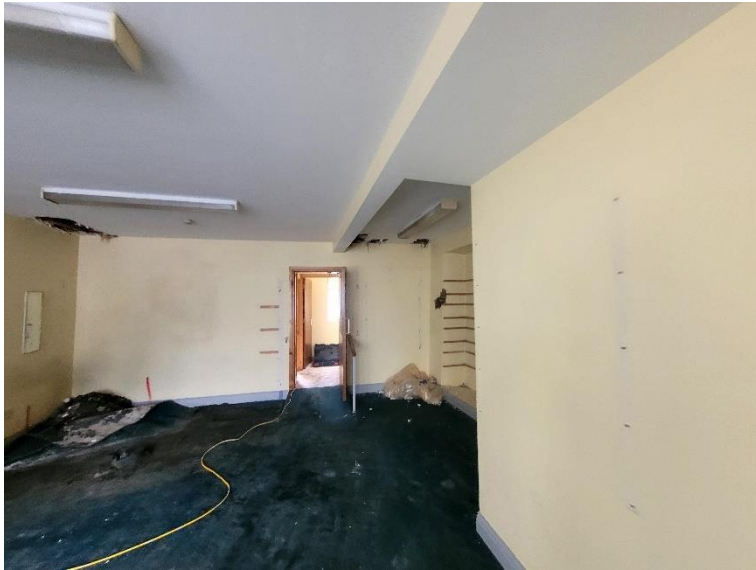
**51**  
Interior of Building B. Not original to build. (credit: Cork County Council)

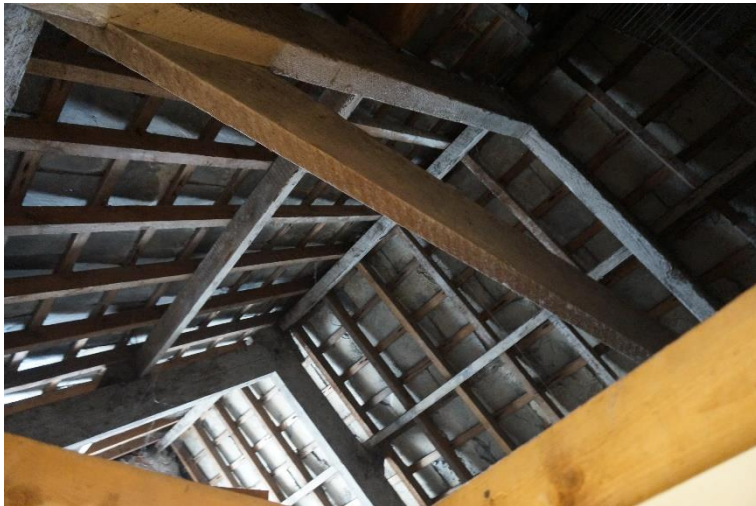
**52**  
Interior of Building B. Original roof structure has been retained. Evidence of parging.

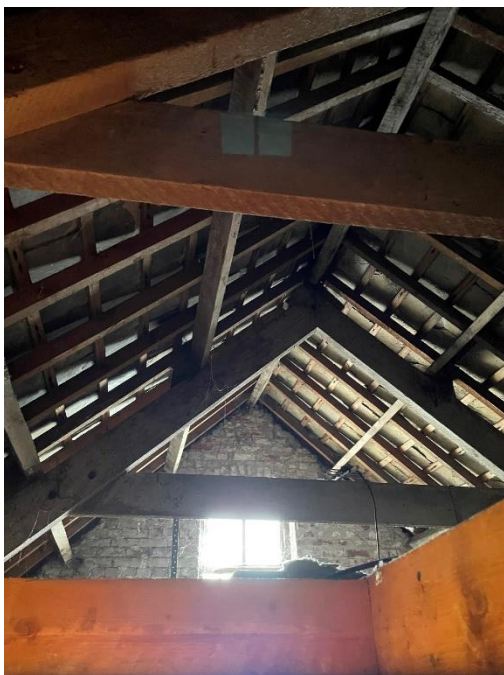
**53**  
Interior of Building B. Original roof structure has been retained. Evidence of parging. (credit: Cork County Council)

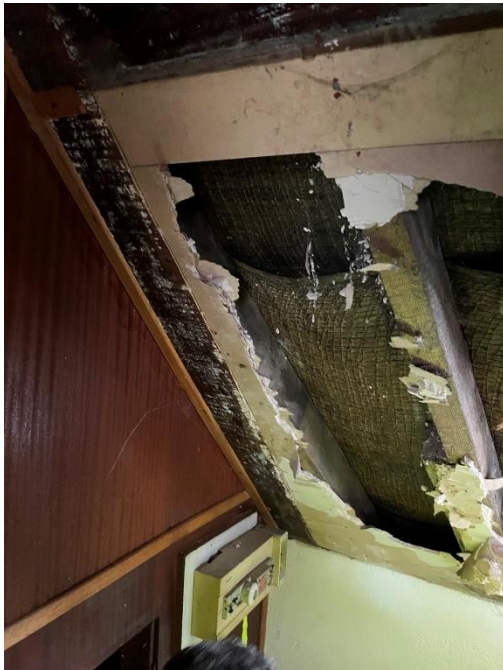
**55**  
Interior of Building B.  
Original roof structure has  
been retained. Evidence  
of parging. (credit: Cork  
County Council)

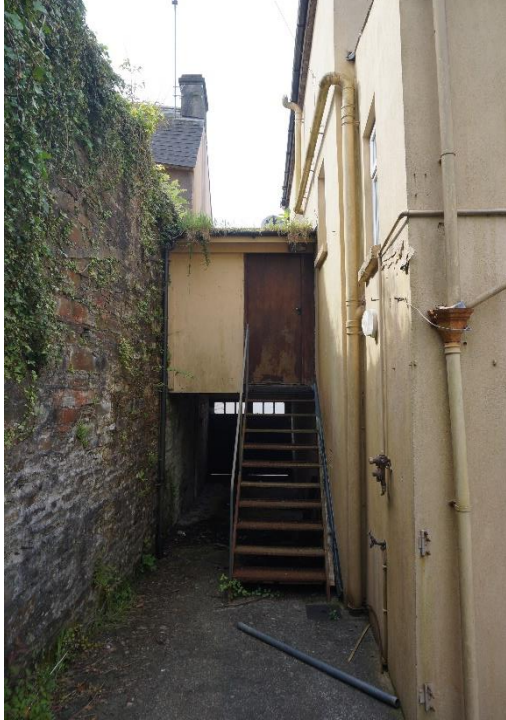
**56**

Rear elevation of Building B. Note gap between buildings could be opened to form a laneway to rear of buildings.

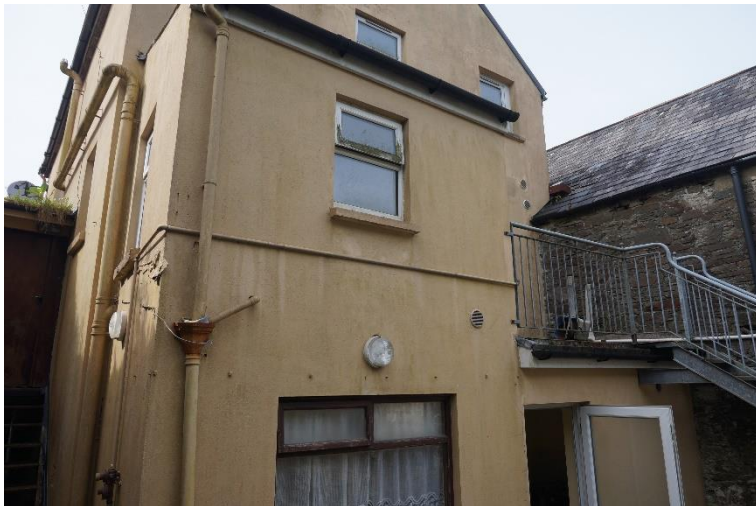
**57**

Rear elevation of Building B.

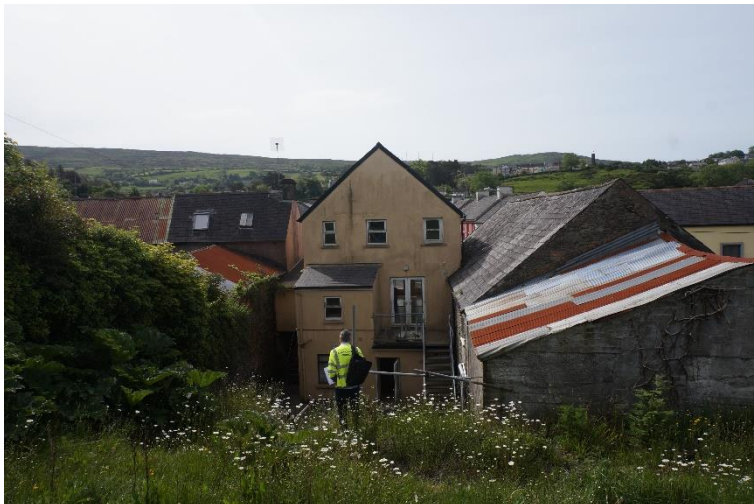
**59**  
Rear elevation of Building  
B. Photo taken from 2m  
high embankment/former  
railway line. Varying roof  
types and gable ends of  
all buildings visible.

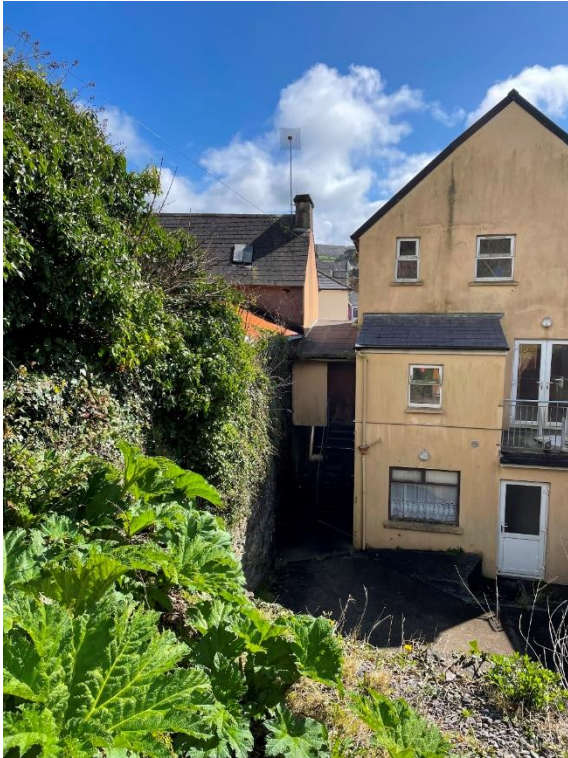
**60**

Rear elevation of Building B. Photo taken from 2m high embankment/former railway line. (credit: Cork County Council).

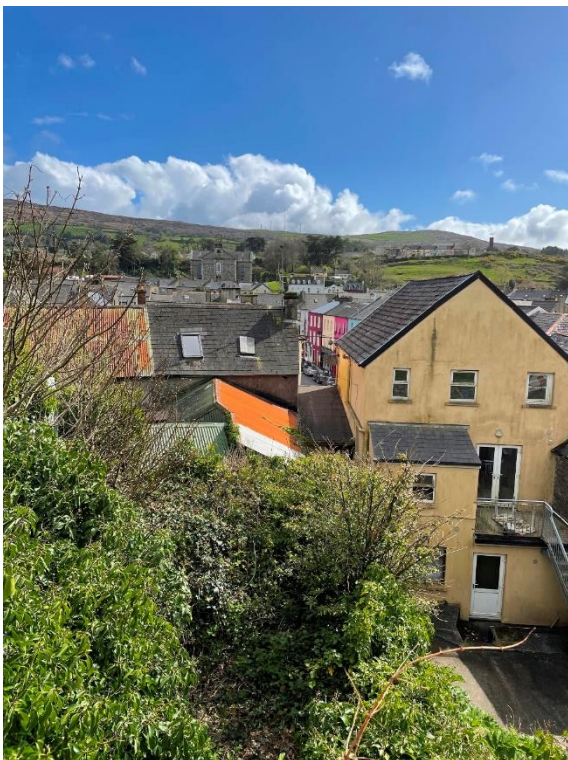
**61**

Rear elevation of Building B and C. Photo taken from 2m high embankment/former railway line. (credit: Cork County Council).

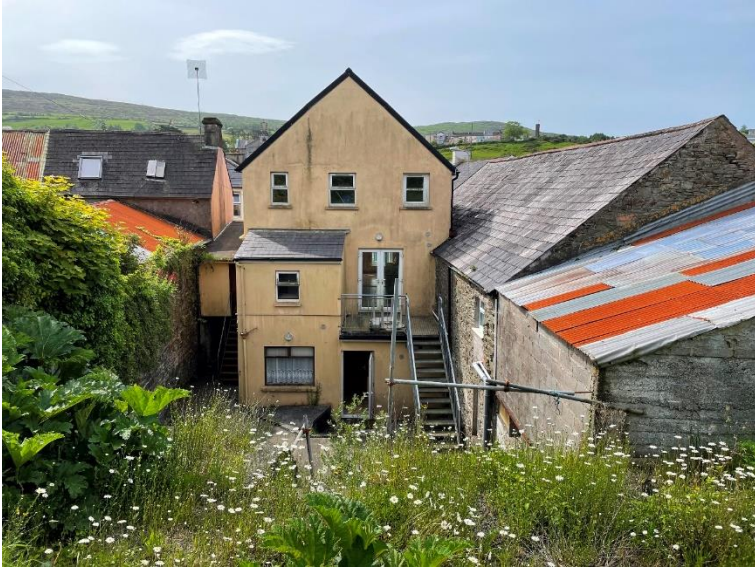
**62**  
Rear elevation of Building B. Photo taken from 2m high embankment/former railway line. (credit: Cork County Council).

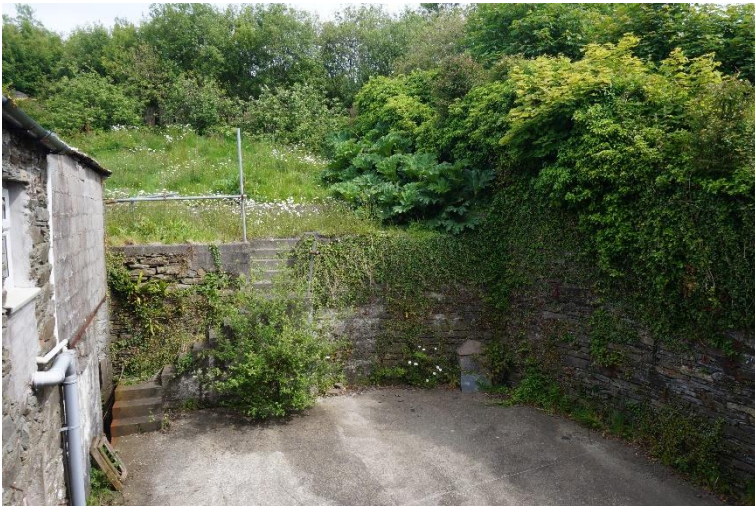
**63**  
Rear garden of Building B. Note 2m high embankment where the former Cork, Bandon, and South Coast Railway ran.

- In terms of the site itself, the varied and abrupt level changes will be both a difficult and exciting design challenge. The condition of the retaining walls should be considered and analysed with removal of vegetation included in this process.

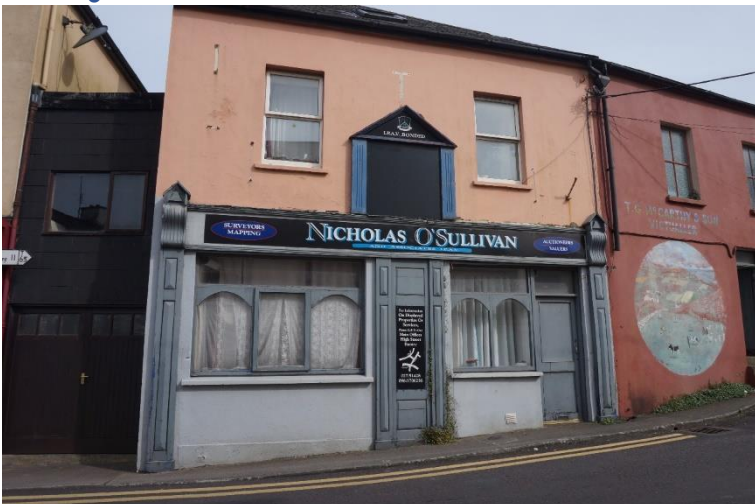
**64**  
Exterior of Building C.

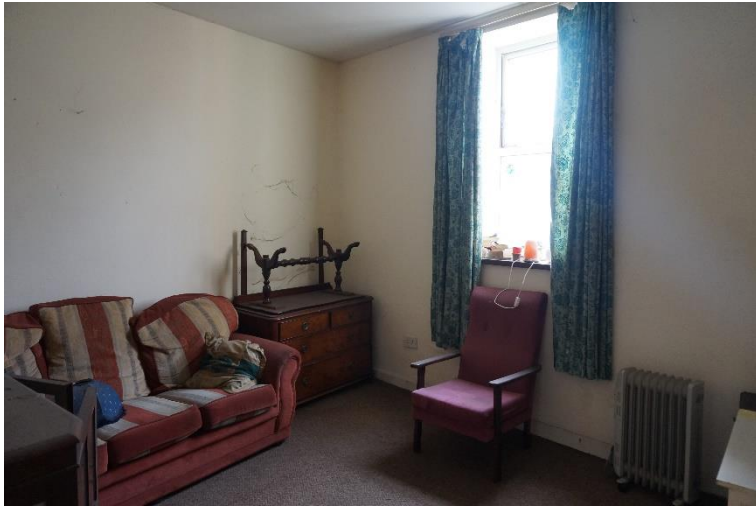
**67**  
Interior of Building C.  
Walls have been dry-  
lined. Not original to build.

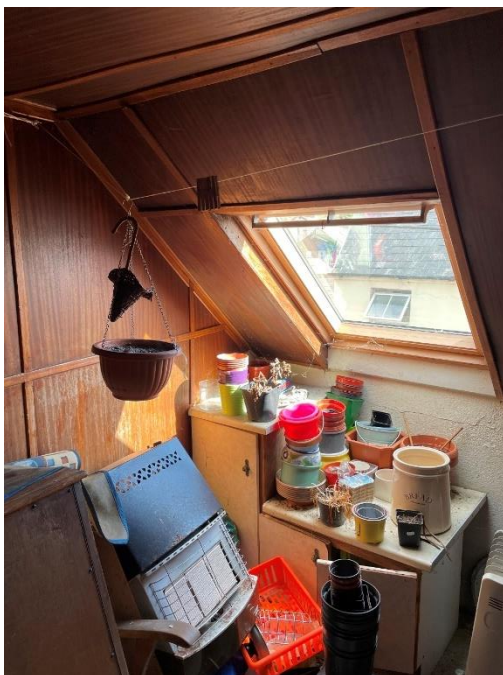
**68**  
Interior of Building C. Attic  
room. Walls have been  
dry-lined. Not original to  
build. (credit: Cork County  
Council)

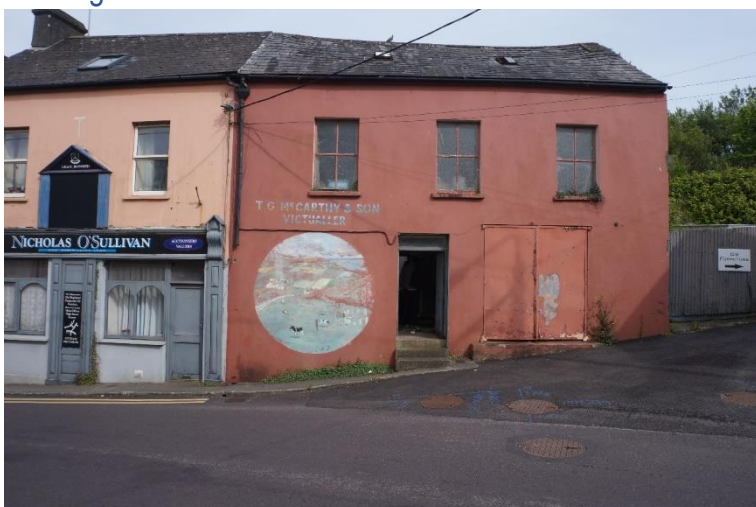
Building is in an extremely poor and vulnerable condition. Most of all the first floor has been lost and the attic floor is at the point of collapse.

**72**  
Exterior of Building D.

- Stabilise structure in the immediate term to prevent further structural deterioration.
- Ensure weather envelope is intact addressing roof allowing temporary repairs to any leaks.
- Permanent works to include:
  - repairs to roof structure to include retention of existing historic trusses and purlins. Allow for new natural slate finishes.

- retain, repair, and consolidate existing stone masonry walls carrying out repairs to buckeyes and distorted areas (particularly beneath first floor window cills). Allow for new external lime render and consider a breathable insulated lime-based Atwater to the internal faces. The existing circular painted mural should be retained, as it provides an illustration of the historical use of the building, contributing to the ACA streetscape.
- reinstatement of first floor in position of floor lost utilising existing joist pockets for new floor joists.
- repair first floor fenestration.
- install new internal partitions and finishes as per design architects' intentions assuming residential use to upper floor.

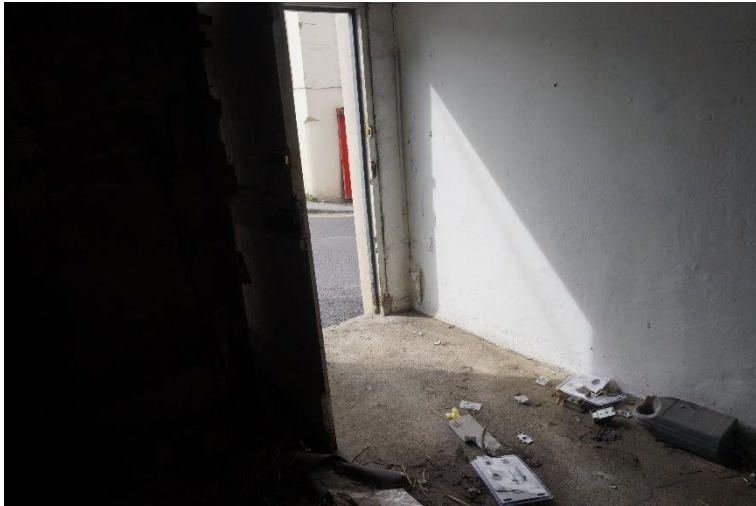
**73**  
Entrance to Building D  
view from inside.

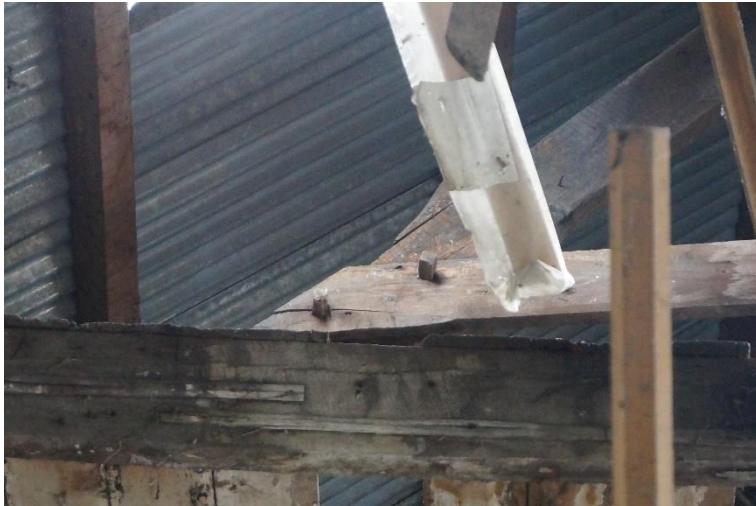
**79**  
Interior of Building D.  
Original roof structure with  
pegged truss detail.

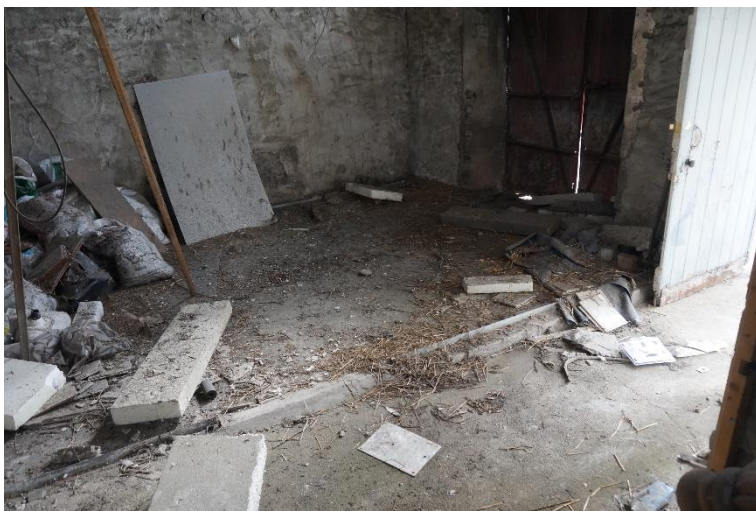
**80**  
Interior of Building D.  
Most likely used as store.

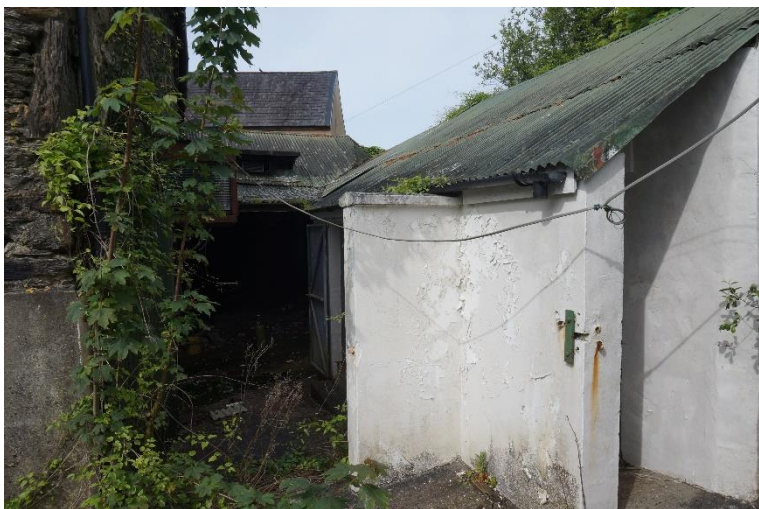
**82**  
Shed in rear garden of  
Building D.

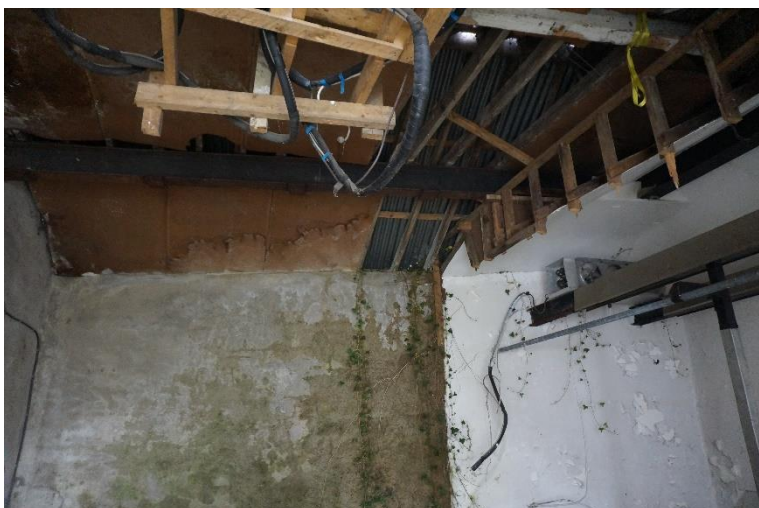
**83**  
Shed in rear garden of  
Building D.
